**Massachusetts Bay
Transportation Authority**

Report from the Deputy General Manager

June 7, 2021

Orange Line Incident Investigation Update

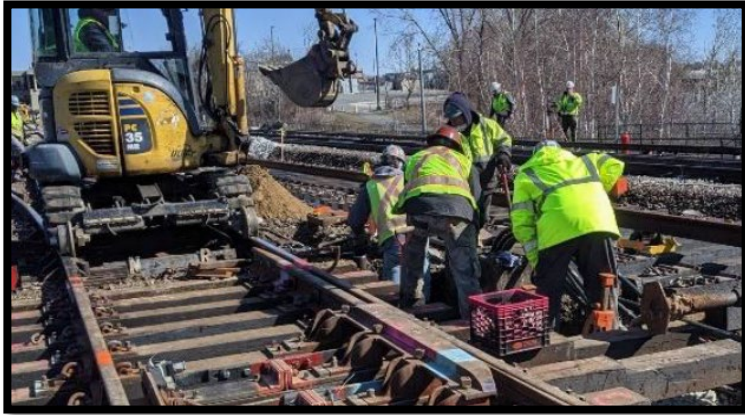
Derailment Investigation Continues – probable causes are a combination of contributing factors.

Infrastructure:

- No guard rail, additional preventative rail used to hold train on tracks, at switch.
- Cross level of track at the switch - Within our standards but approaching limit.
- Coefficient of friction of track at switch - Estimated to be higher than industry standard.

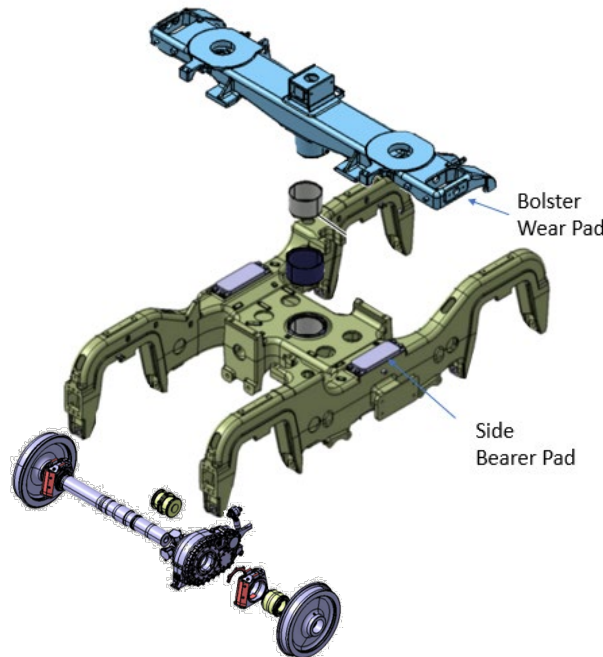
Vehicle:

- Excessive rotational force of truck – rotational force found to be outside of design limits due to degradation of performance of side bearer pads.

All parties are working to reintroduce the cars back into revenue service.
