Assess Existing Pumping Capacities, Permits and Current and Future Vulnerabilities

Massachusetts Bay Transportation Authority

MBTA GREATER BOSTON AREA, MA PUMP RESILIENCY & CLIMATE CHANGE HURRICANE SURGE MAP

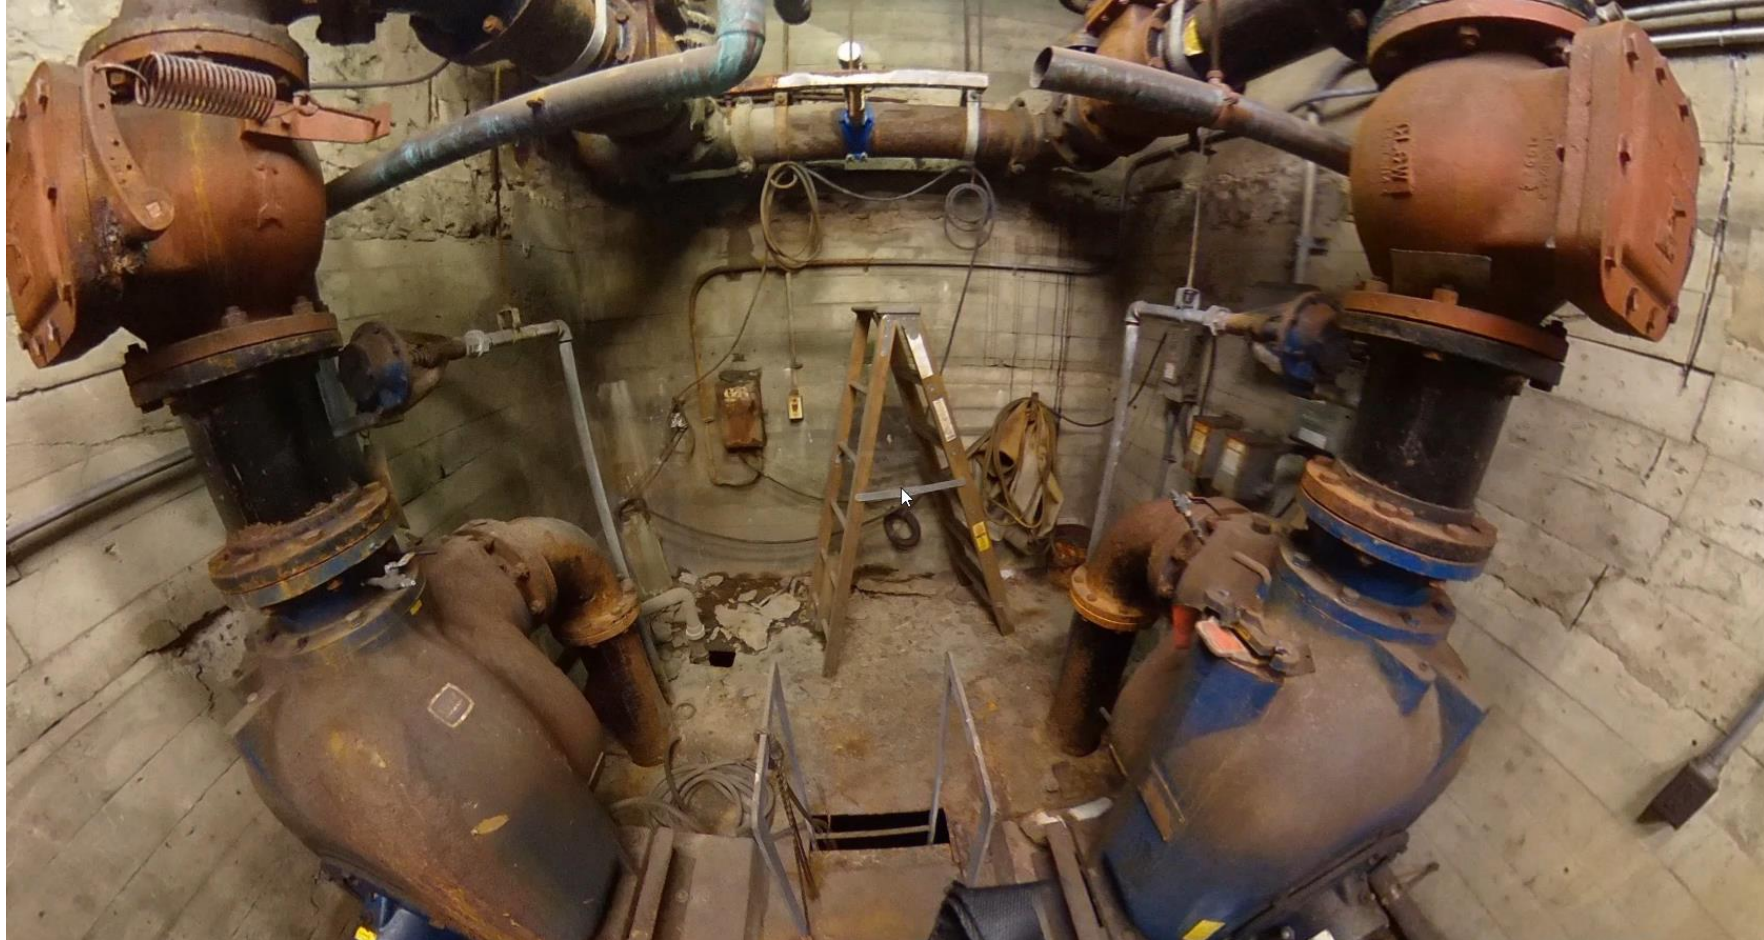
Prudential in **Green Line**
Nearest station: Copley Station.

Enter by riding the green line and getting off at the pump room in the tracks.

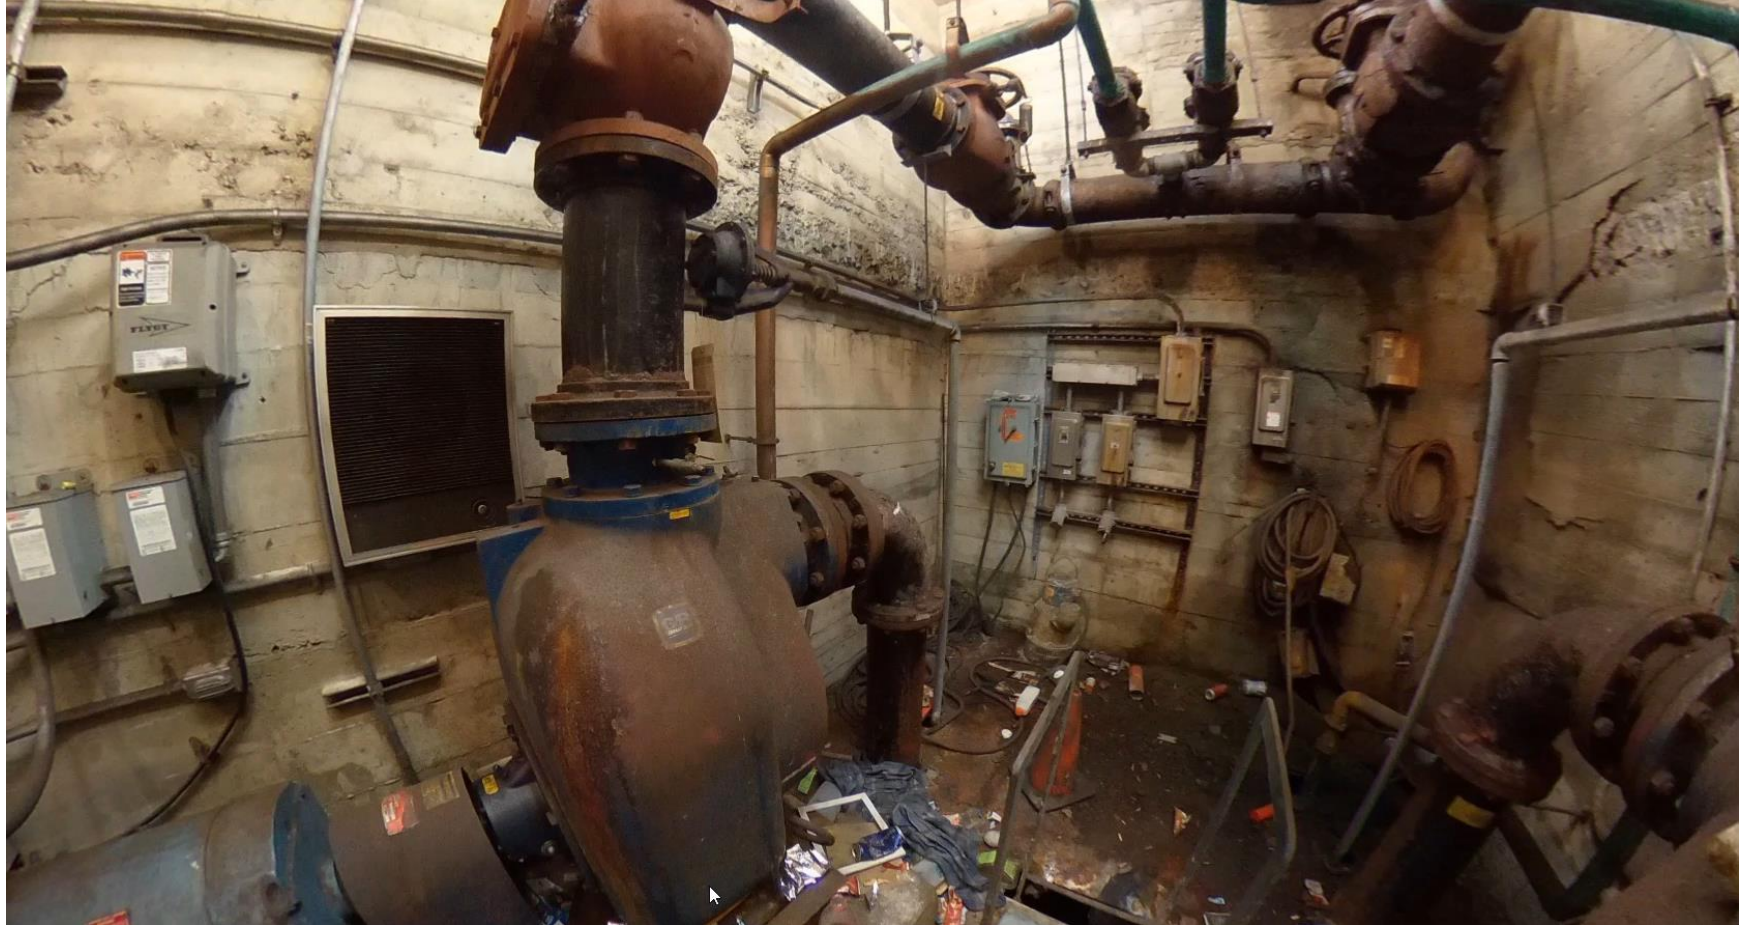
Symphony in **Green Line**
Nearest station: Symphony

400ft down the ROW platform. Enter through a single door on the ROW

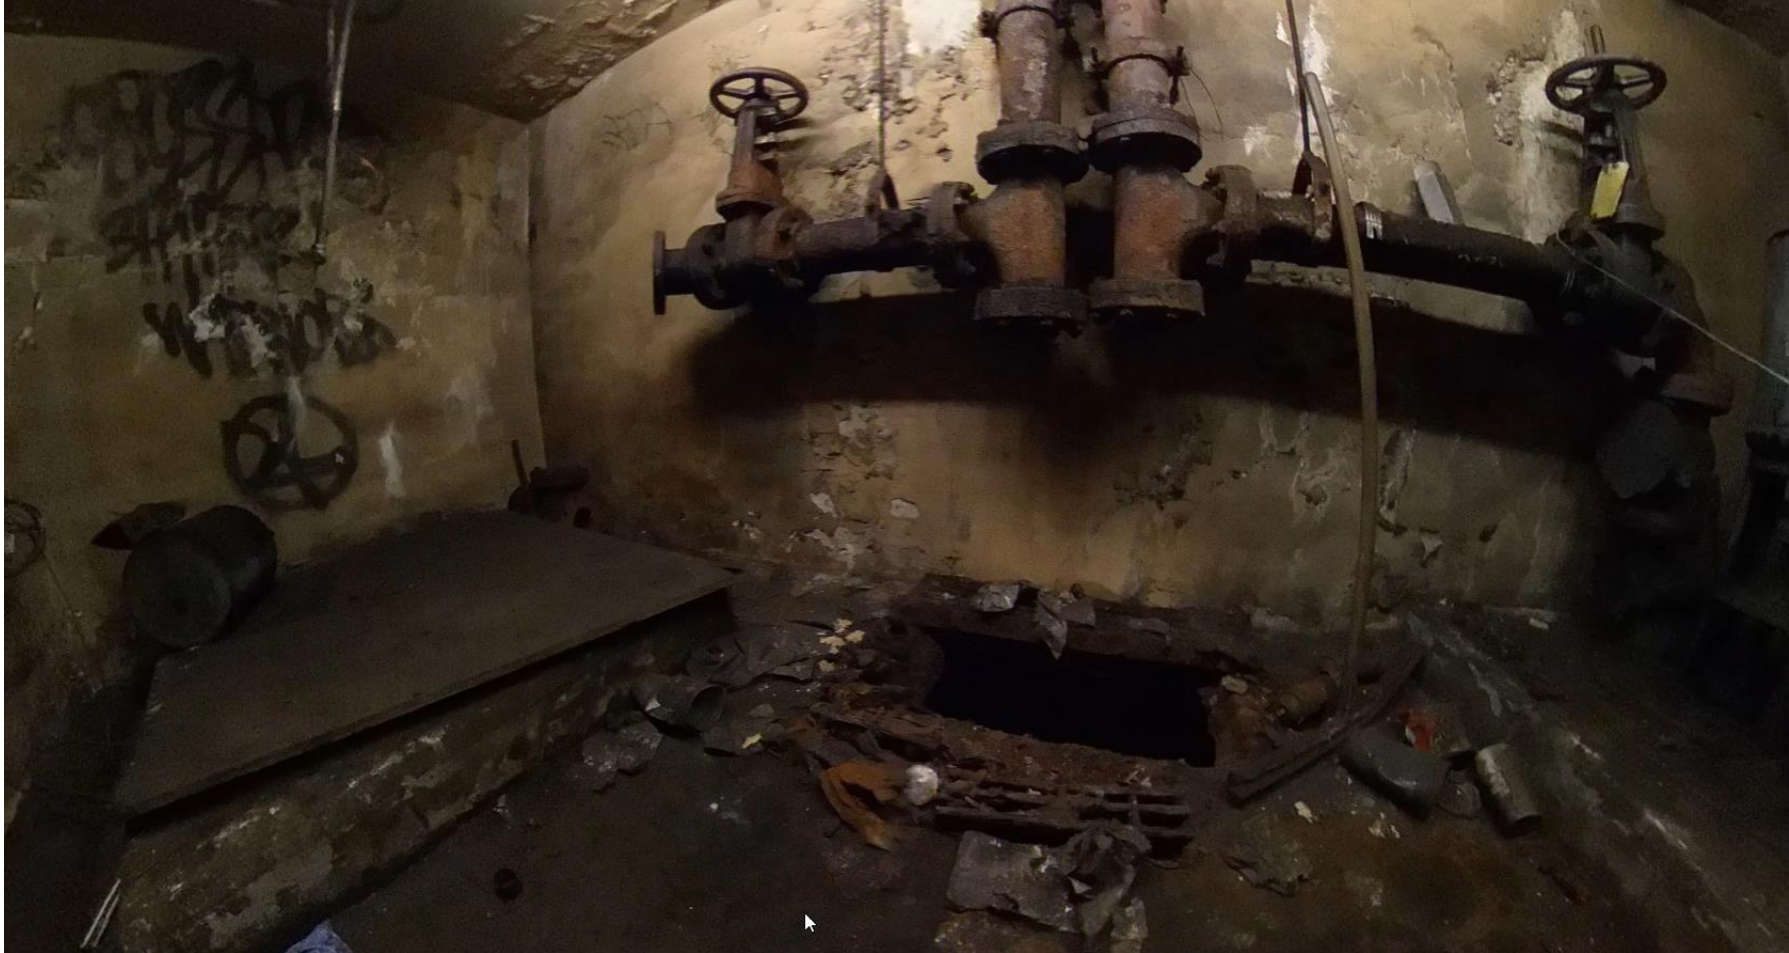
Harvard Station in Red Line
Nearest station: Harvard Station

Located below abandoned station. Enter through maintenance area across outbound tracks and through cable bundle.

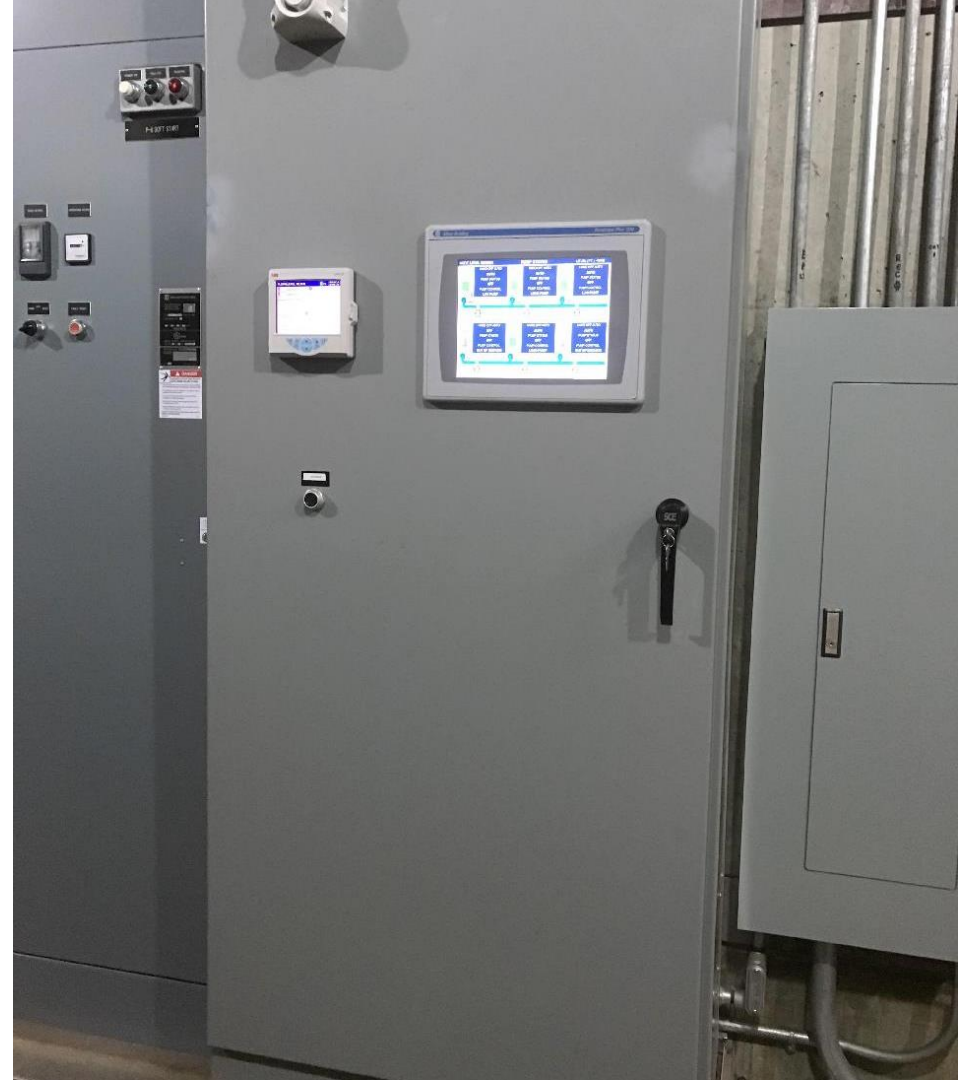
Gurney St.

- Orange Line
- Nearest Station: Roxbury Crossing
- Enter through a hatch located next to parking lot on street level.

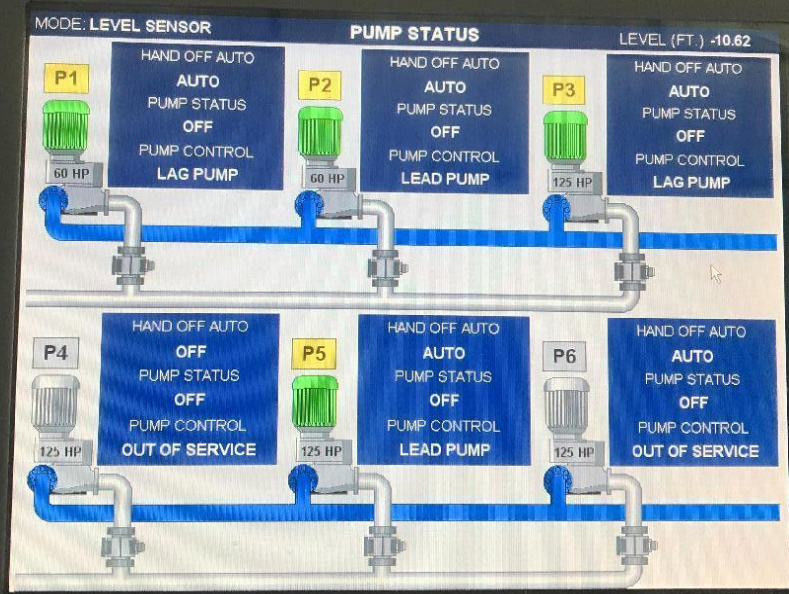
PUMP 1 FAULT HISTORY		
Alarm time	Acknowledging time	Message
9/15/2018 1:10:19 PM		PUMP 1 POWER FAIL
9/15/2018 1:08:16 PM		SOFTSTART 1 FAULTED
9/15/2018 1:08:12 PM		PUMP 1 POWER FAIL
9/15/2018 1:00:26 PM		PUMP 1 POWER FAIL
9/15/2018 1:00:26 PM		PUMP 1 POWER FAIL
9/15/2018 12:59:27 PM		PUMP 1 POWER FAIL
9/8/2018 8:15:54 PM		PUMP 1 POWER FAIL
9/8/2018 8:15:50 PM		PUMP 1 POWER FAIL
9/8/2018 8:15:45 PM		PUMP 1 POWER FAIL
9/8/2018 8:15:40 PM		PUMP 1 POWER FAIL
9/8/2018 8:15:33 PM		PUMP 1 POWER FAIL
9/8/2018 8:15:27 PM		PUMP 1 POWER FAIL
9/8/2018 8:15:21 PM		PUMP 1 POWER FAIL
