**Massachusetts Bay
Transportation Authority**

Safety Engineering Update

January 12, 2023

Orange Line Type 14 – Grounding Strap Issue

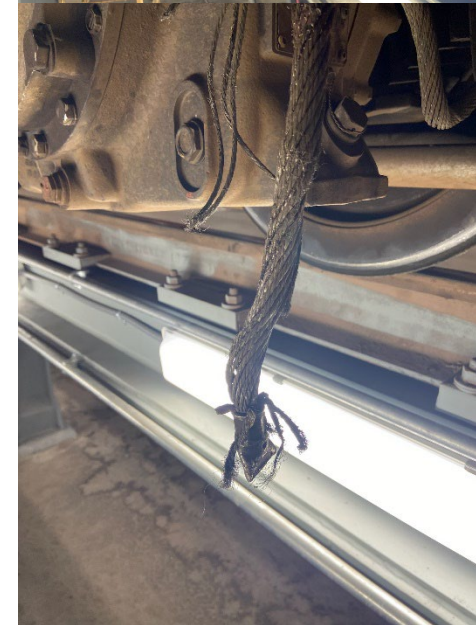
- On Monday December 26, 2022 during a routine inspection of a Type 14 vehicle, the inspection engineer discovered a grounding strap disconnected and hanging under the train.
- Entire fleet was cycled through Wellington Carhouse to be inspected.
- Multiple broken grounding straps were discovered, primarily on the #2 and #3 axles.
- Some grounding straps made contact with the rotating axles prompting Vehicle Engineering and Maintenance to remove those vehicles from service until axles were replaced.

Broken Ground Strap

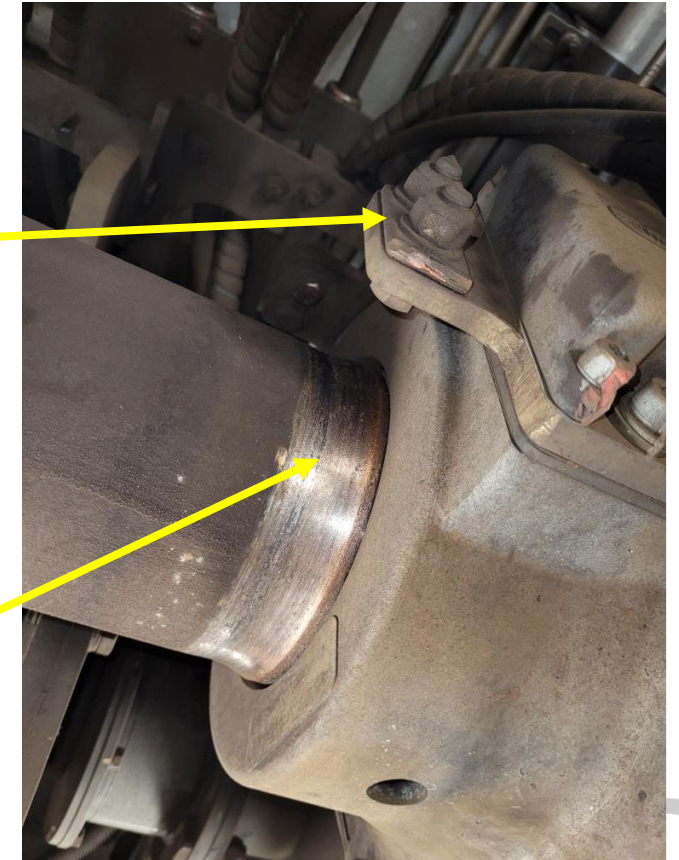
Ground Strap
Connection
Point

- As of January 3, 2023, repairs were made to all vehicles for this issue, except 4 cars (repairs underway for these cars).
- Strap connectors and cables being assessed for material failure.
- Strap routing is being assessed as a contributing factor.
- Operational factors are being assessed as a contributing factor.
- Investigation is still ongoing, as a probable cause has not yet been identified.
- Vehicles are being inspected weekly to identify any further issues.
