Appendix E
Hazardous Materials

PHASE I ENVIRONMENTAL SITE ASSESSMENT

MBTA Draw 1 Bridge
Causeway Street
Boston, MA 02114
February 2020

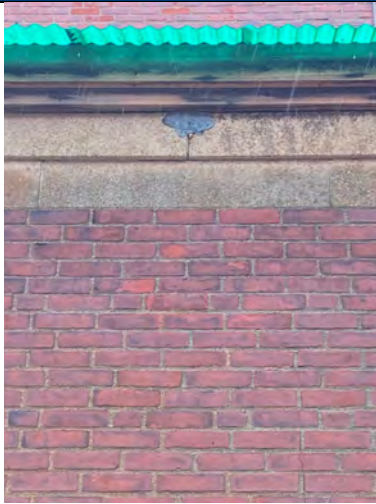
Asbestos Type	Chrysotile
Homogeneous Area	Tower A Exterior Brick Facade
Total Approximate Quantity	60 SF
Condition	Good
Material Type	Misc.
NESHAP Category	RACM
Notes	Not Applicable

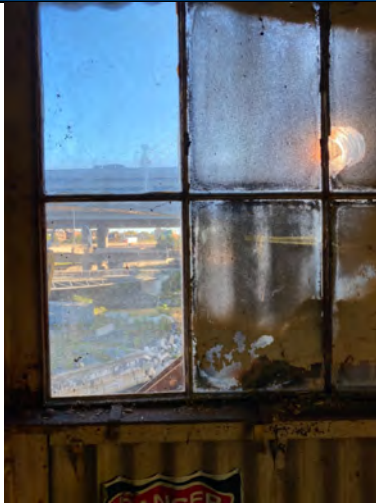
Asbestos Type	No Asbestos Detected
Homogeneous Area	Mechanical Rooms, Spans 1 And 2
Total Approximate Quantity	8 Each
Condition	Damaged
Material Type	Misc.
NESHAP Category	N/A
Notes	4 windows in each mech room

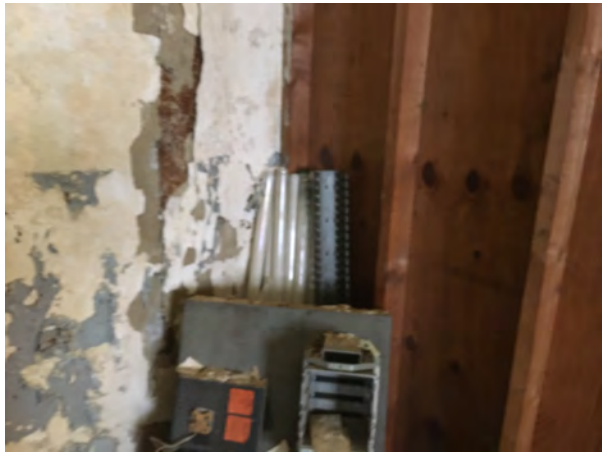
ITEM		
Area	Tower A - 1st Floor

Description	Heavy Metal Containing Devices Fluorescent (Green Tip)	
Quantity	4	
Notes	4' (Stockpiled)

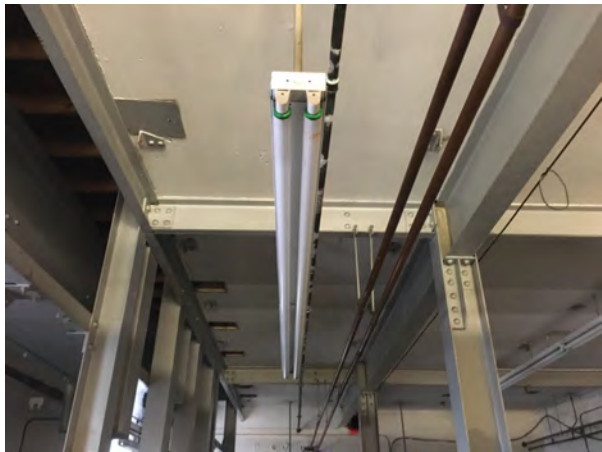
ITEM		
Area	Tower A - 1st Floor

Description	Heavy Metal Containing Devices Fluorescent (Green Tip)	
Quantity	15	
Notes	8' - 5 Bulbs Stockpiled (1 Bulb Broken)

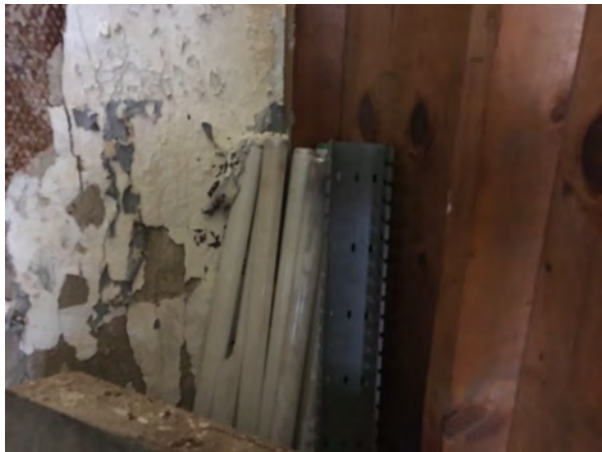
ITEM		
Area	Tower A - 1st Floor

Description	Heavy Metal Containing Devices Fluorescent (Silver Tip)	
Quantity	33	
Notes	4' (Stockpiled)

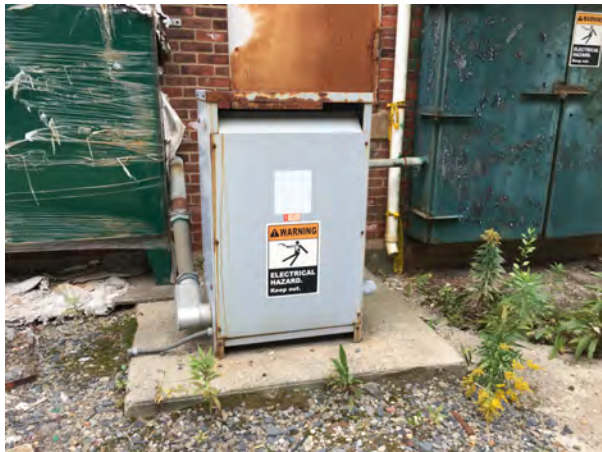
Description	PCB Containing Devices Transformer	
Quantity	1	
Notes	N/A
