Massachusetts Bay Transportation Authority

Green Line Derailment Update

MBTA Fiscal and Management Control Board

October 17, 2016

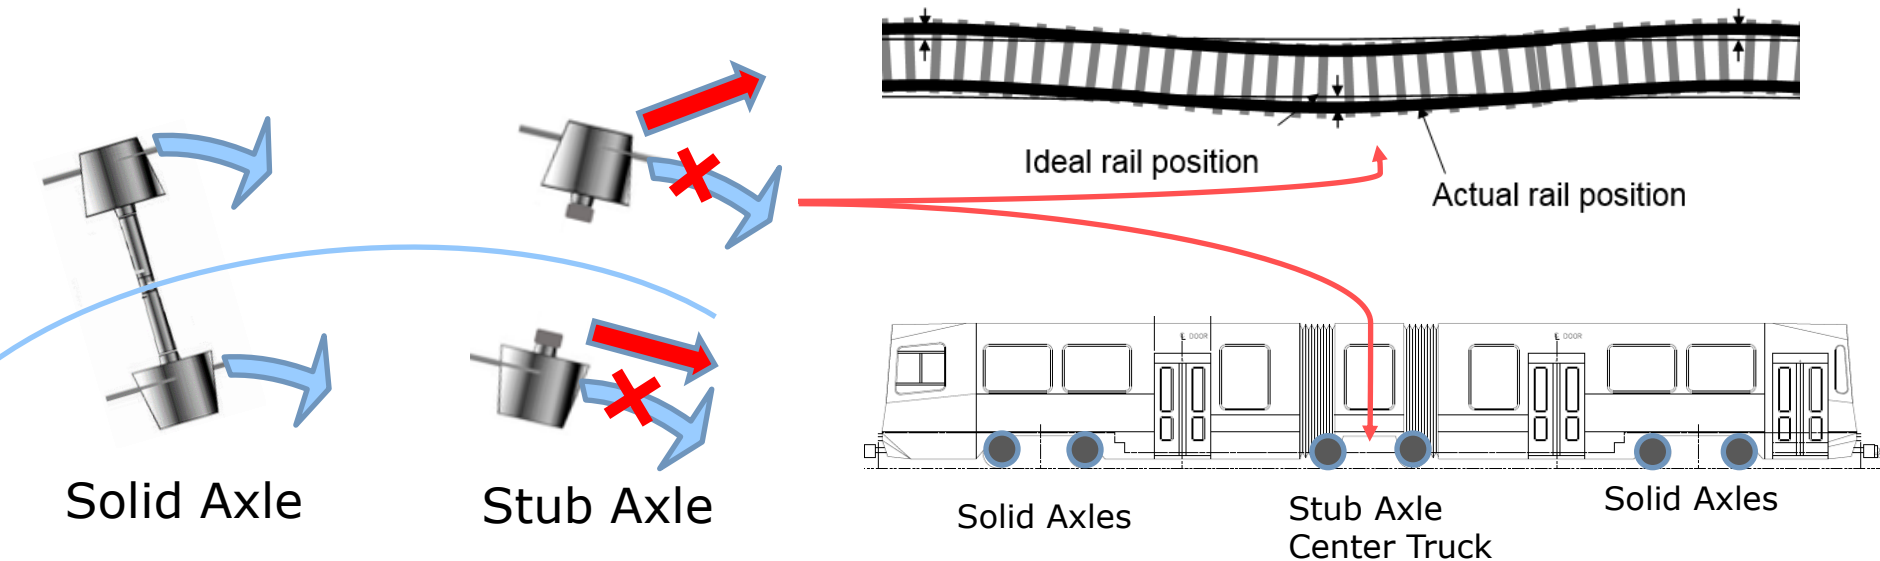
- To meet the low floor requirement, the Type 8 required a “stub” axle center truck.
- However, this design was based on *ideal track conditions* and was overly sensitive to track condition variations.
