Memorandum

To :	Andrew Brennan, Sr. Director of Energy and the Environment, Department of Environmental Affairs, MBTA
From :	M.V. Martello, EIT, Climate Change Resiliency Intern, Department of Environmental Affairs, MBTA
Re :	MBTA Bus Facilities
Subject :	Climate Change Coastal Flood Vulnerability Summary
Date :	September 15 th , 2020

Climate Change Coastal Flood Vulnerability Summary

MBTA Bus Facilities

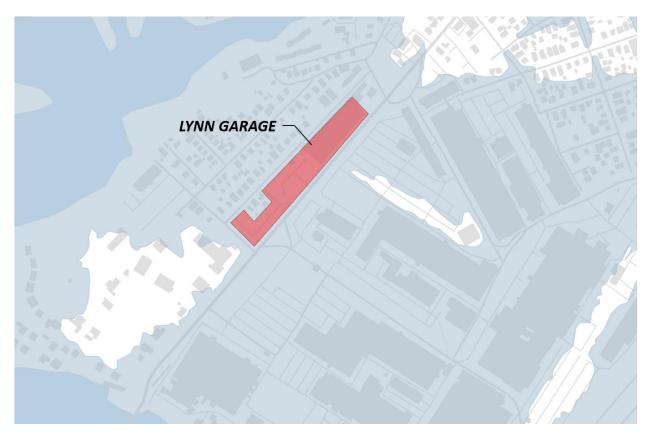
Figure 6: Lynn Garage and extent of FEMA 1-500 year flood map. Note that the bus garage lies within the 1-100 year floodplain

The entirety of the Lynn Garage lies within the current 1-100 year floodplain, as designated by FEMA and shown in Figure 6. The garage lies within an AE flood zone, and therefore could expect up to 3 feet of coastal flooding (Hatheway, 2005). The Lynn Bus Garage houses 89 buses (9% of the MBTA's total bus fleet) and its service area represents 8% of the bus network based on passenger flow data.

The following facilities are currently within the FEMA 1-500 year floodplain and may be inadequately protected from flooding under current conditions. For each of these locations, further study using the anticipated MC-FRM data and a more detailed vulnerability assessment are recommended. These locations have been ranked by severity of flooding and relative importance based on passenger flow:

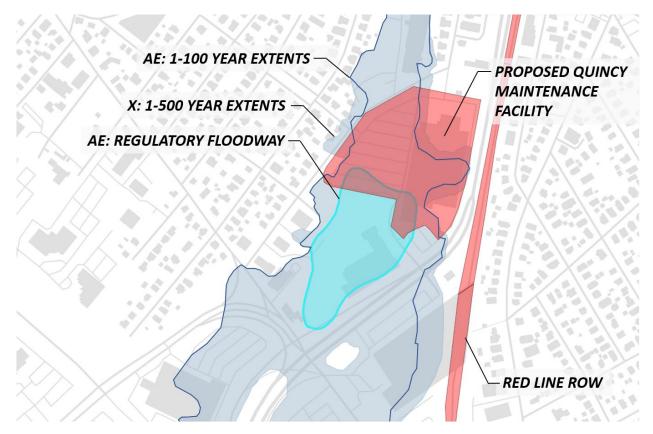
Proposed Quincy Garage and Maintenance Facility

Figure 7: Proposed Quincy Maintenance Facility and the current FEMA flood map. A large portion of the proposed facility lies within the current 1-100 year flood plain; a portion of the proposed facility also lies within a current regulatory floodway.

Also vulnerable according to current FEMA flood maps is the proposed site for the New Quincy Garage and Maintenance Facility. Shown in Figure 7, the site lies within the 1-100 year and 1-500 year flood plain extents. Similar to the Lynn Garage, the site is located in an AE flood zone, and therefore could experience up to 3 feet of coastal flooding (Hatheway, 2005), with an additional portion of the site within a FEMA designated floodway. However, Tetra Tech Rizzo (2007) notes that the FEMA flood maps at this location do not reflect floodway improvements to Town Brook implemented by DCR since 1980. Further analysis conducted by Tetra Tech Rizzo (2007) determined that these improvements resulted in a 4.2 foot reduction in 1-100 year flood elevation at this site, reducing projected flood extents to only a small portion of the parking lot. However, conditions have changed since this assessment, as additional portions of Town Brook were culverted north of the site and the Tetra Tech Rizzo (2007) study may not reflect current flood exposure.

This site will replace the current Quincy Garage, which houses 86 buses (8% of the MBTA's total bus fleet) and services 6% of the bus network based on passenger flow data. Additionally, this is the first MBTA facility designed to support and house an electric bus fleet as the MBTA moves towards its bus facilities modernization goals (MBTA; 2020b). Flooding of this facility may also damage electric charging infrastructure, which could greatly increase the costs and service impacts associated with flooding.

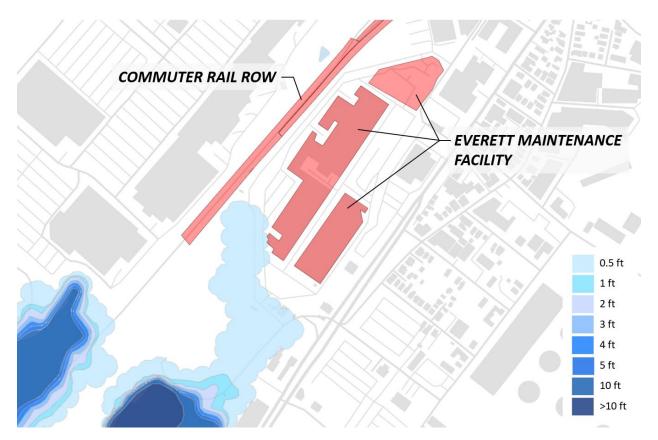
Figure 8: Everett Maintenance Facility exposure to projected 1-100 year flood event with +8.2 in. of SLR (projected 2030; Bosma et al., 2015). Note that the shades of blue reflect the depth of projected flooding

A small portion of the Everett Maintenance Facility is projected to be exposed to coastal flooding (to a depth of 0.5 ft) under the 1-100 year coastal flood event with +8.2 in. of SLR (projected 2030) shown in Figure 8. The flood extents shown would likely result in little to no damage at the facility. However, under the 1-100 year coastal flood event with +41 in. of SLR, the majority of the Everett Maintenance Facility is projected to be exposed to coastal flooding (projected 2070). A maximum flood depth of 4 feet is projected under this scenario, as shown in Figure 9. Further analysis by the Woods Hole Group released as part of a study by the City of Chelsea et al. (2019) shows this location floods also from the northeast via the Newburyport/Rockport Line, shown in Figure 10. While the Everett Maintenance Facility does not permanently house buses and therefore is not the origin of any routes (or passenger flows) its operation is critical to regular bus service.

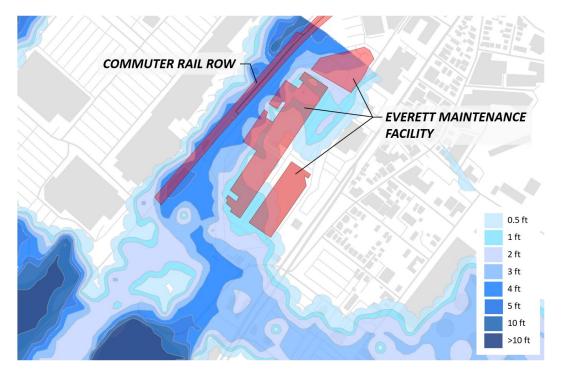
Figure 9: Everett Maintenance Facility exposure to projected 1-100 year flood event with +41 in. of SLR (projected 2070; Bosma et al., 2015). Note that the shades of blue reflect the depth of projected flooding

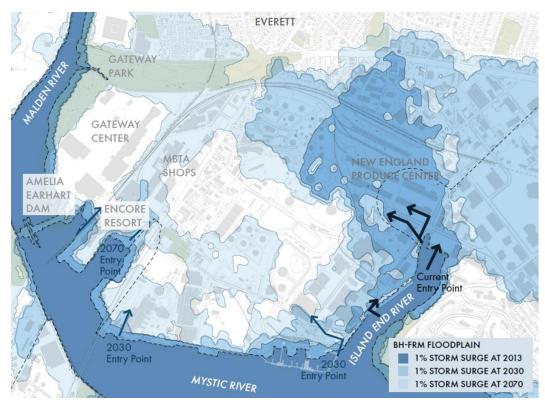
Figure 10: Summary of 1-100 year (1%) storm surge inundation extents in proximity of Island End River under +0in SLR (2013), +8.2in SLR (2030), +41in SLR (2070). Note that the Everett Maintenance Facility is labeled "MBTA Shops" (City of Chelsea et al., 2019)

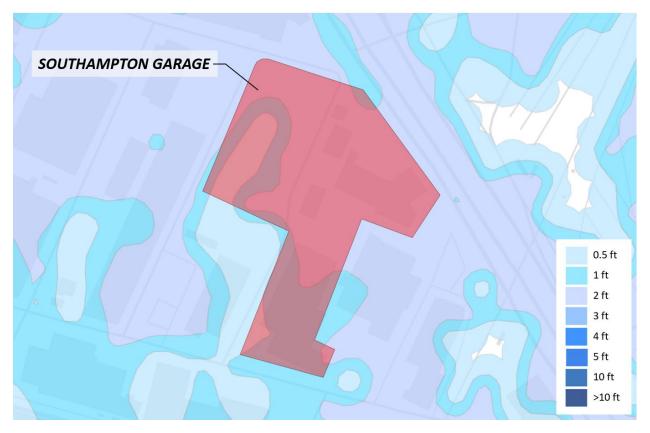
Figure 11: Southampton Garage exposure to projected 1-100 year flood event with +41 in. of SLR (projected 2070; Bosma et al., 2015). Note that the shades of blue reflect the depth of projected flooding

Southampton Garage is projected to be exposed to coastal flooding under the 1-100 year coastal flood event with +41 in. of SLR (projected 2070). Shown in Figure 11, a maximum flood depth of 2 feet is projected across the majority of the facility under this scenario. The Southampton Garage houses 104 buses (10% of the MBTA's total bus fleet) and its service area represents 13% of the bus network (including the Silver Line) based on passenger flow data.

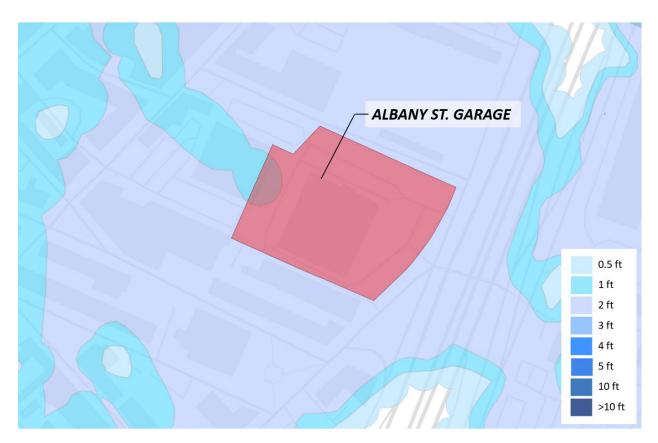
Figure 12: Albany Street Garage exposure to projected 1-100 year flood event with +41 in. of SLR (projected 2070; Bosma et al., 2015). Note that the shades of blue reflect the depth of projected flooding

Albany Street Garage is projected to be exposed to coastal flooding under the 1-100 year coastal flood event with +41 in. of SLR (projected 2070). Shown in Figure 12, a maximum flood depth of 2 feet is projected across nearly the entire facility under this scenario. The Albany Street Garage houses 116 buses (11% of the MBTA's total bus fleet) though its service area only represents 2% of the bus network based on passenger flow data.

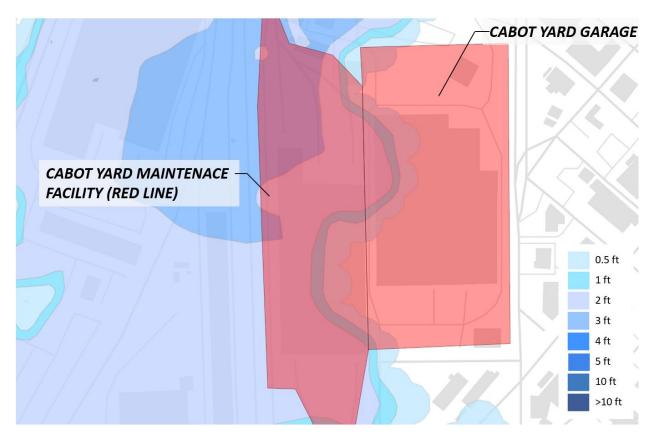
Figure 13: Cabot Yard Garage exposure to projected 1-100 year flood event with +41 in. of SLR (projected 2070; Bosma et al., 2015). Note that the shades of blue reflect the depth of projected flooding

Cabot Yard Garage is projected to be minimally exposed to coastal flooding under the 1-100 year coastal flood event with +41 in. of SLR (projected 2070). Shown in Figure 13, a maximum flood depth of 2 feet is projected across only a small portion of the facility under this scenario, with much more severe flooding expected for the adjacent Red Line facility. The Cabot Yard Garage houses 180 buses (17% of the MBTA's total bus fleet) and its service area represents an even greater 37% of the bus network based on passenger flow data. Since the projected flood pathways affecting this facility arise from the Fort Point Channel and flow through the rail yard northwest, coastal resilience improvements at this facility should be coordinated with the adjacent Red Line facility.

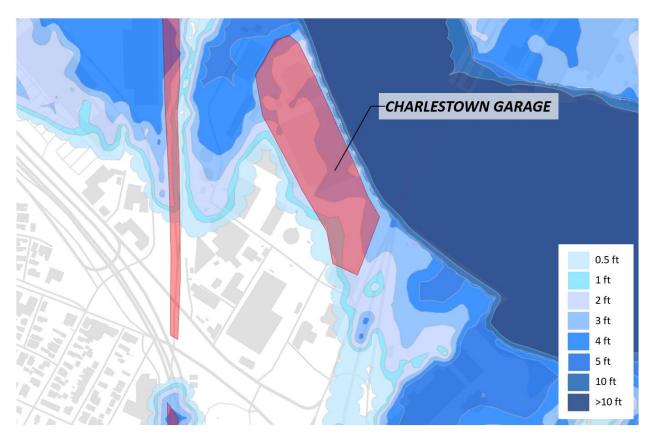
Figure 14: Charlestown Garage exposure to projected 1-100 year flood event with +41 in. of SLR (projected 2070; Bosma et al., 2015). Note that the shades of blue reflect the depth of projected flooding

Under the available BH-FRM results, the Charlestown Garage is projected to be exposed to coastal flooding under the 1-100 year coastal flood event with +41 in. of SLR (projected 2070). Shown in Figure 14, a maximum flood depth of 3 feet is projected across a large portion of the facility under this scenario, with more severe flooding expected for adjacent facilities. **However, these flood projections do not reflect the recently upgraded seawall along the garage's boundary with the Mystic River. As a result of these improvements, projected flooding under the aforementioned SLR condition is expected to be minimal (Bosma, 2020; Figure 15).** The Charlestown Garage is the MBTA's largest bus facility and houses 254 buses (24% of the MBTA's total bus fleet) and its service area represents 14% of the bus network based on passenger flow data. Because of the recent improvements to the seawall, no further coastal resilience actions are likely required at this time.

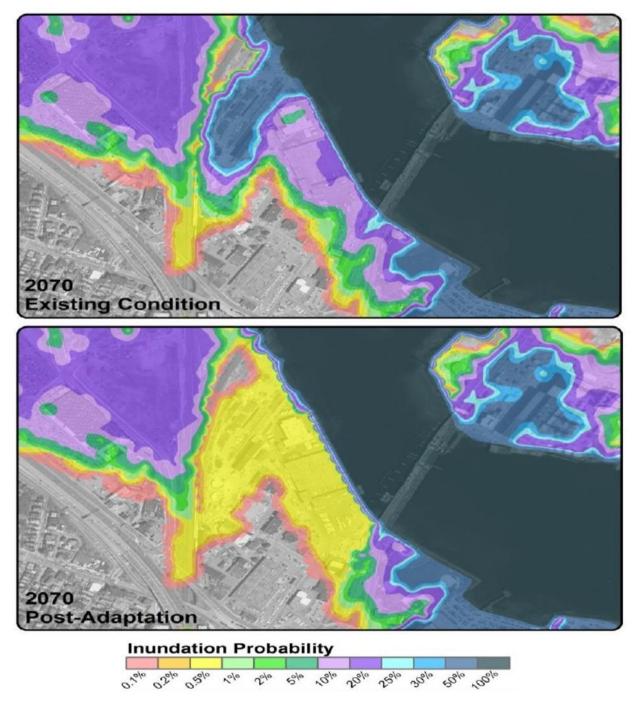
Figure 15: Changes in inundation probability under +41in SLR (2070) regime resulting from recent improvements in the Charlestown Bus Garage seawall (Bosma et al., 2020)

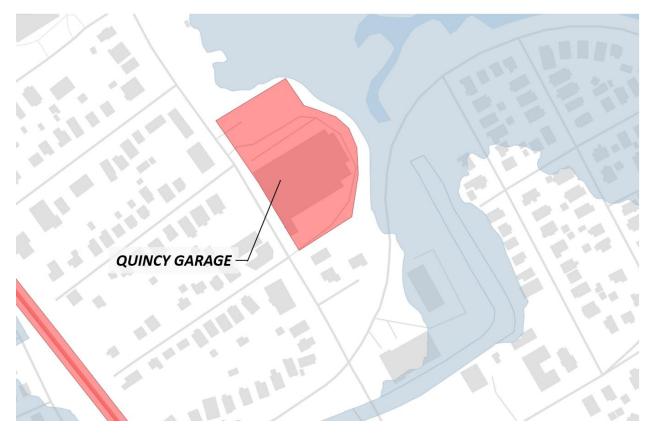
Figure 16: Quincy Garage and the current FEMA 1-100 year floodplain. Note the close proximity of the floodplain to the boundaries of the facility.

The Quincy Garage lies outside the current 1-100 year floodplain, as designated by FEMA and shown in Figure 16. Based on this flood map, the facility is minimally exposed to coastal flooding, though it is likely that under future SLR projections the site would be vulnerable. While this facility is expected to be replaced in the near-term with the proposed facility shown previously (Figure 7), should the MBTA retain this facility, further investigation of this site using MC-FRM is recommended. The Quincy Bus Garage houses 86 buses (8% of the MBTA's total bus fleet) and services 6% of the bus network based on passenger flow data.

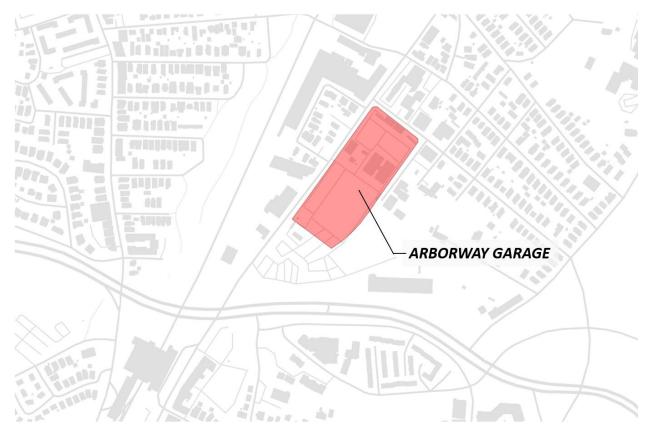
Figure 17: Location of the Arborway Garage. Note that current FEMA flood maps do not indicate any significant flood risks at this location.

The Arborway Garage lies outside the current FEMA 1-500 year floodplain, shown in Figure 17. Based on available information, the facility is minimally exposed to coastal or precipitation-based flooding. However, the location is roughly coincident with the original stream bed of Stony Brook (Wightman, 1863) and lies adjacent to the existing Stony Brook culvert (Weiskel et al., 2005) shown in Figure 18. The proximity to the culverted Stony Brook and historic streambed may be indicative of some degree of flood risk, however further study would be required to fully understand the flood risk at this location. The Arborway Garage houses 118 buses (11% of the MBTA's total bus fleet) and services 19% of the bus network based on passenger flow data.

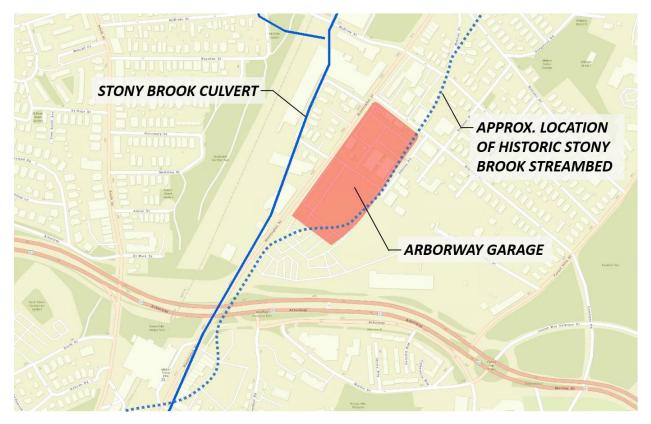
¹ Note that while Arborway Garage is not currently vulnerable according to FEMA flood maps, the site lies in the original stream bed for Stony Brook (Wightman, 1863) which has since been culverted.

Figure 18: The Stony Brook culvert and approximate location of its historic streambed in the proximity of the Arborway Garage (after Weiskel et al. 2005; Wightman, 1863).

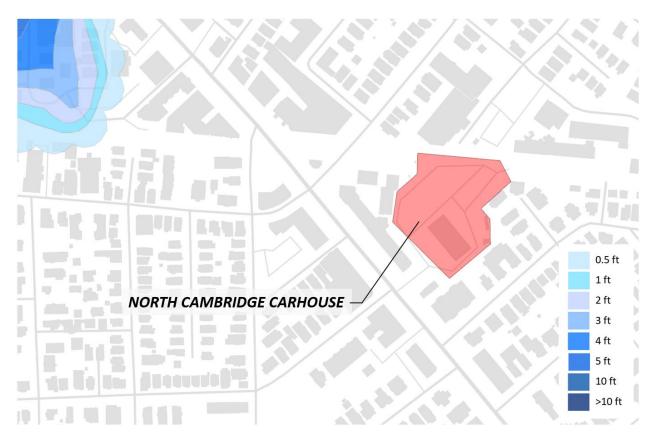
Figure 19 : Location of the North Cambridge Carhouse. Note that projected 1-100 year coastal flood under +41 in. SLR (projected 2070; Bosma et al., 2015) does not reach the facility

The North Cambridge Carhouse lies outside the projected 1-100 year coastal floodplain under +41 in. of SLR (projected 2070; Bosma et al., 2015) as shown in Figure 19. Based on available information, the facility is minimally exposed to coastal or precipitation-based flooding, though further investigation of this site using MC-FRM is recommended. The North Cambridge Carhouse stores 28 buses (3% of the MBTA's total bus fleet) and services 1% of the bus network based on passenger flow data.

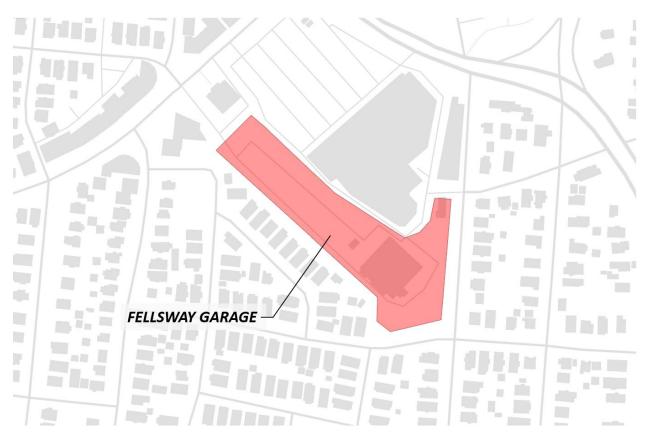
Figure 20: Location of the Fellsway Garage. Note that current FEMA flood maps do not indicate any significant flood risks at this location.

The Fellsway Garage lies outside the current FEMA 1-500 year floodplain, as shown in Figure 20. Based on available information, the facility is minimally exposed to coastal or precipitation-based flooding. However, limited coastal flood projection information (Mystic River Watershed Association, n.d.) indicates that this location may be exposed under expected 2070 conditions. Further investigation into this location with MC-FRM data when available is recommended. The Fellsway Garage houses 76 buses (7% of the MBTA's total bus fleet) and services 1% of the bus network based on passenger flow data.
