Climate Change Coastal Flood Vulnerability Screening
of
MBTA Commuter Rail Facilities and Parking Lots

MIT Transit Lab

Prepared by: Michael V. Martello, EIT

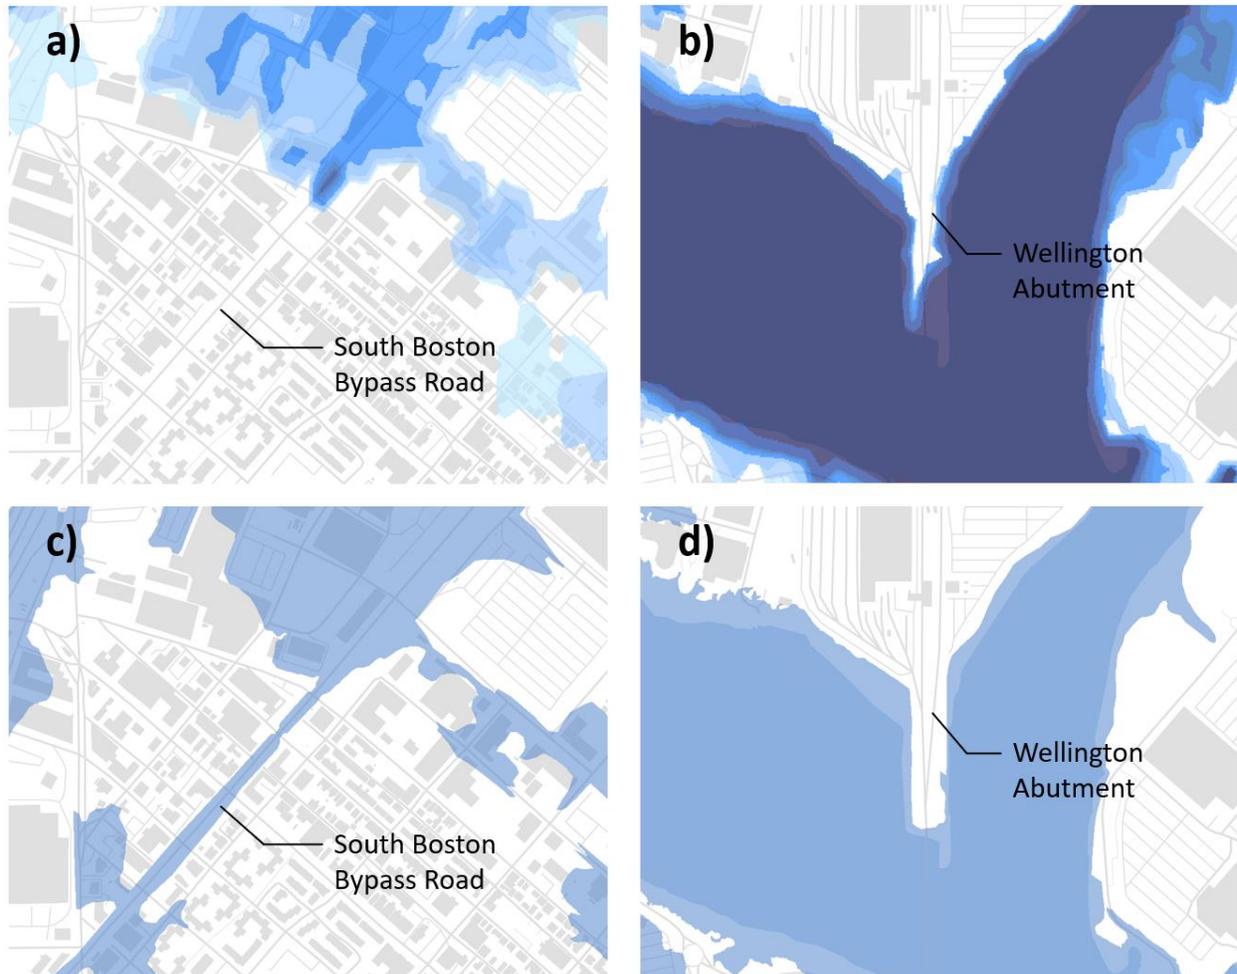
While the coastal flood extents and flood risk data produced by the MC-FRM has a very high spatial resolution (at best 10 ft) this resolution may be insufficient in urban areas under certain circumstances. Specifically, some flood pathways that would likely arise in reality are not too small to be captured by the MC-FRM, such as the South Boston Bypass Road as show in Figure 2. Conversely, other

areas are shown to flood in the MC-FRM that in fact would not likely be flooded. For example, the bridge abutment at Wellington Yard along the Orange Line is shown to flood under MC-FRM flood projections, though is not expected to flood based on FEMA flood maps, as shown in Figure 2.

Figure 2: Minor discrepancies between the MC-FRM +1.2 ft SLR 1-100 year flood depths (a, b) and the FEMA 1-500 year floodplain (c, d). A flood path along the South Boston Bypass Road not captured by the MC-FRM (left). An area of inundation along the Orange Line ROW in Wellington shown in the MC-FRM that is slightly incongruent with historic FEMA data (right).

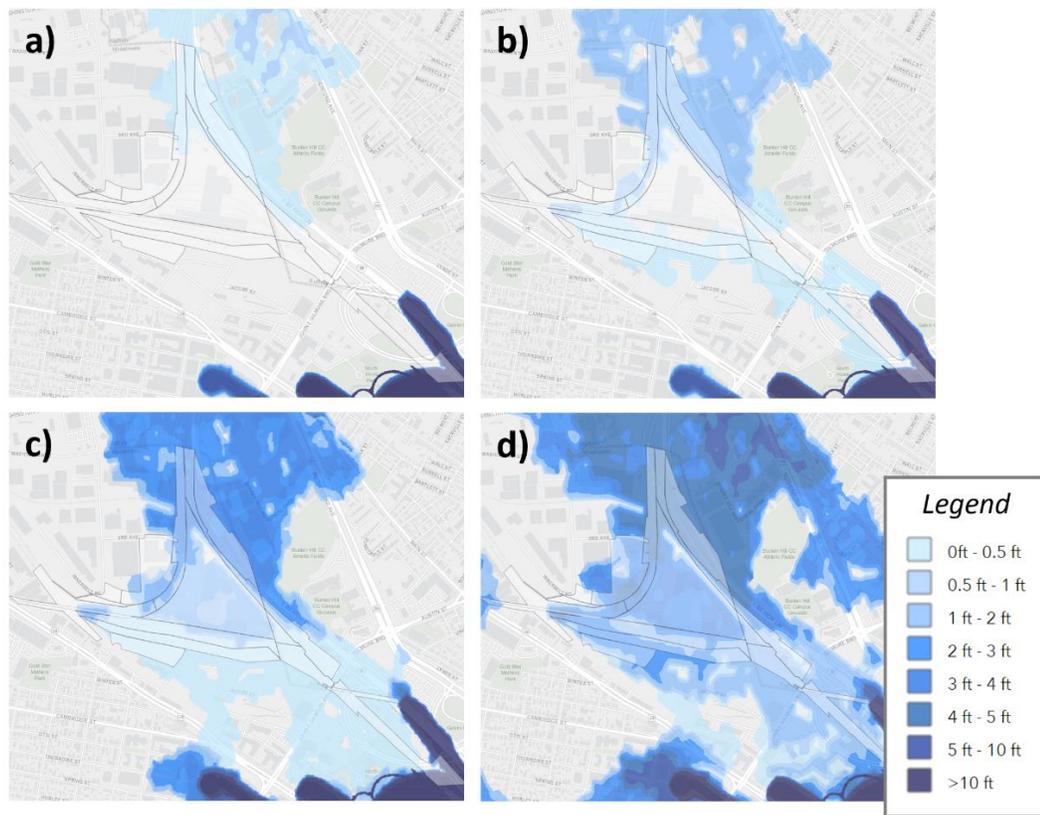
As shown in Figure 5, the Commuter Rail Maintenance Facility (CRMF) is subject to partial inundation in the northern portion of the adjacent tracks under a 1-100 year coastal flood event under present sea level conditions (a). More extensive flooding surrounding the maintenance facility is expected for a storm with the same return period and 1.2 ft of SLR (b). The facility is expected to flood with 2-3 ft of standing water under the 1-100 year flood event with 2.4 ft of SLR (c). With 4.2ft of SLR, the 1-100 year flood is expected to inundate the facility with 3-4 feet of standing water (d). The CRMF is a critical component of the entire commuter rail system, as it serves as the primary location for passenger car and locomotive maintenance. Extensive flooding at this facility is likely to result in significant damage to maintenance equipment, inventory of spare parts, and un-evacuated rolling stock (AECOM, 2018). Based on evaluations of similar coastal flood impacts on the Orient Heights Maintenance facility on the Blue Line, a similar level of inundation would result in complete loss of service for a two week period, with prolonged service impacts lasting for a year or more (MBTA, 2019b). A more comprehensive vulnerability assessment of this location, including a detailed review of immobile maintenance equipment locations and vulnerability is recommended.

Figure 5: Projected 1-100 year flood depths at the Commuter Rail Maintenance Facility under: a) present sea level conditions, b) +1.2 ft of SLR, c) +2.4 ft of SLR, d) +4.2 ft of SLR

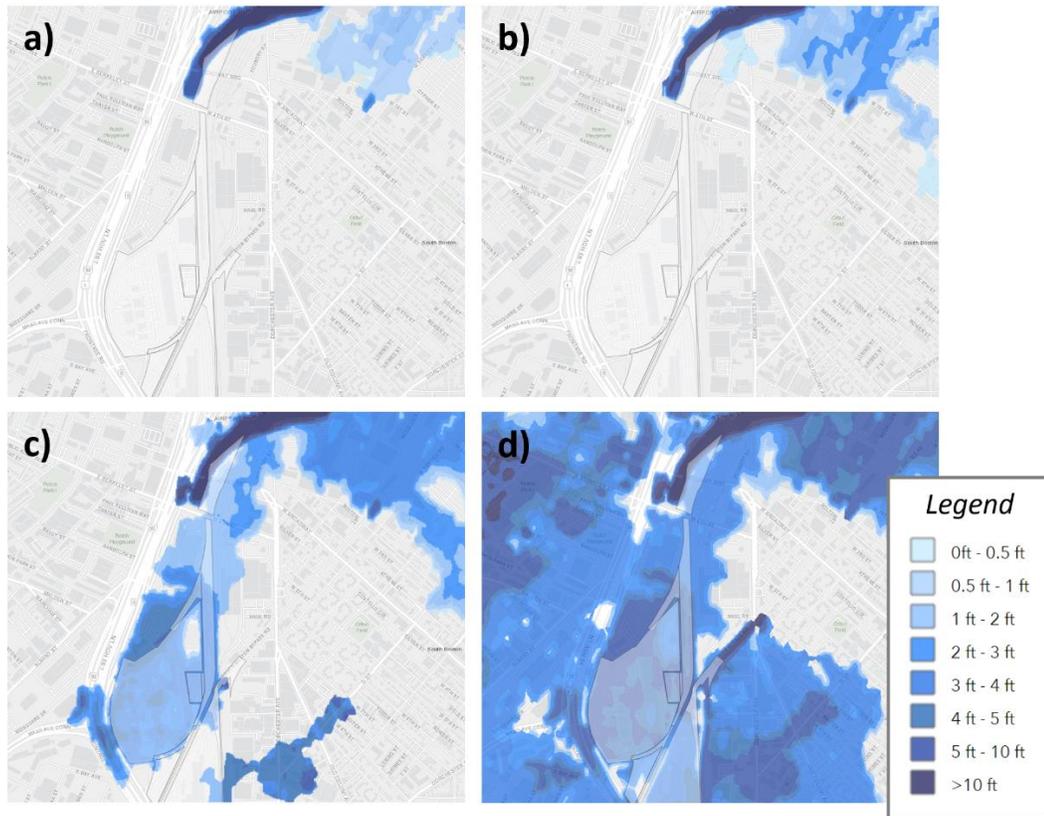
As shown in Figure 6, the Widett Service and Inspection Maintenance Facility and Amtrak Southampton Street Yard are both subject to significant flooding (3-5 feet) under a 1-100 year coastal flood event under more severe (i.e., +2.4 ft and +4.2 ft of SLR) sea level rise scenarios (c, d). Under present conditions and with 1.2 ft of SLR (a, b) these locations are not vulnerable to coastal flooding based on MC-FRM projections, though they are vulnerable to flooding with a 1-500 year return period based on the present FEMA FIRM. The Widett Service and Inspection Maintenance Facility services trains on the southern portion of the commuter rail system. Similar to the CRMF, extensive flooding at this facility is likely to result in significant damage to maintenance equipment, inventory of spare parts, and un-evacuated rolling stock (AECOM, 2018). Should this facility flood, it is likely that operations could be temporarily shifted to the CRMF, if that facility is still operable. While the MBTA does not own the Amtrak Southampton Street Yard, this yard is critical to operations along all south side routes and could therefore have significant implications for commuter rail service. Coordination with Amtrak for further assessment of the vulnerability of their Southampton Street Yard is recommended.

Figure 6: Projected 1-100 year flood depths at the Widett Service and Inspection Maintenance Facility under: a) present sea level conditions, b) +1.2 ft of SLR, c) +2.4 ft of SLR, d) +4.2 ft of SLR

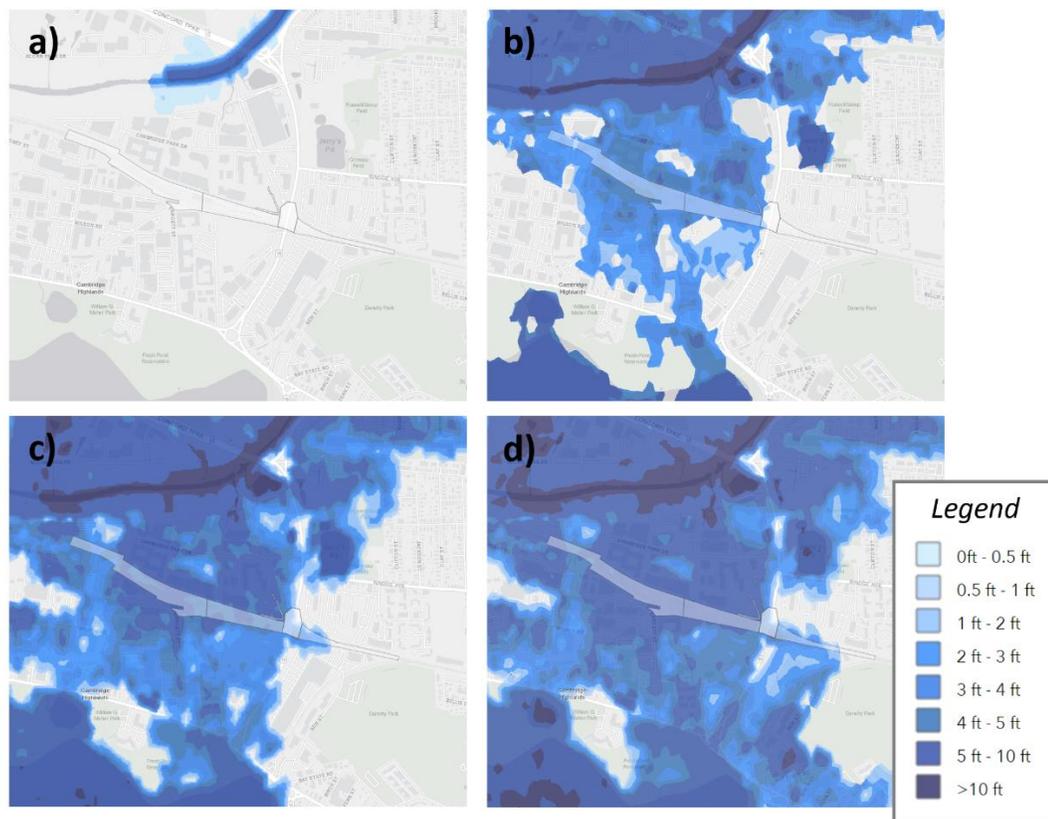
As shown in Figure 7, the West Cambridge Maintenance Facility is not subject to coastal flooding under a 1-100 year coastal flood event given present sea level conditions (a). However, this location is within the FEMA 1-100 year flood plain, indicating a precipitation-based flood vulnerability under present conditions. With 1.2 ft of SLR, the MC-FRM projects the 1-100 year coastal flood event will result in 2-4 ft of standing water at this facility (b), with 5-10 feet of standing water expected with 2.4 ft or 4.2 ft of SLR (c, d). Coastal flood risk at this location is the result of the flanking and overtopping of the Amelia Earhart Dam (owned and operated by the Department of Conservation and Recreation; DCR) downstream on the Mystic River. Attenuation of future coastal flood risk is therefore dependent upon improvements to the dam and heightening of adjacent land. The West Cambridge Maintenance Facility maintains all on-track vehicles and equipment for the commuter rail system and is also the main storage location for essential non-revenue vehicles, including snow vehicles. Immobile equipment, materials, inventory, and vehicles on site at this facility would be significantly damaged under higher SLR scenarios. Further investigation into the vulnerability of this location and the systemwide implications of operations disruption at this facility is recommended.

Figure 7: Projected 1-100 year flood depths at the West Cambridge Maintenance Facility under: a) present sea level conditions, b) +1.2 ft of SLR, c) +2.4 ft of SLR, d) +4.2 ft of SLR

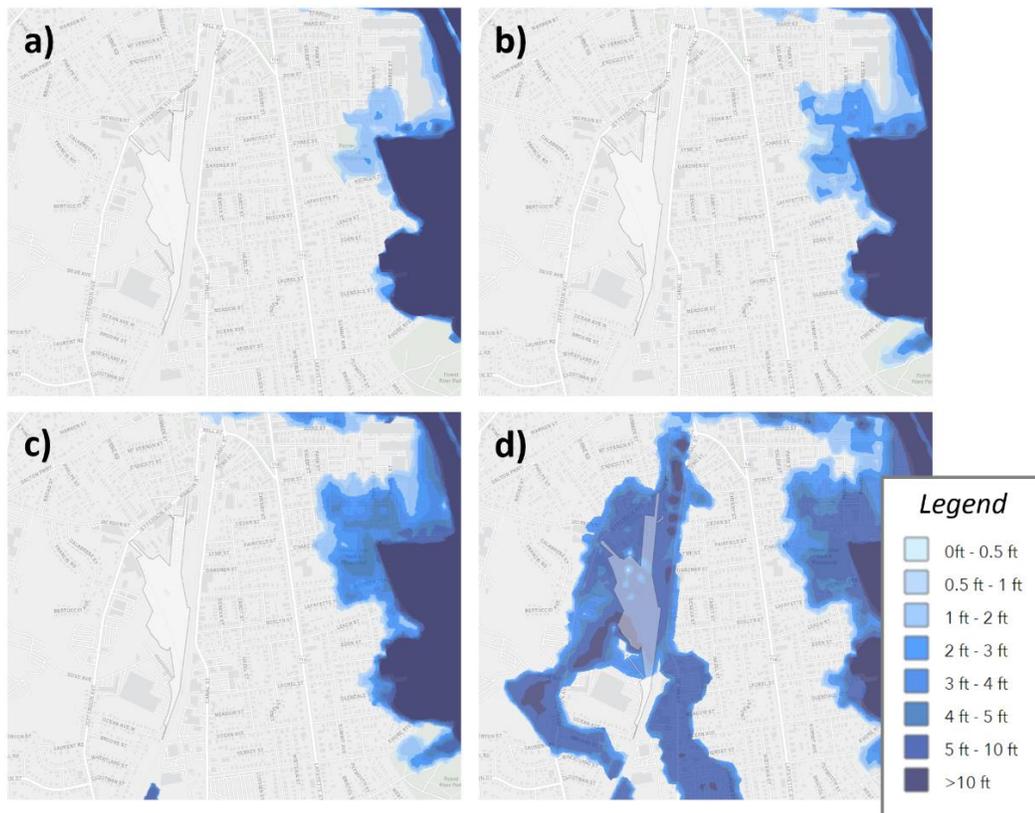
While the Salem Maintenance Facility, Storage, and Offices are minimally exposed to coastal flood risk for SLR conditions less than 4.2 ft based on MC-FRM results (Figure 8) the expected level of flooding under 4.2 ft of SLR (5-10 ft depth of standing water) is significant. Further, it appears likely that the MC-FRM neglects the presence of the tunnel under Washington Street in Salem. Given that the FEMA FIRM at present places this location and the other end of the tunnel (Salem Station) entirely within the 1-100 year floodplain, further review of the present-day coastal flood risk for this location is recommended. The MC-FRM estimates Salem Station (including the parking facility) and the tunnel entrance are exposed to coastal flooding under a 1-10 year event under present conditions. Given the exceptionally high vulnerability of Salem Station and the tunnel entrance, a detailed vulnerability assessment (and hydraulic model) of Salem Station and garage, the adjacent tunnel, and the maintenance facility is recommended.

Figure 8: Projected 1-100 year flood depths at the Salem Maintenance Facility, Storage, and Offices under: a) present sea level conditions, b) +1.2 ft of SLR, c) +2.4 ft of SLR, d) +4.2 ft of SLR
