MBTA QUINCY CENTER GARAGE

Demolition

April 6, 2017

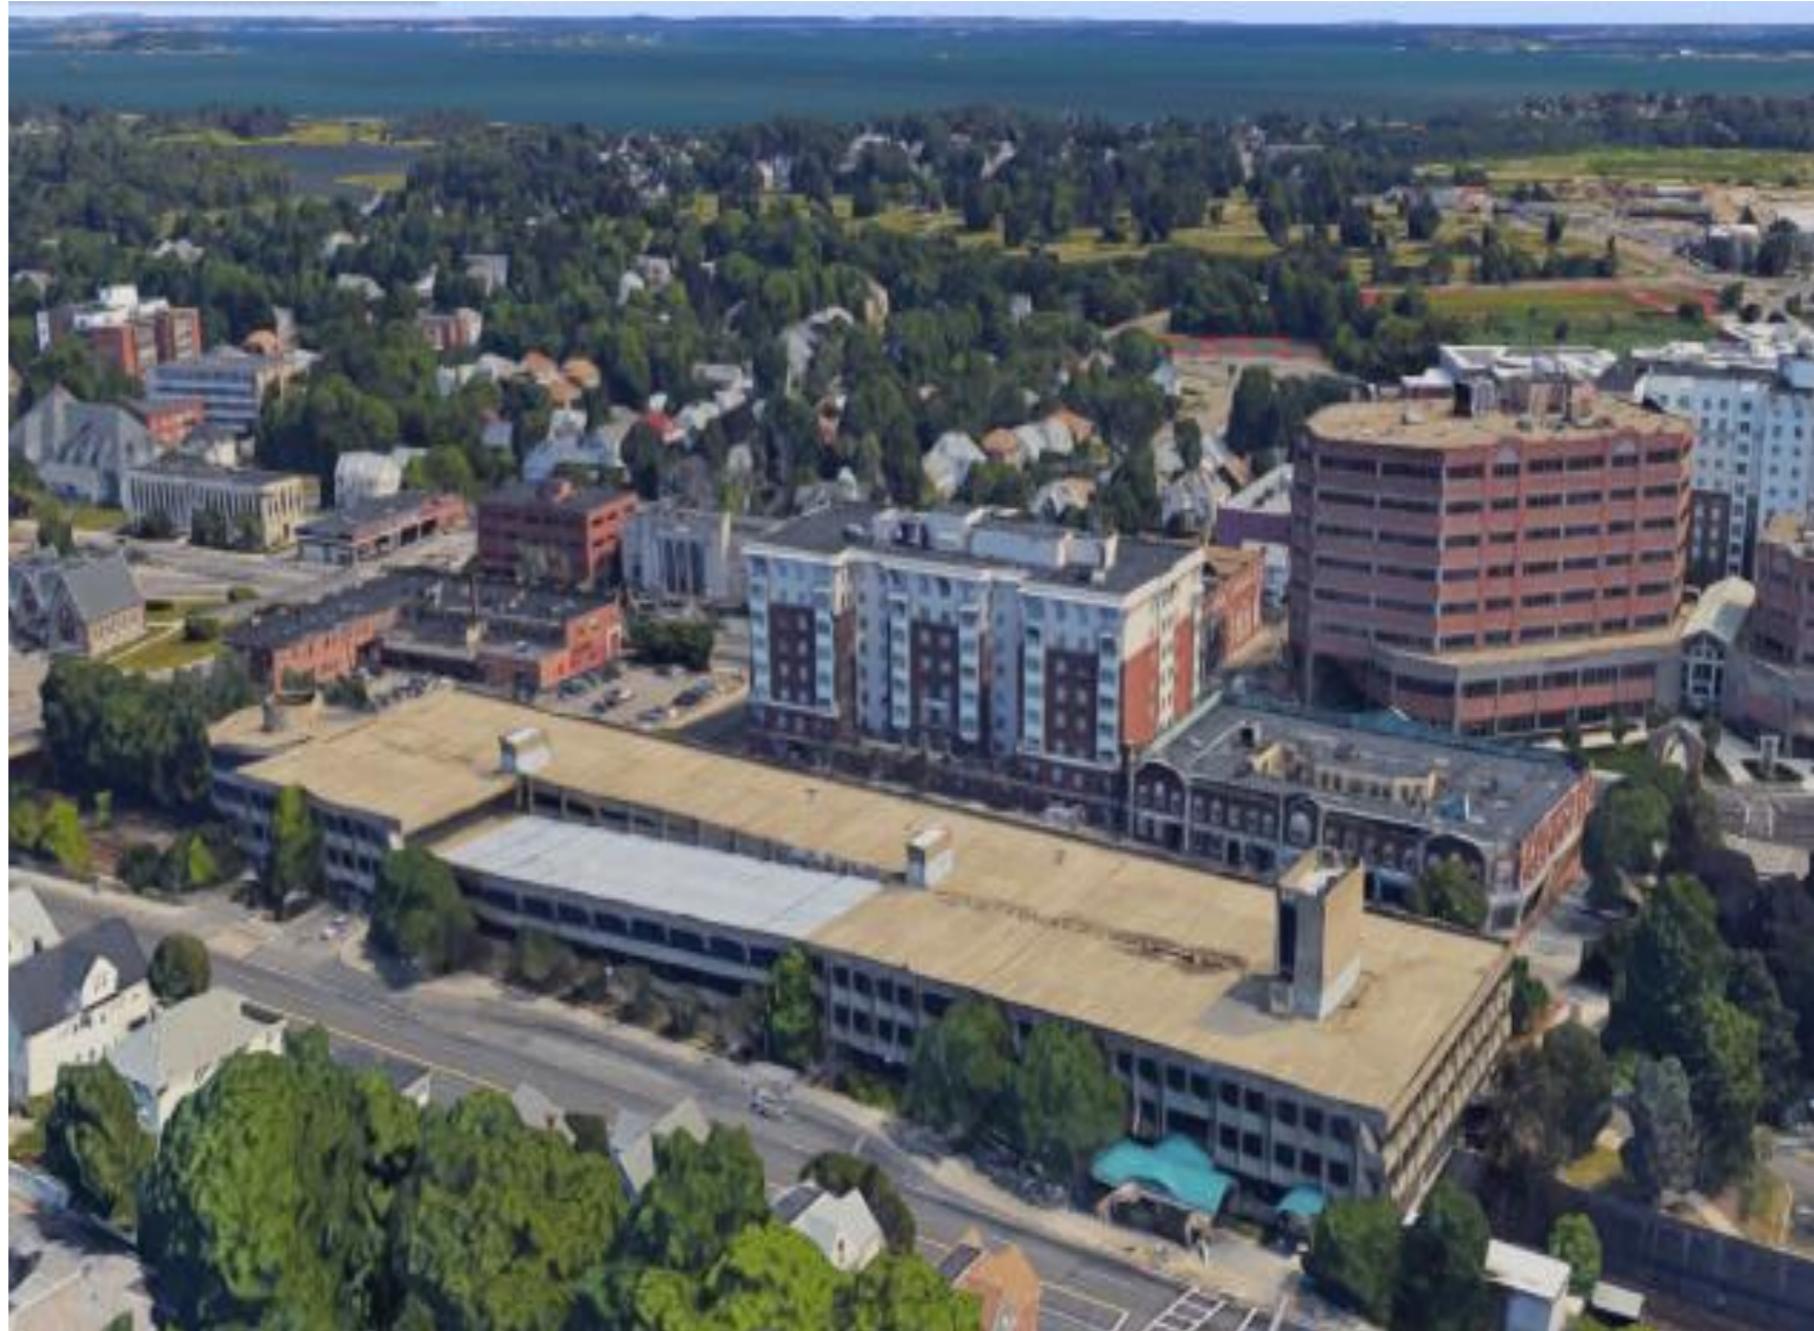
DEMOLISH LEVELS 3, 4 AND 5

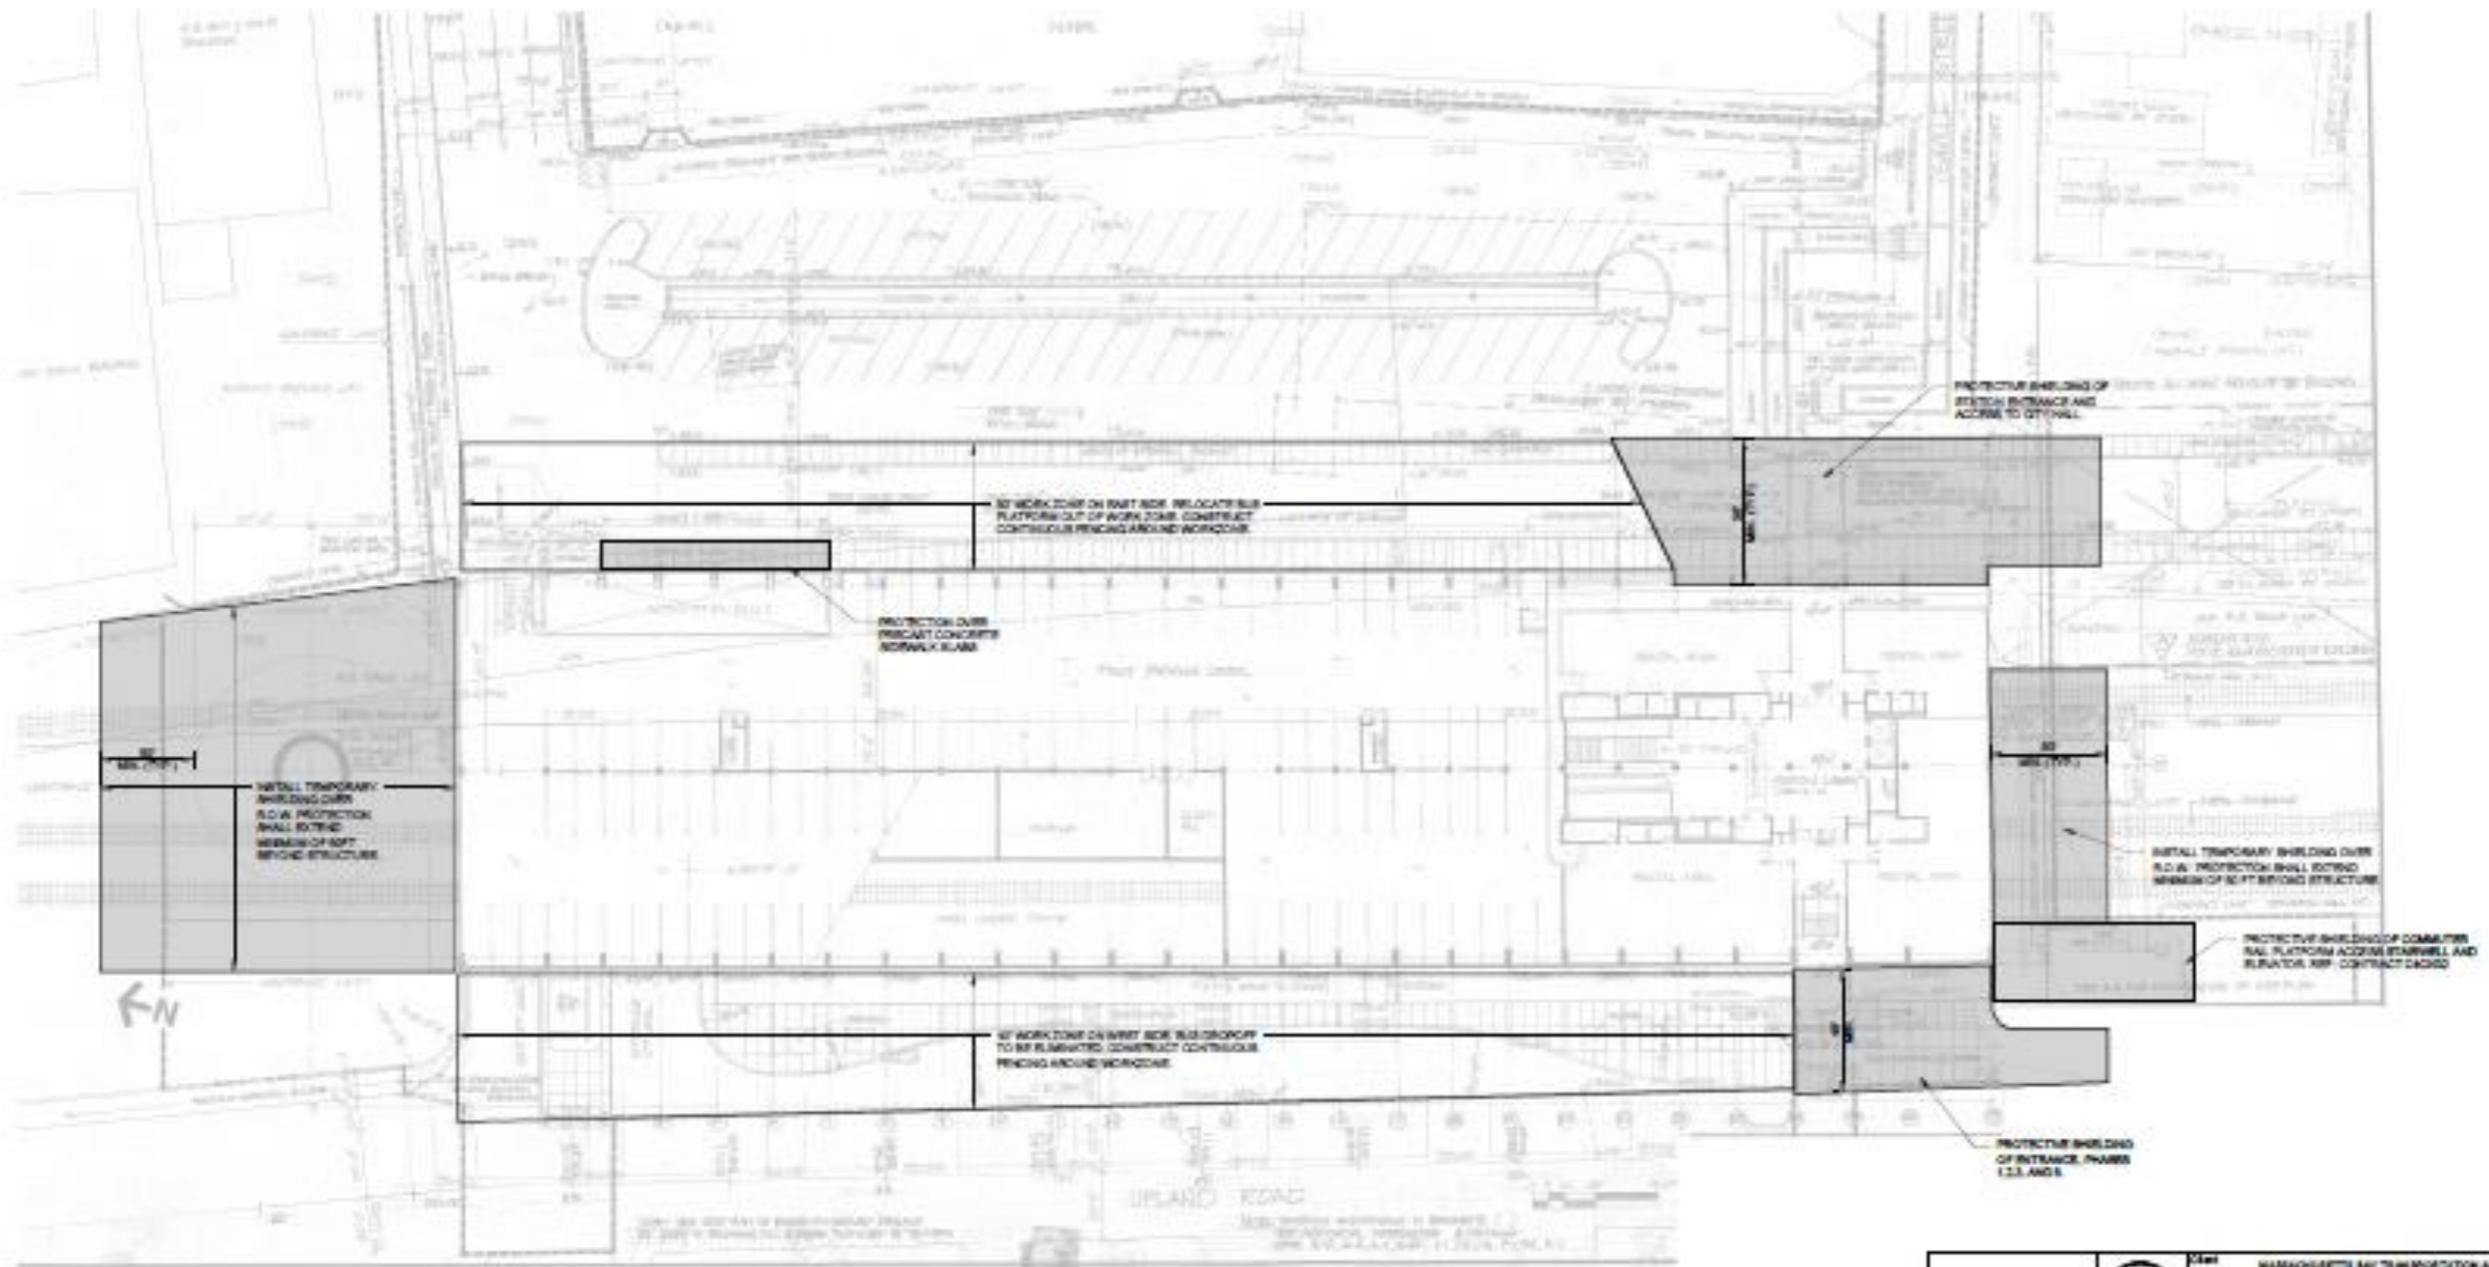
LIMITS OF SITE TEMPORARY SHIELDING
 SEE TEXT FOR DETAILS

Proposed Temporary Overhead Shielding

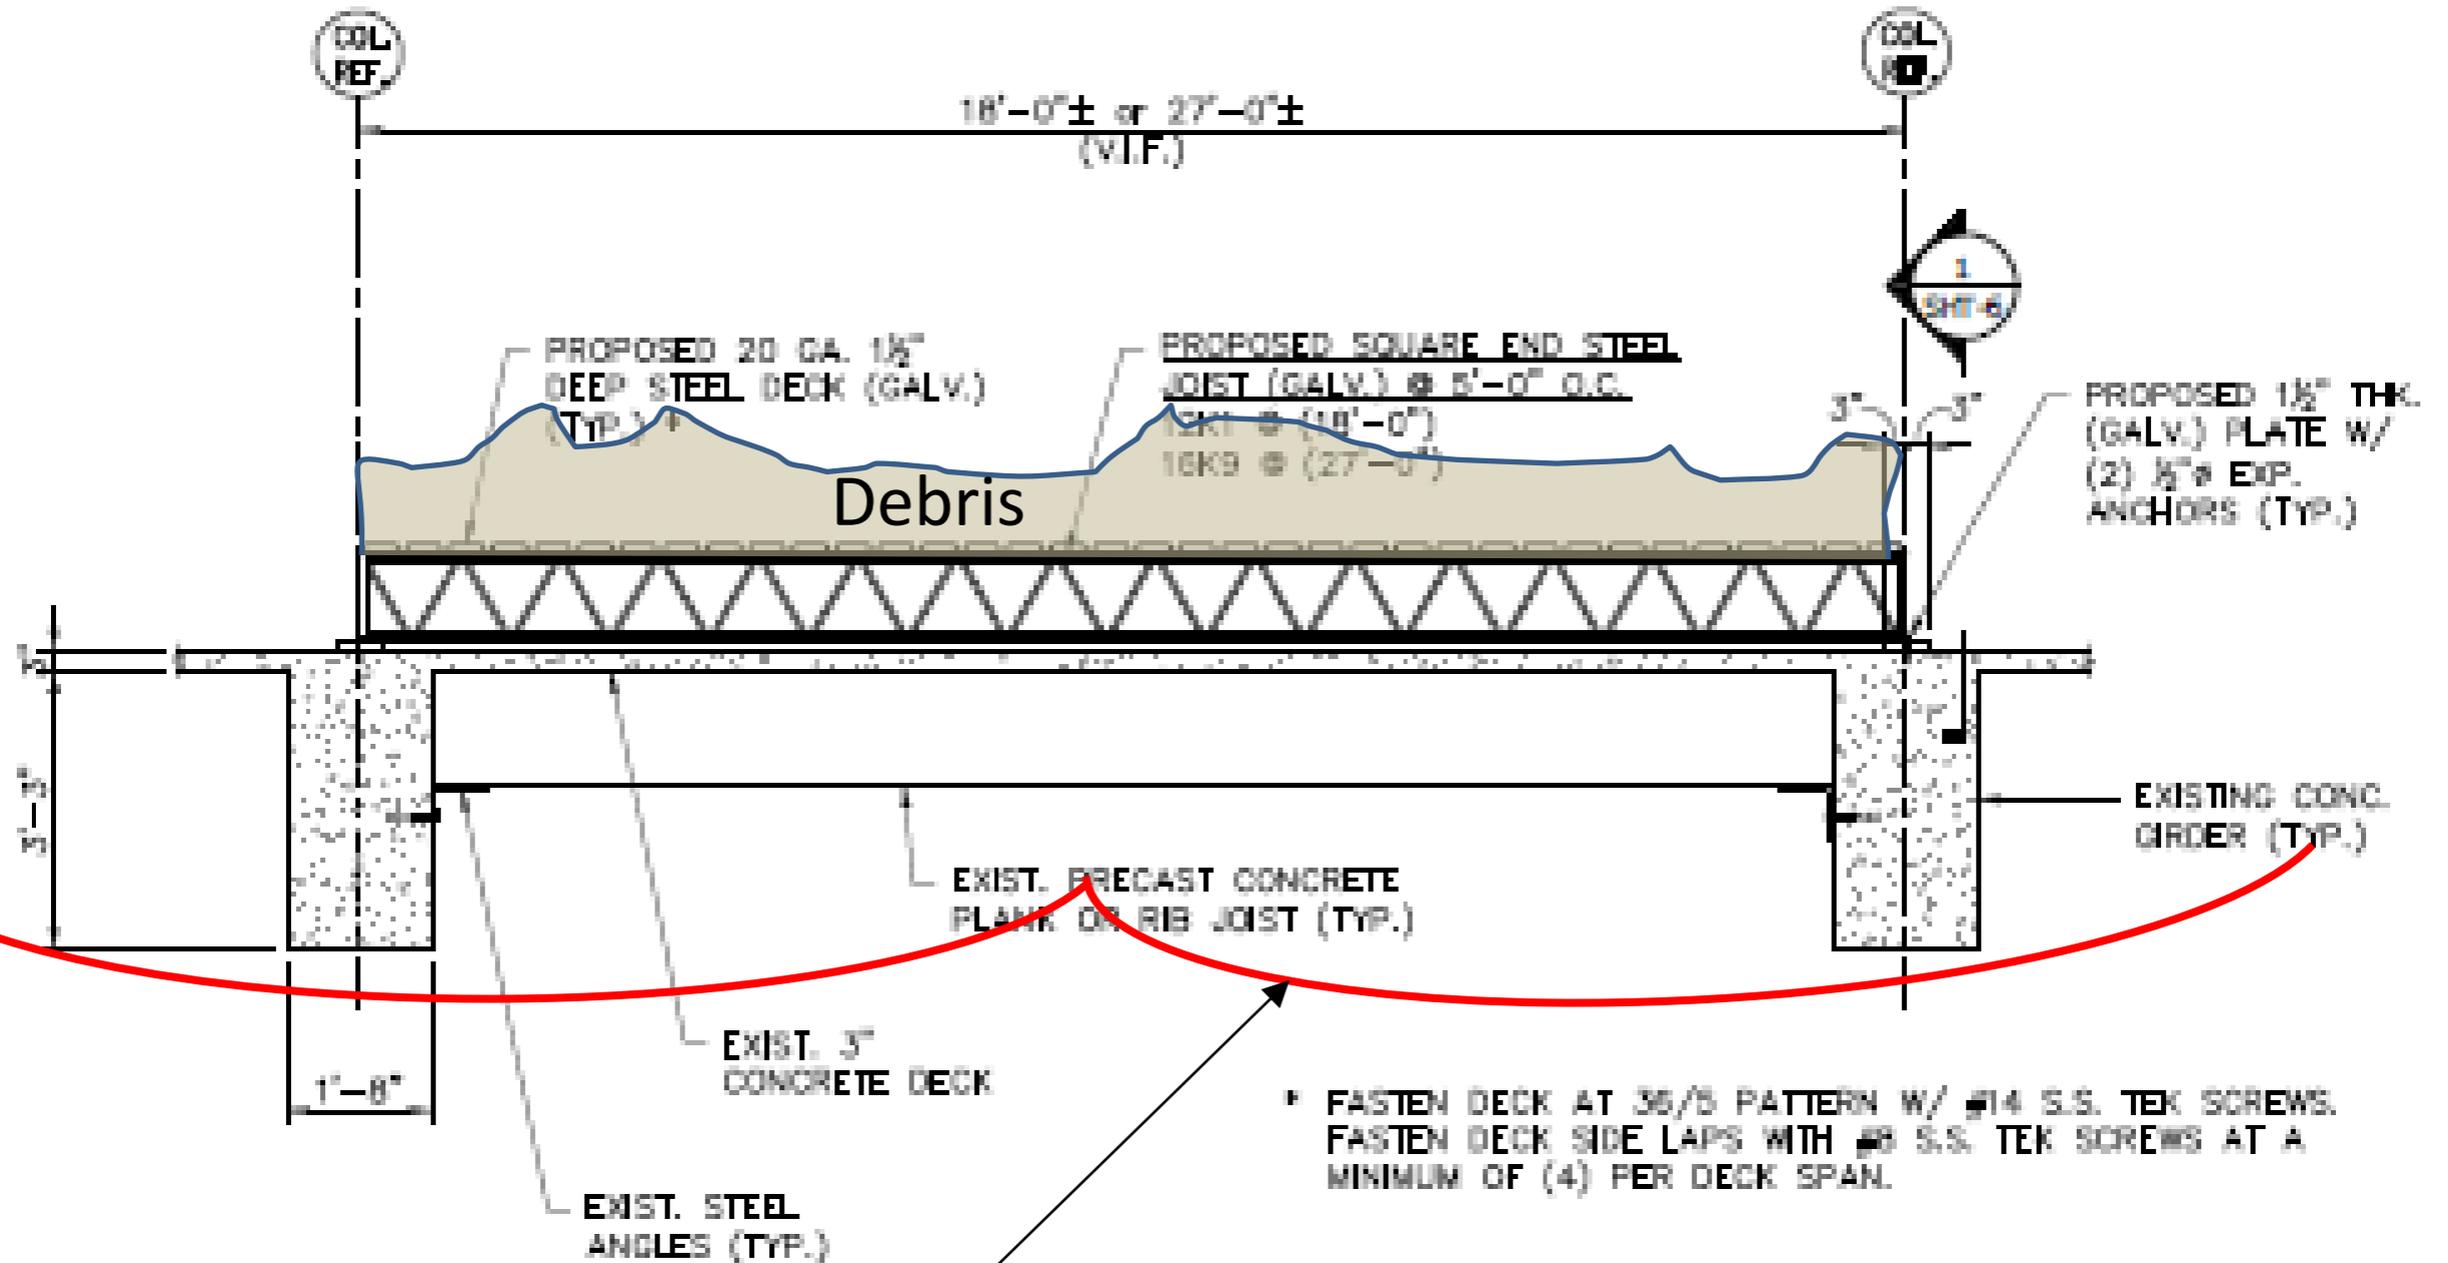
Net above occupied spaces to catch minor beam spalls

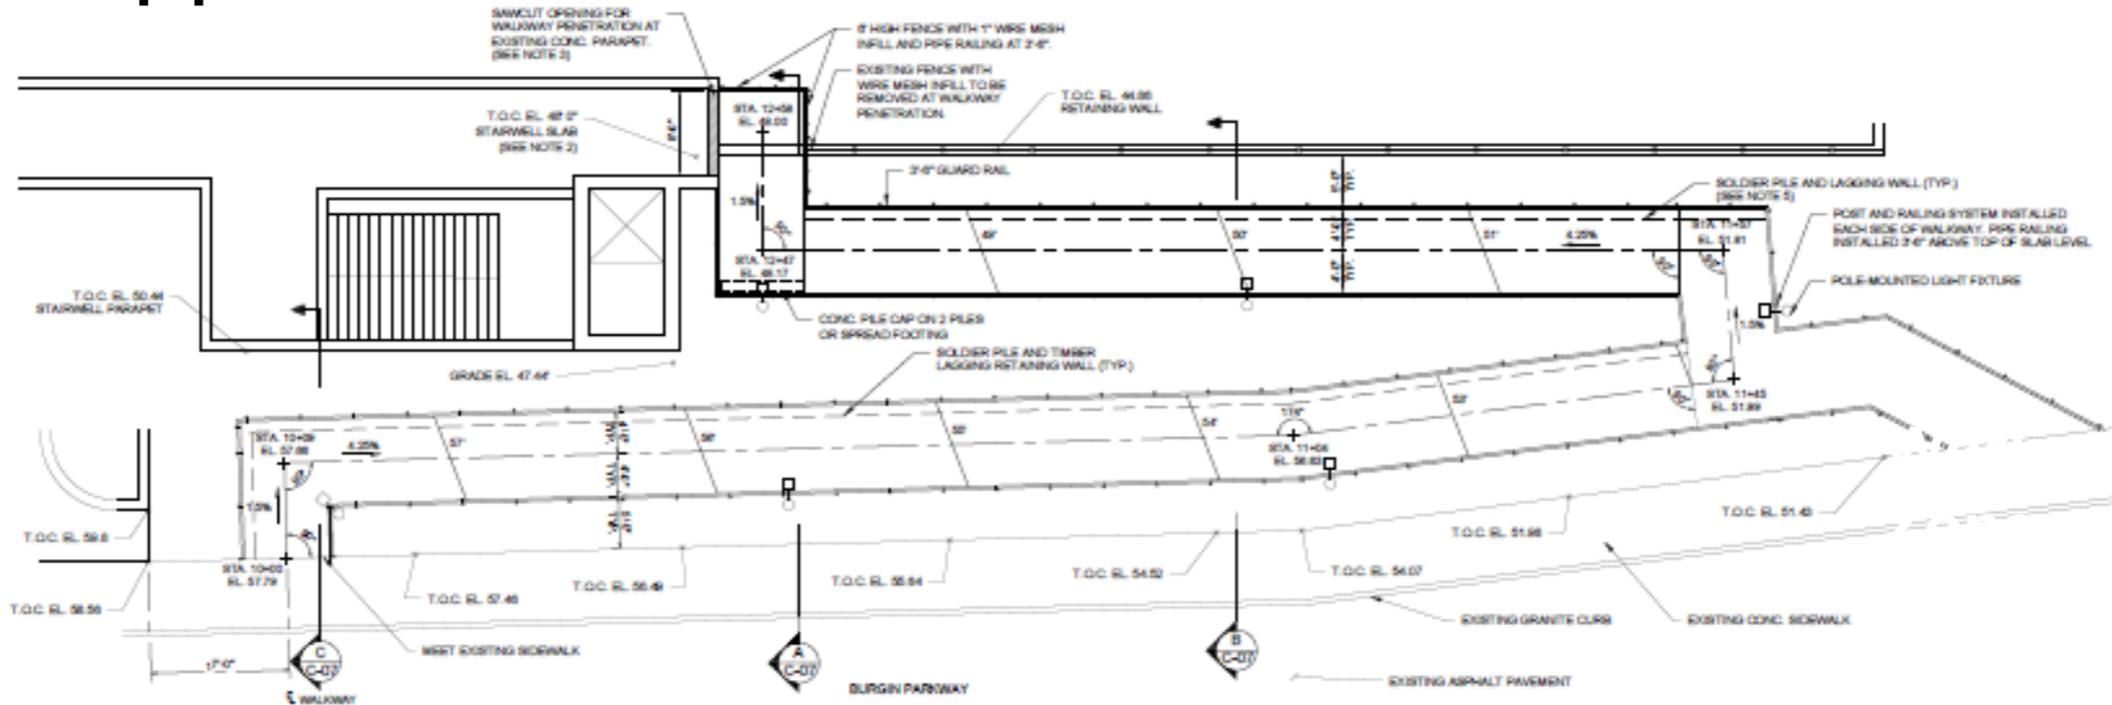
BURGIN PARKWAY ENTRANCE TEMPORARY WALKWAY
SCALE 1/8" = 1'-0"

3. CUT AN 8'-0" OPENING IN EXISTING 12" THICK CONCRETE PARAPET WALL CENTERED IN EXISTING HALLWAY. REMOVE EXISTING GLASS WALL AND FRAMING BACK TO EXISTING CORNER COLUMN.

4. WALKWAY SHALL HAVE CLEAR WIDTH OF 8'-0".
 5. MAXIMUM WALKWAY SLOPE SHALL NOT EXCEED 4.25%. MAXIMUM CROSS SLOPE SHALL NOT EXCEED 1.5%.
 6. REMOVE ALL TREES AND VEGETATION WHICH INTERFERES WITH PROPOSED WALKWAY CONSTRUCTION.

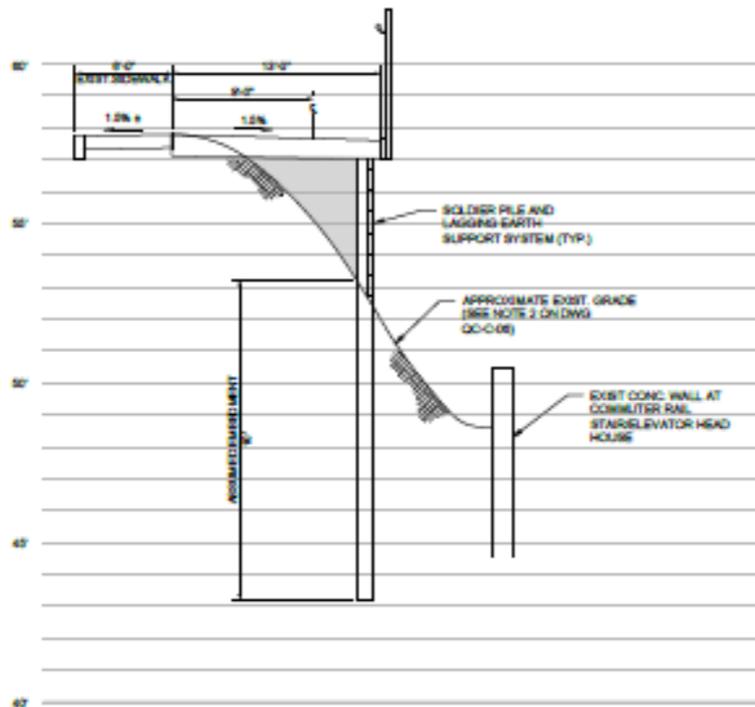
C SECTION
C-06

SCALE: VERT 3/8" = 1'-0"
HORIZ 3/16" = 1'-0"

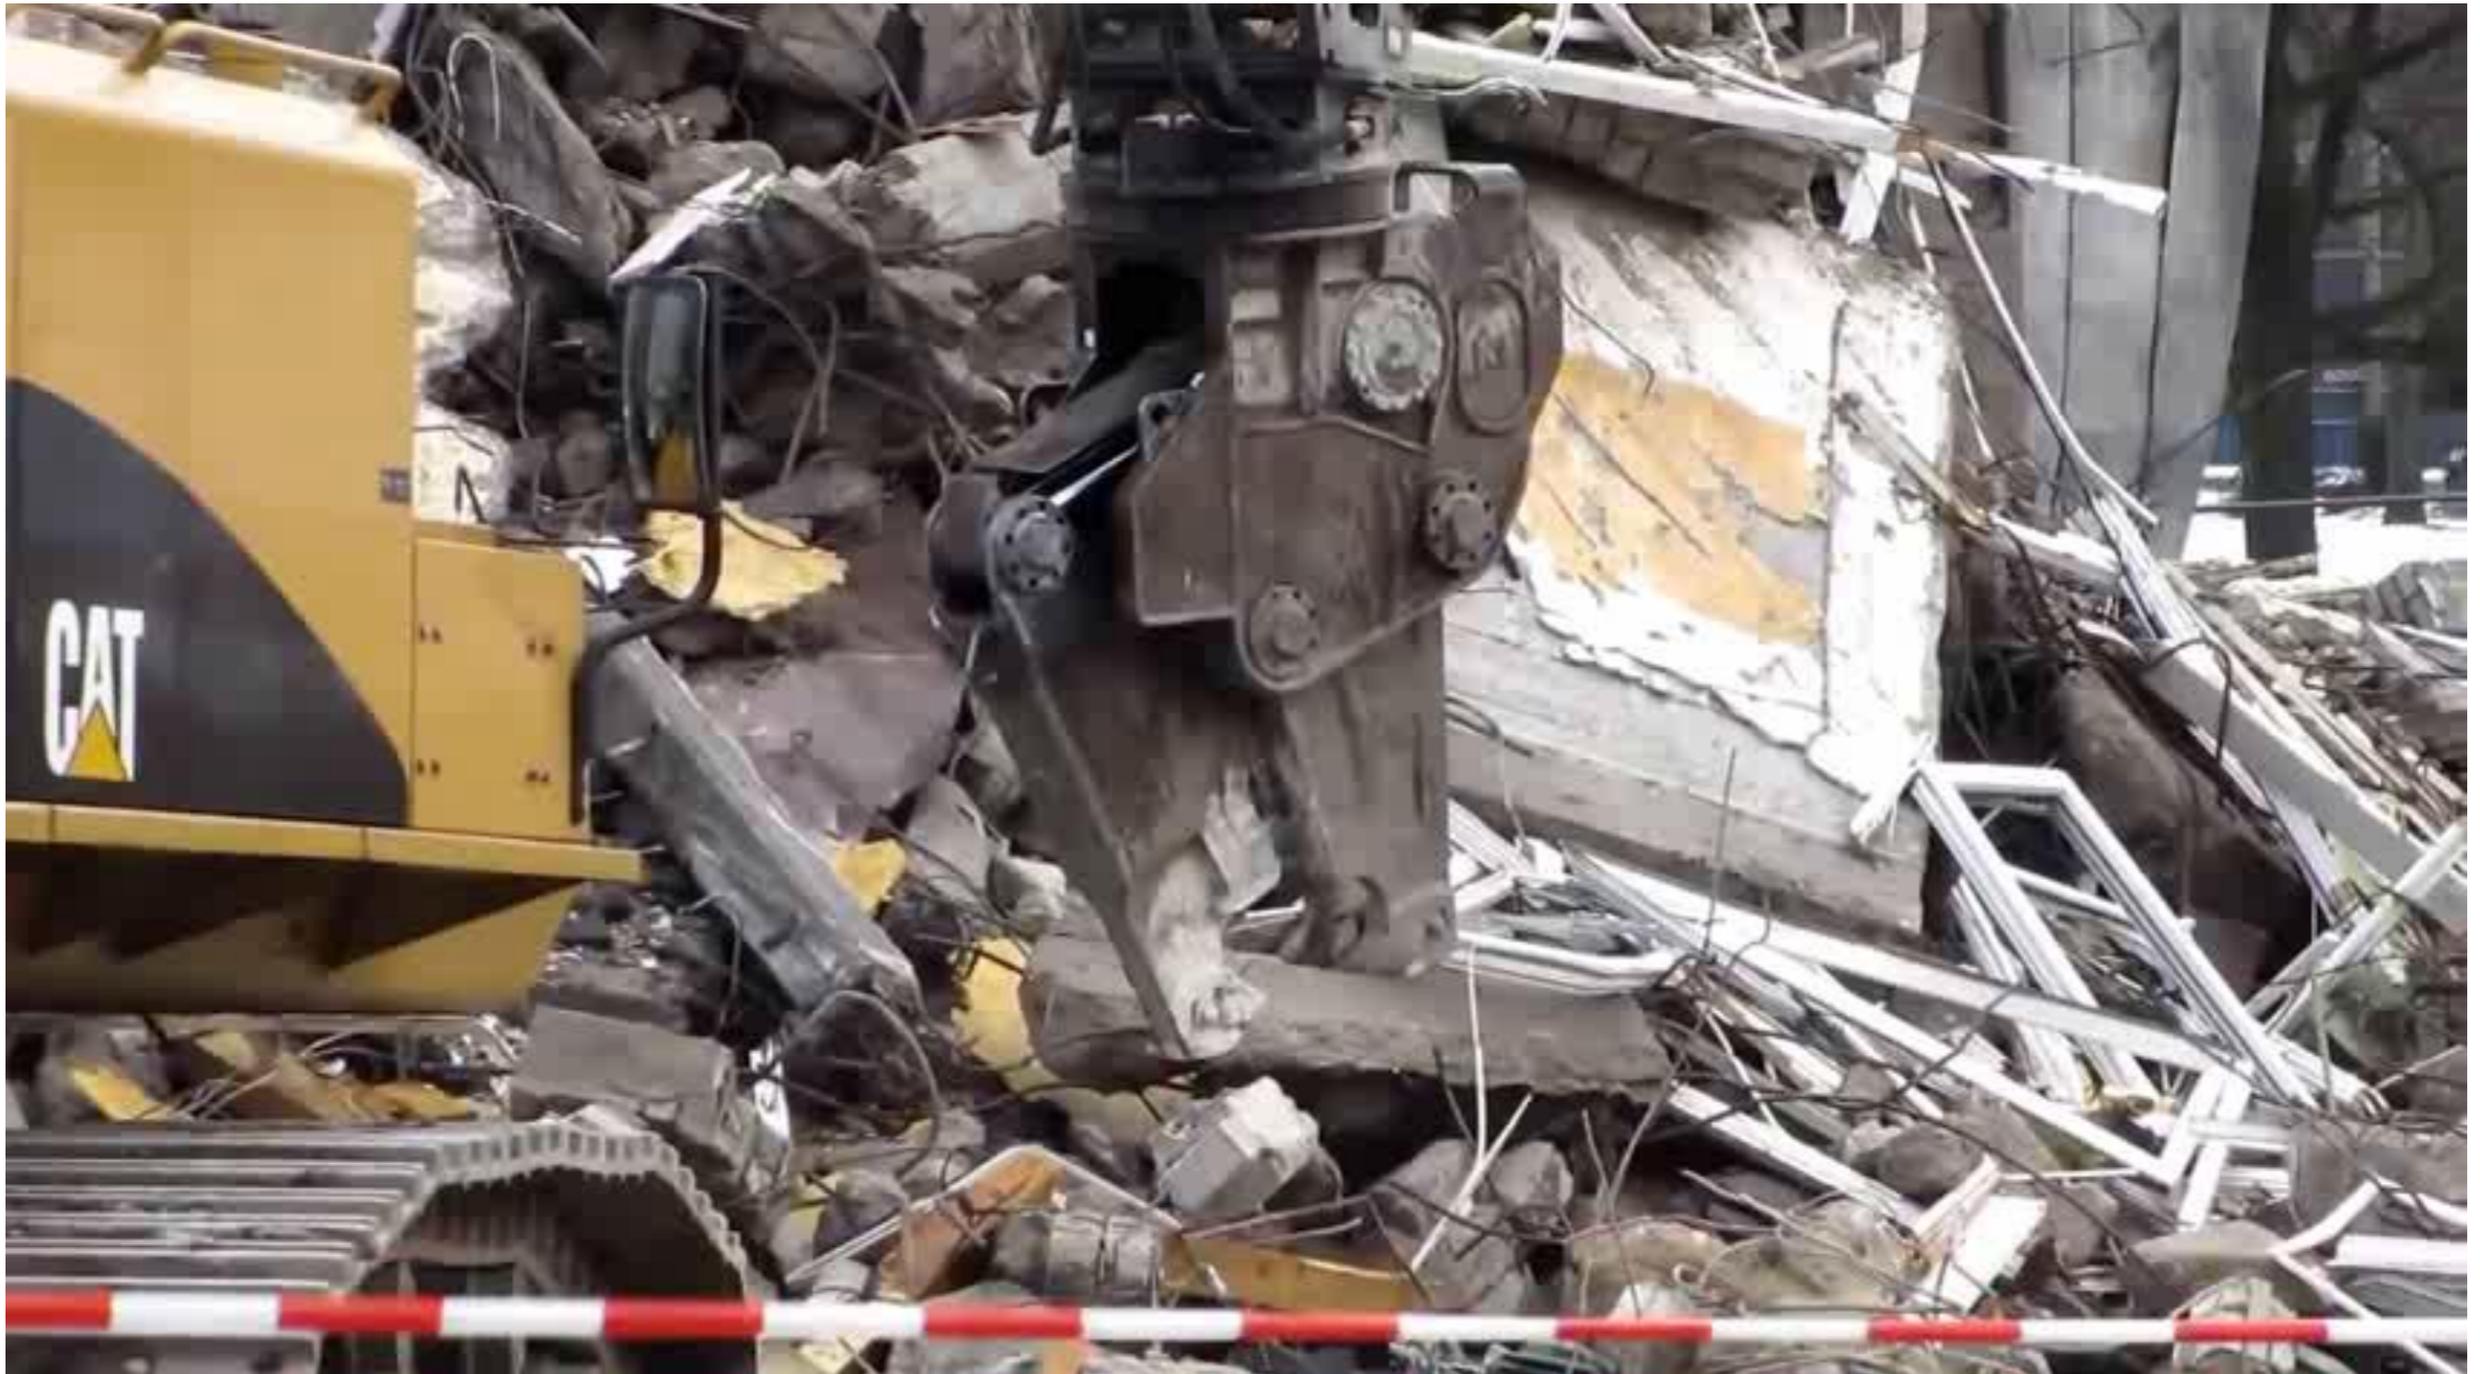
Example of Long-Boom Excavator Demolishing Building

- • Cut and pick
- ~~Implosion~~
- ~~Wrecking ball~~
- • Long-boom excavators with rotating wide mouth pulverizers
- • Small equipment hammers/pulverizers

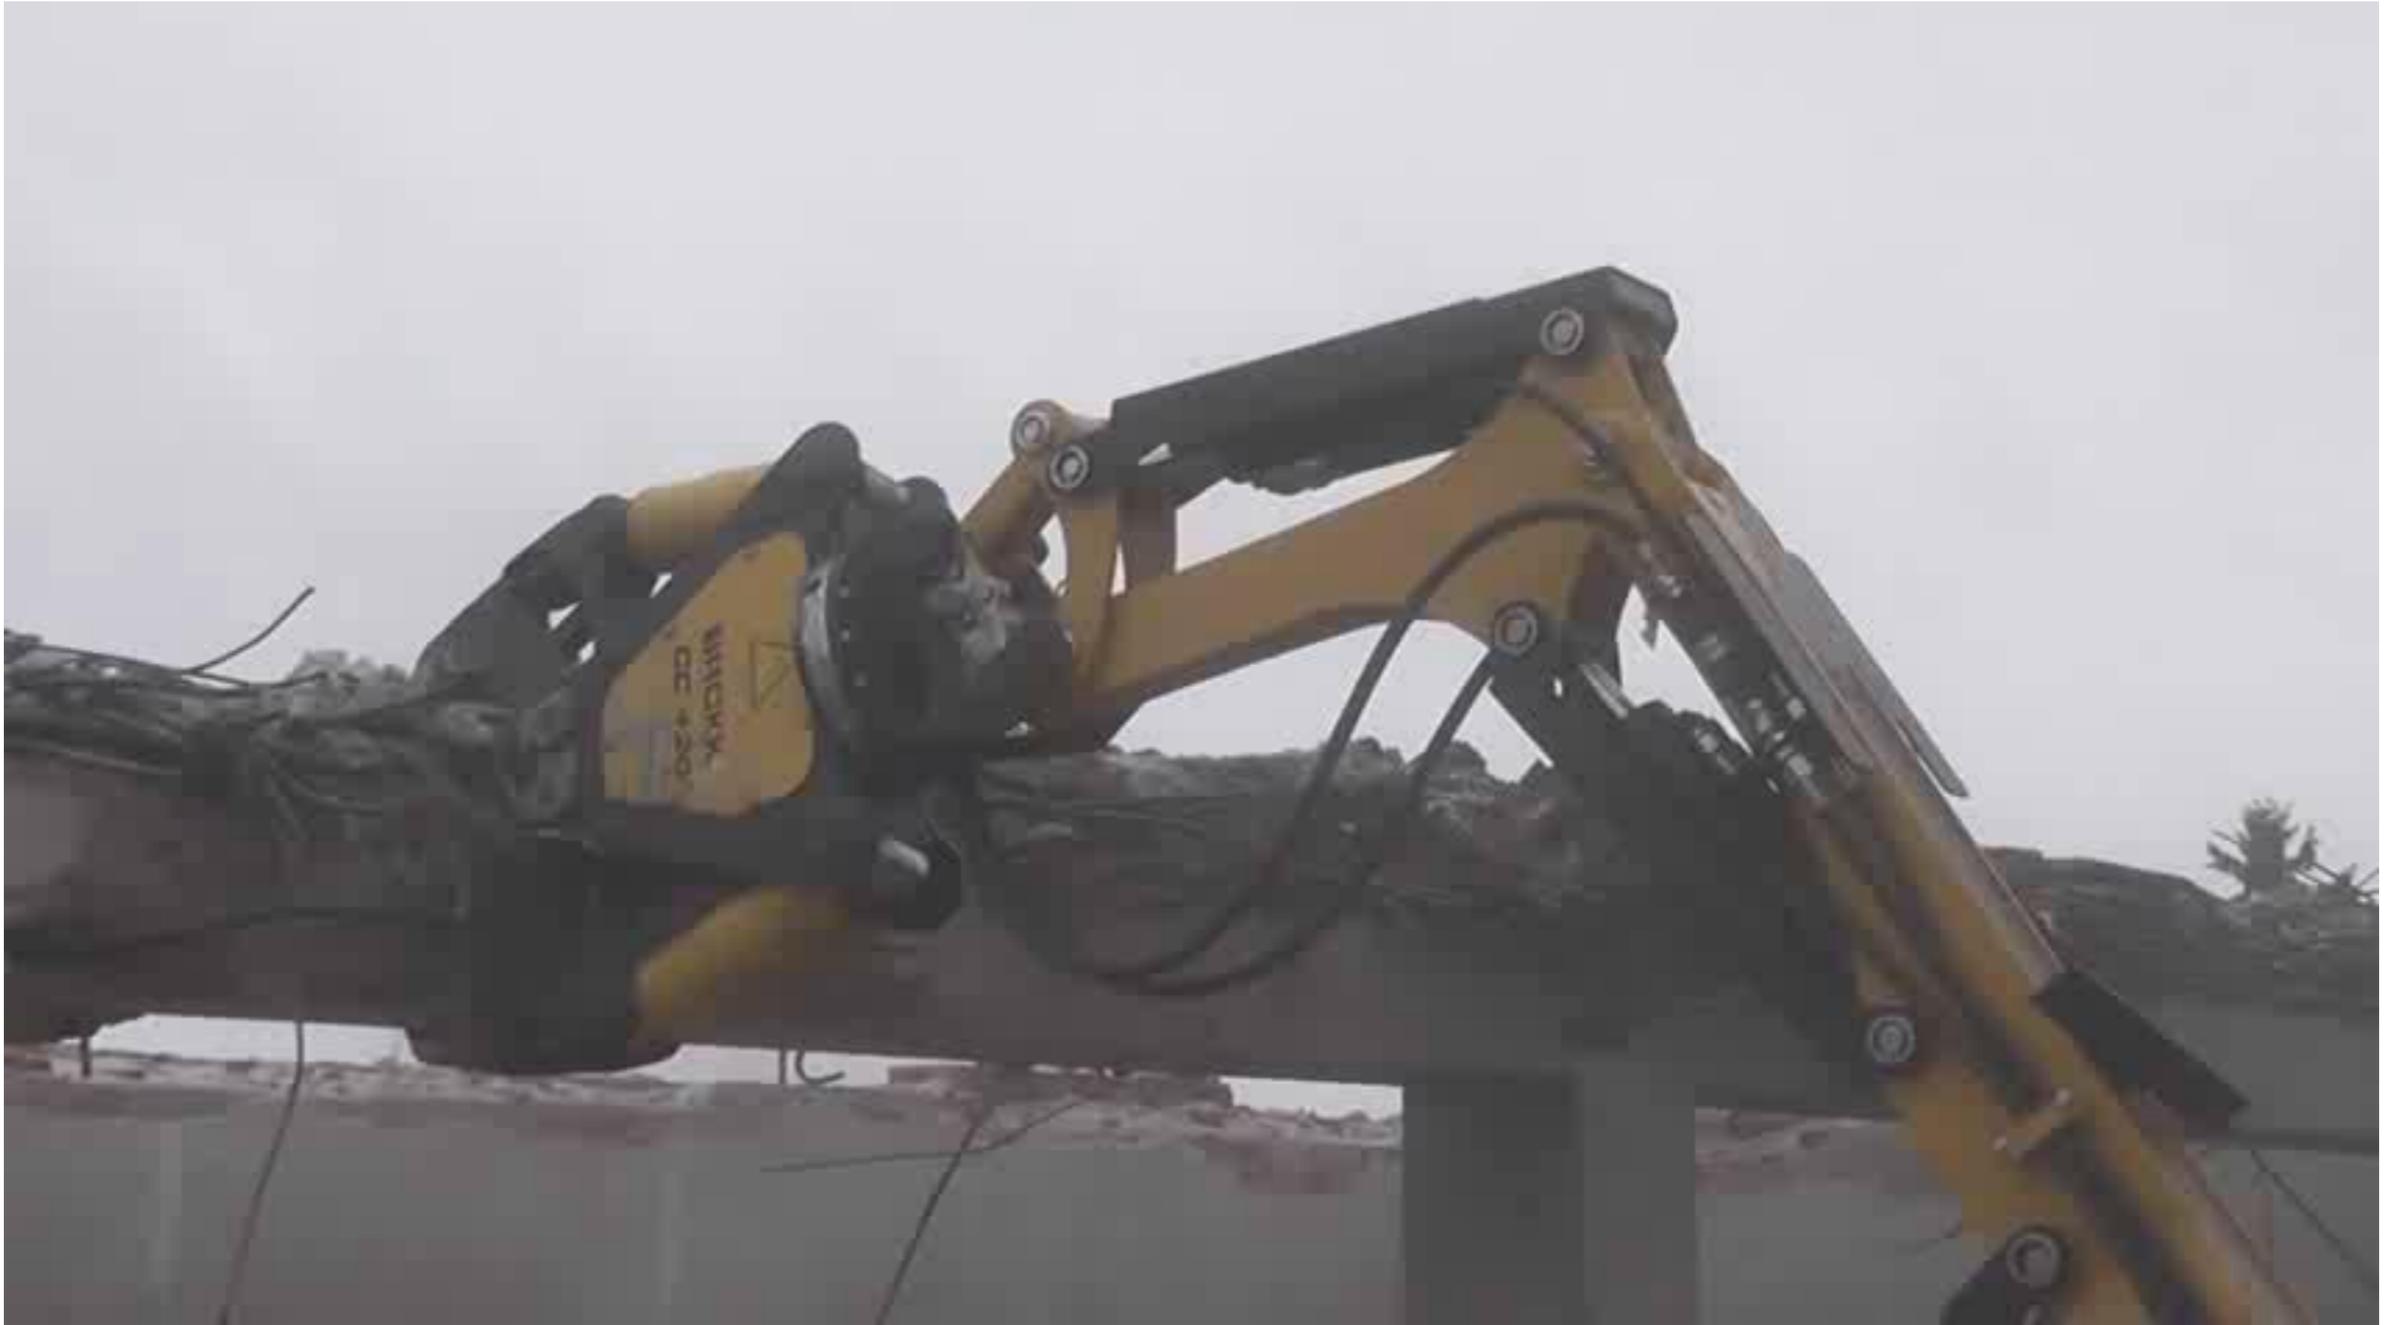
Example of Concrete Beam Being Pulverized
