MBTA | Worcester Union Commuter Rail Station Accessibility Improvements and Associated Track Work

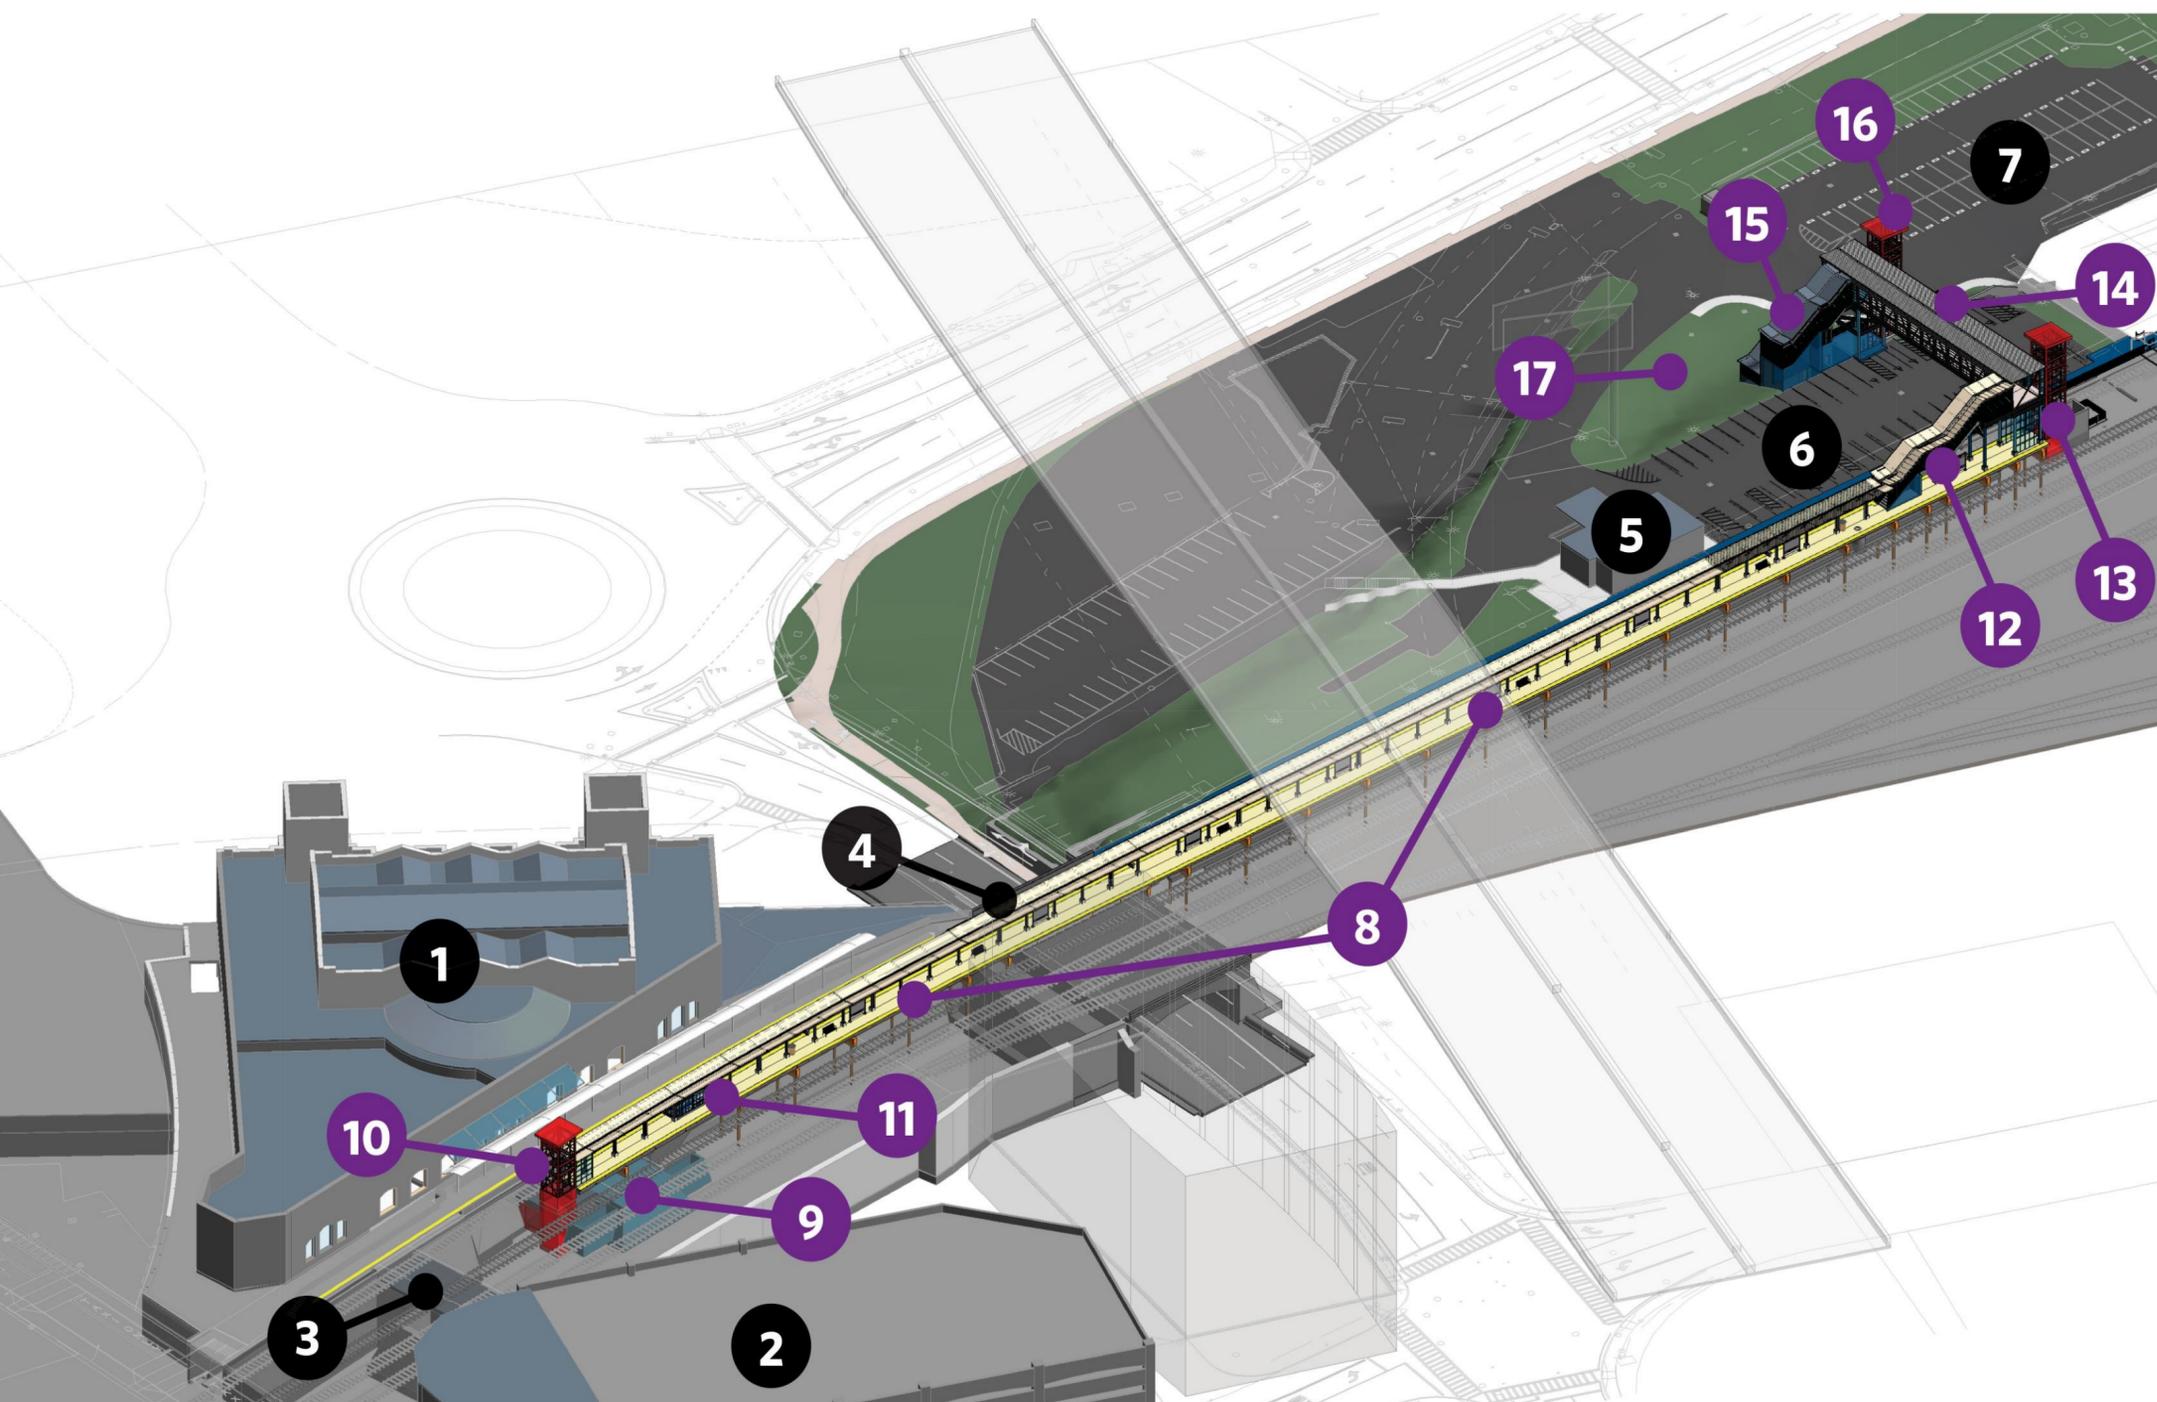
OVERALL 3D VIEW AT STATION

Existing Features:

1. Union Station Building
2. Union Station Parking Garage
3. Pedestrian Tunnel to Parking Garage
4. Grafton Street Bridge
5. Keolis Building
6. MBTA Upper Parking Lot
7. MBTA Lower Parking Lot

Proposed Features:

8. Center Island Platform
9. Platform Access Corridor (Below)
10. Elevator #1
11. Stair #1
12. Stair #2
13. Elevator #2
14. Pedestrian Bridge
15. Stair #3
16. Elevator #3
17. Rainwater Retention Area

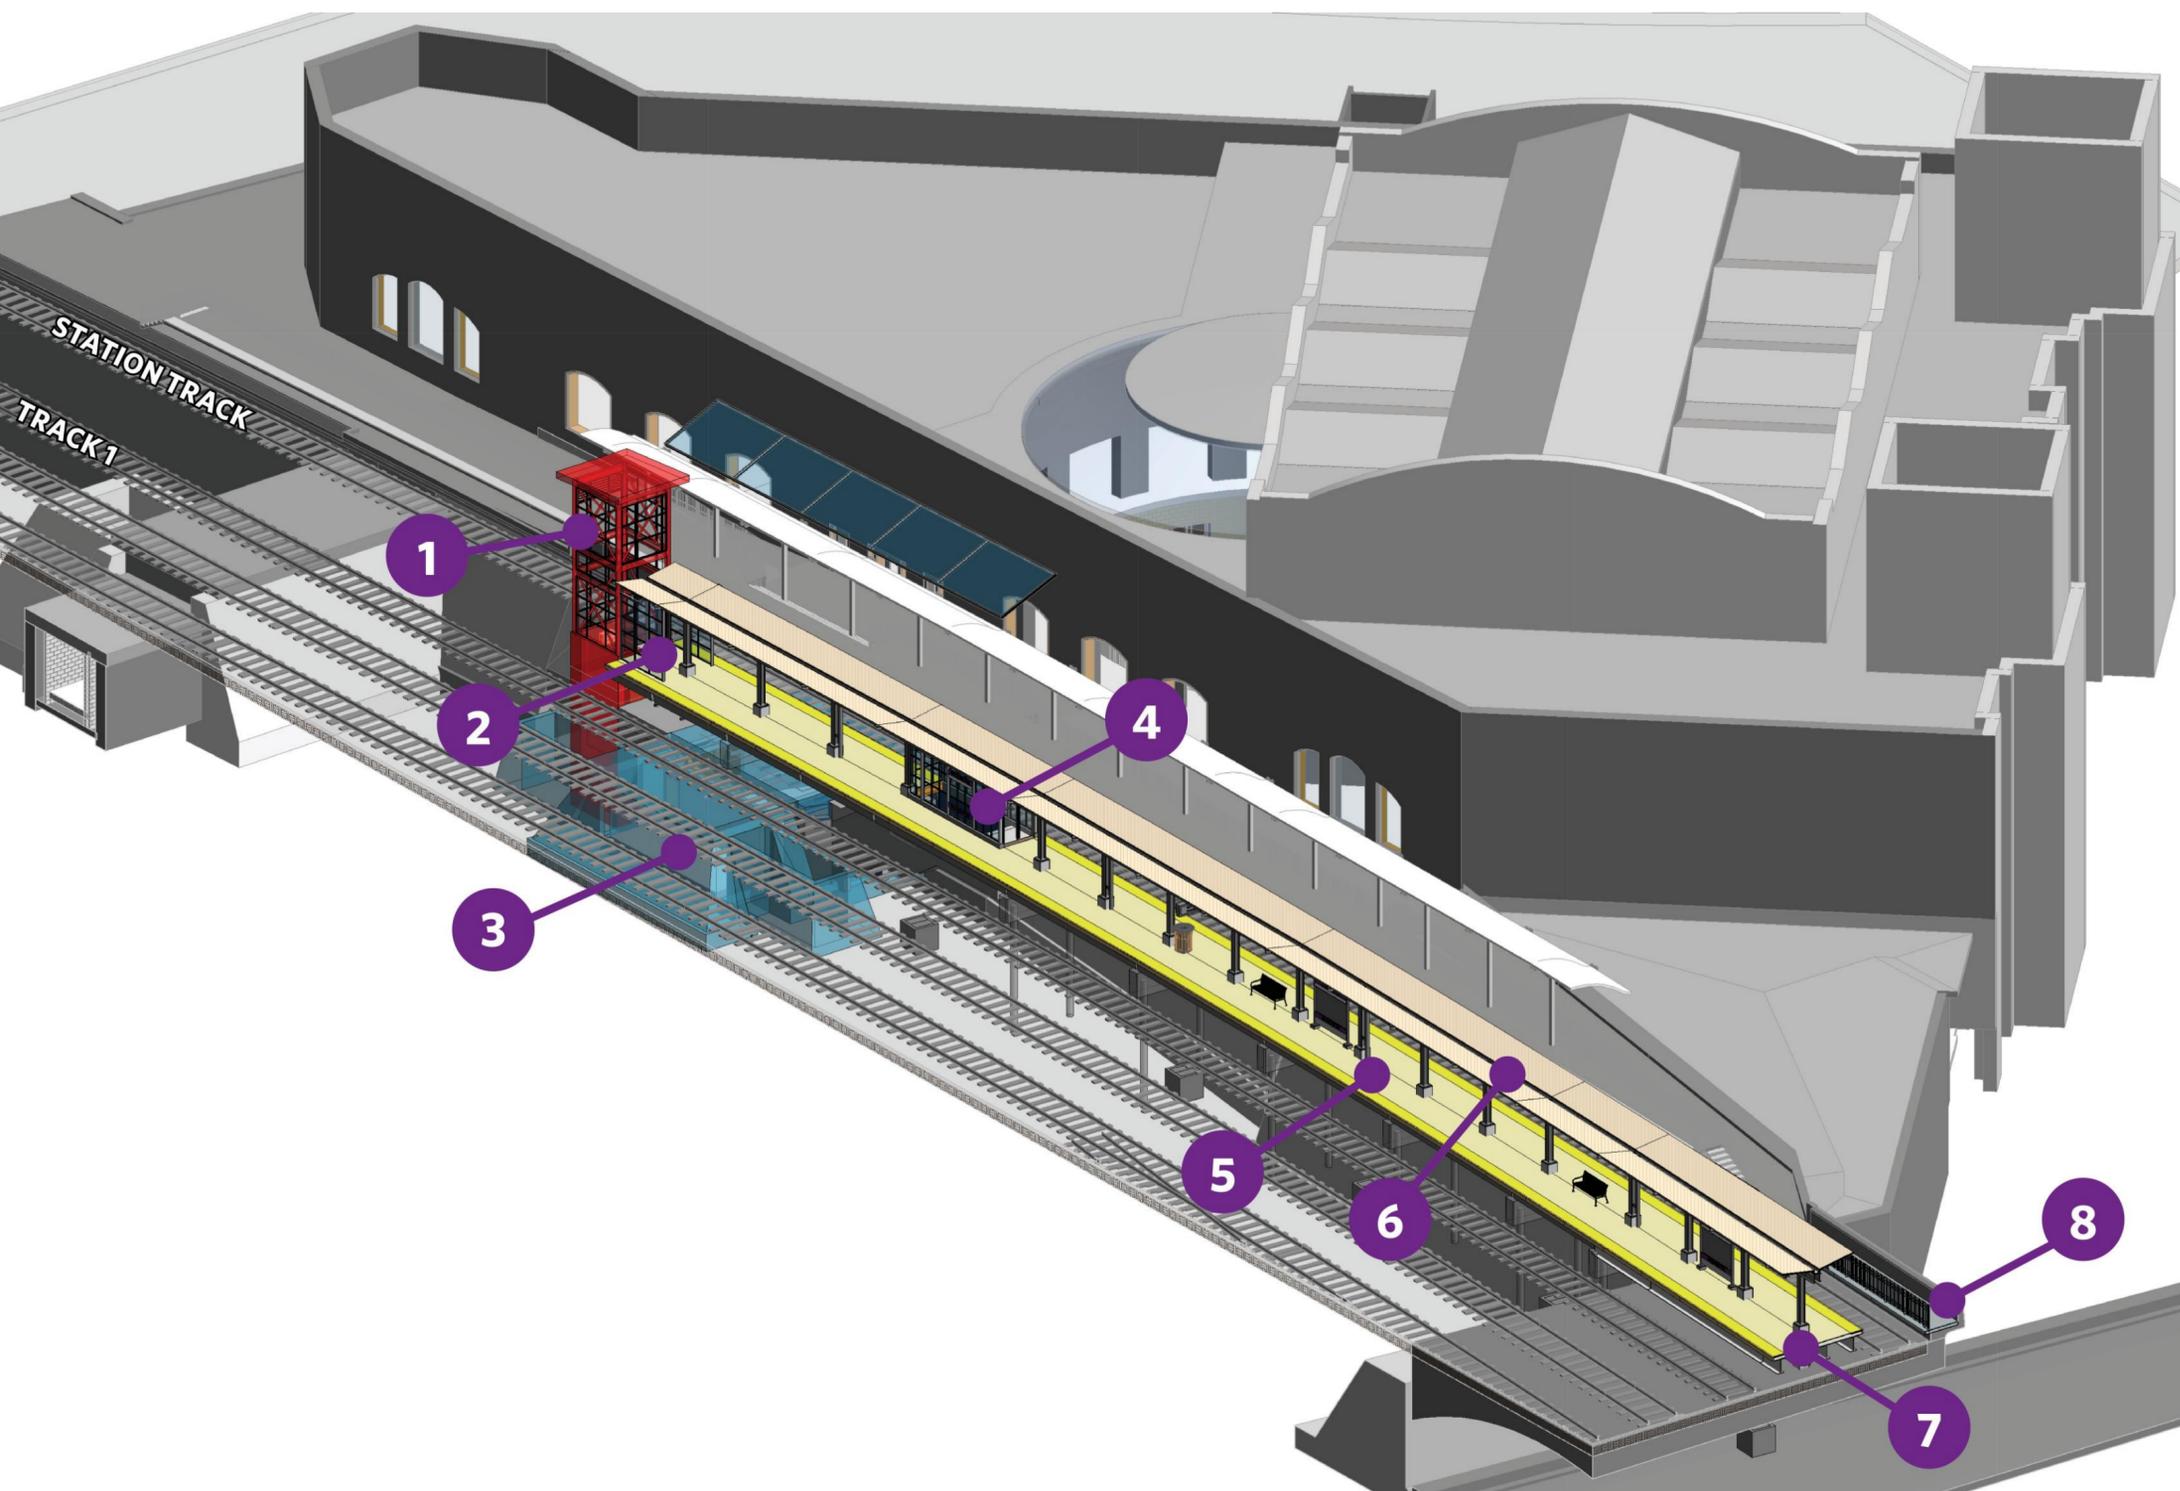
WEST END 3DVIEW

Key Features:

1. Elevator #1
2. Elevator Lobby at Platform
3. Platform Access Corridor (Below)
4. Stair #1 with Enclosure
5. Center Island Platform
6. Continuous Canopy
7. Platform Spans over Grafton Street. Bridge
8. Accessible Walkway

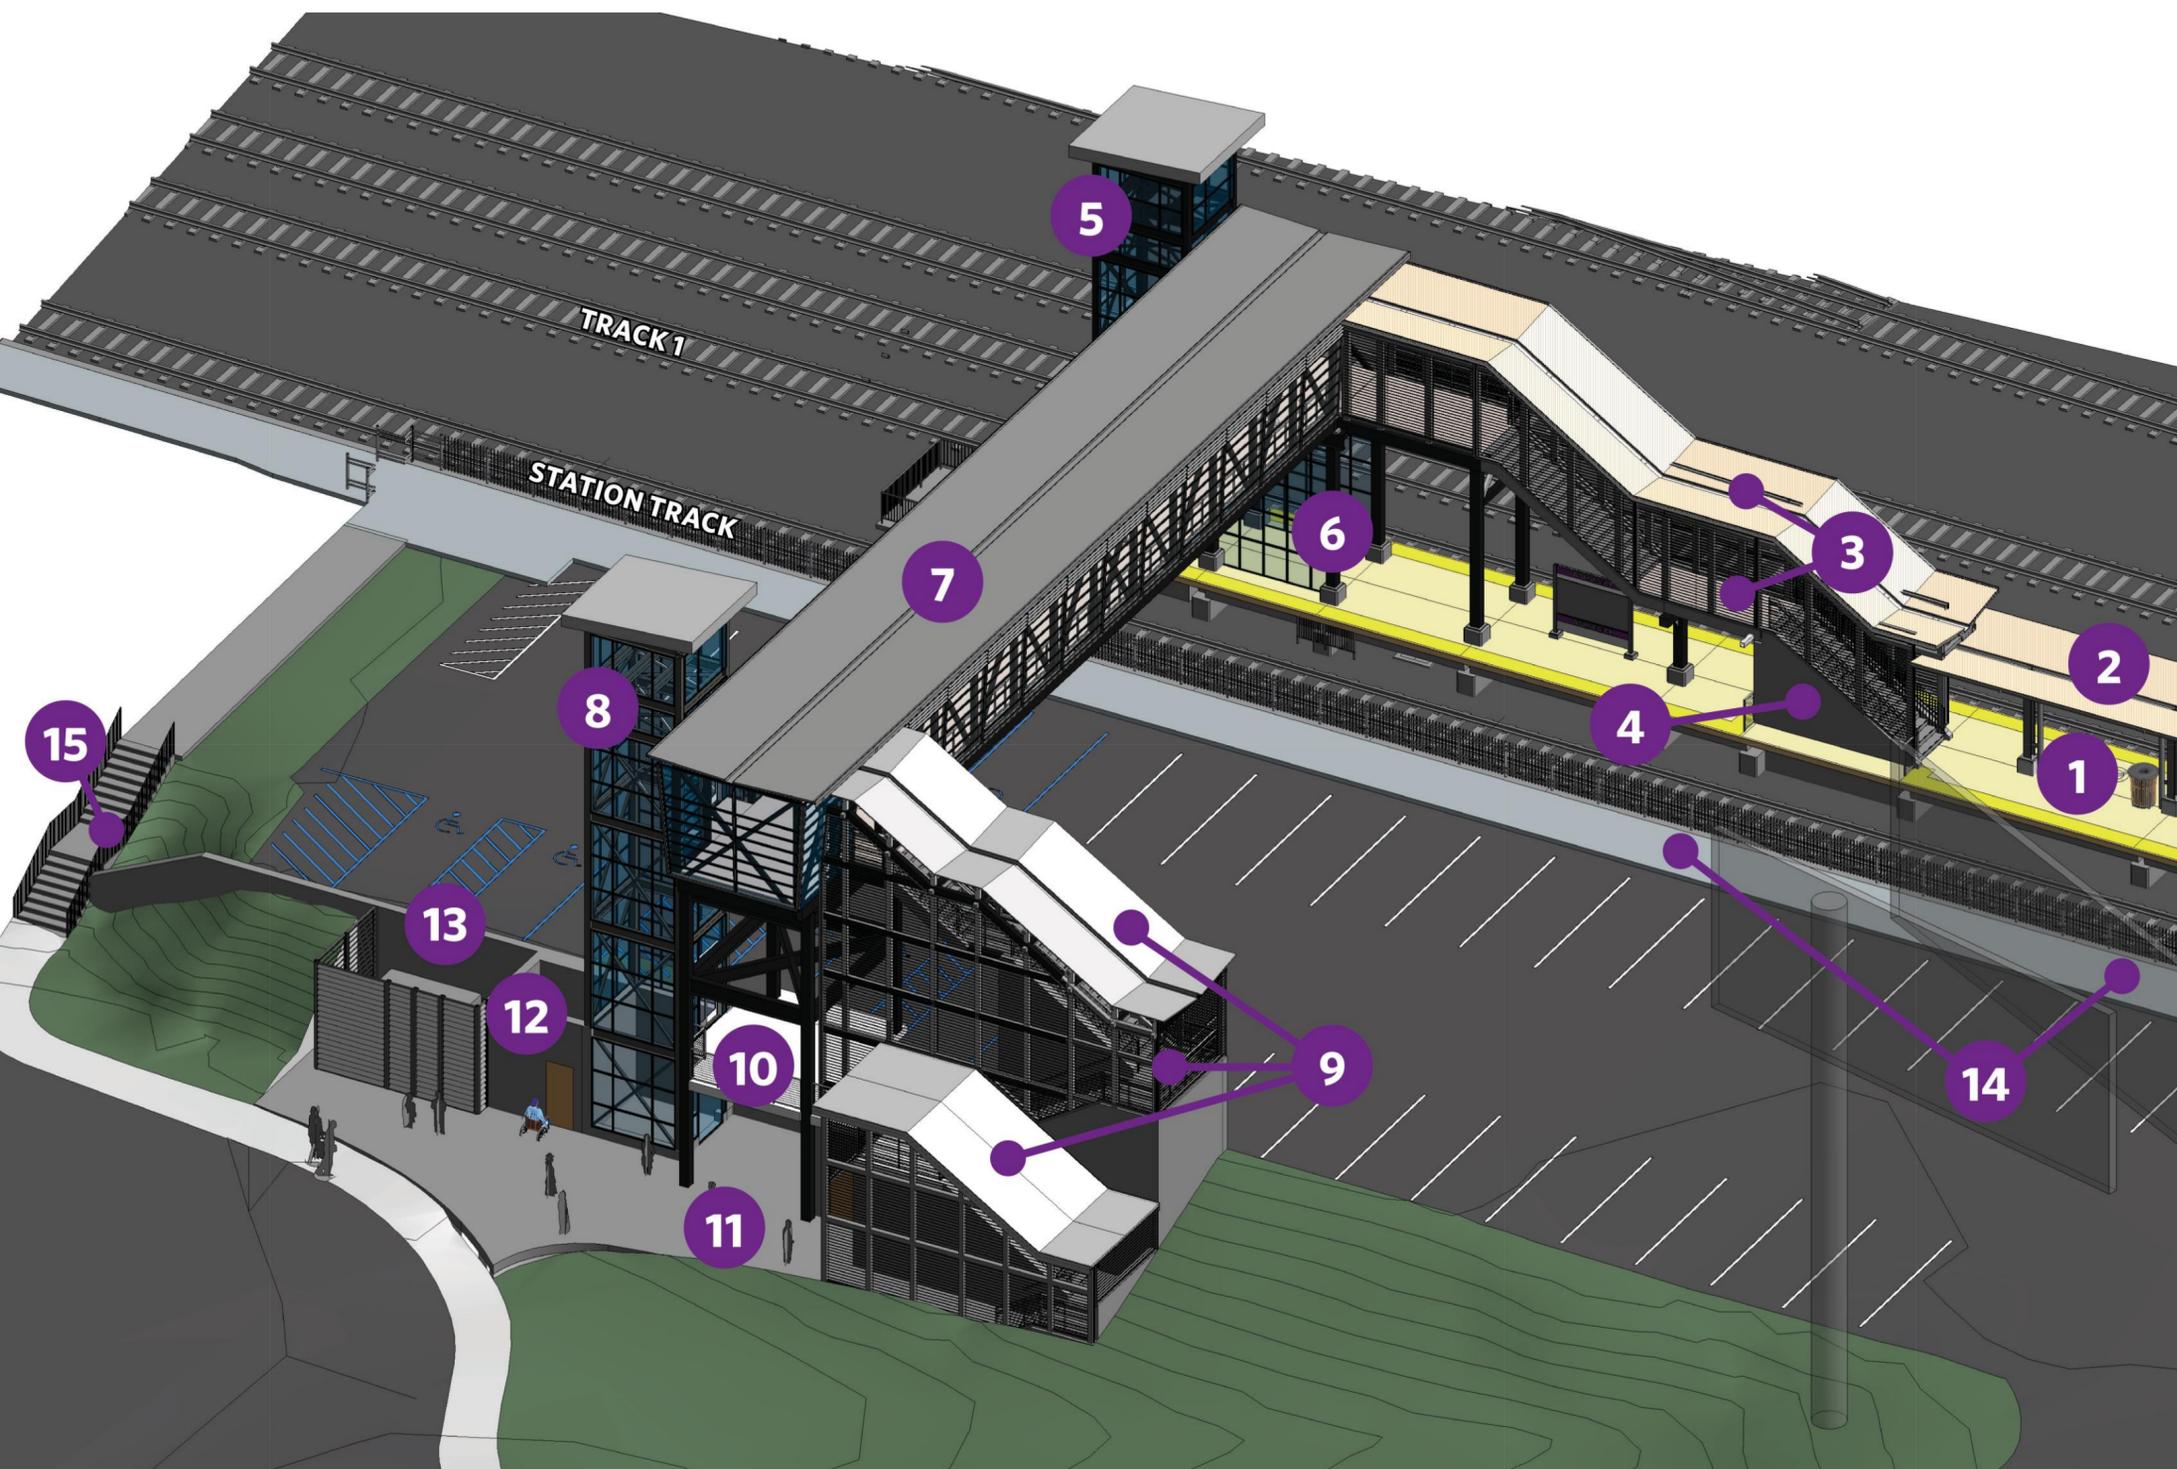
EAST END 3DVIEW

Key Features:

1. Center Island Platform
2. Continuous Canopy
3. Stair #2 with Roof and Screening
4. Storage room below stairs
5. Elevator #2
6. Elevator Lobby
7. Pedestrian Bridge
8. Elevator #3
9. Stair #3 with Roof and Screening
10. Upper landing
11. Lower landing/Plaza
12. EMR #3
13. Backup generator and enclosure
14. Accessible walkway with fence
15. Existing concrete stairs

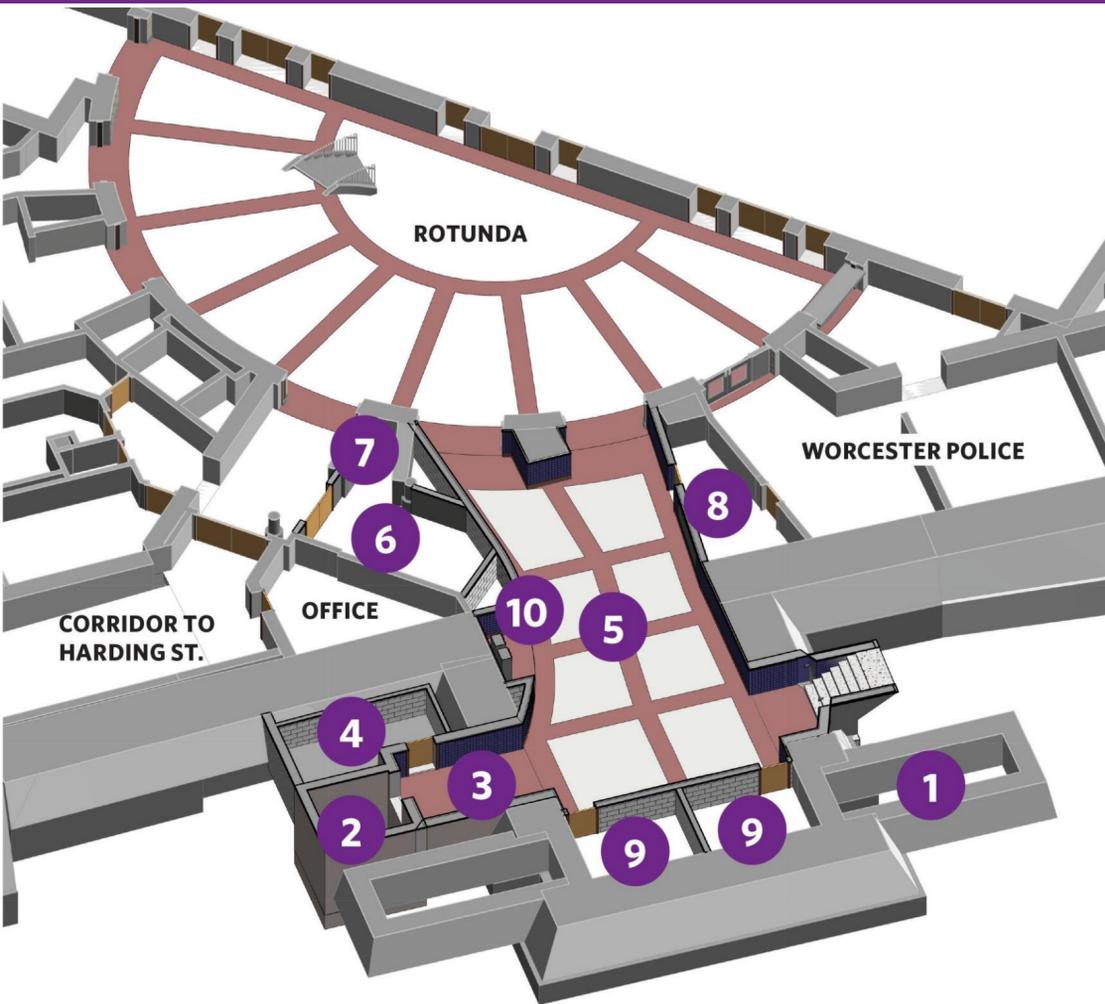
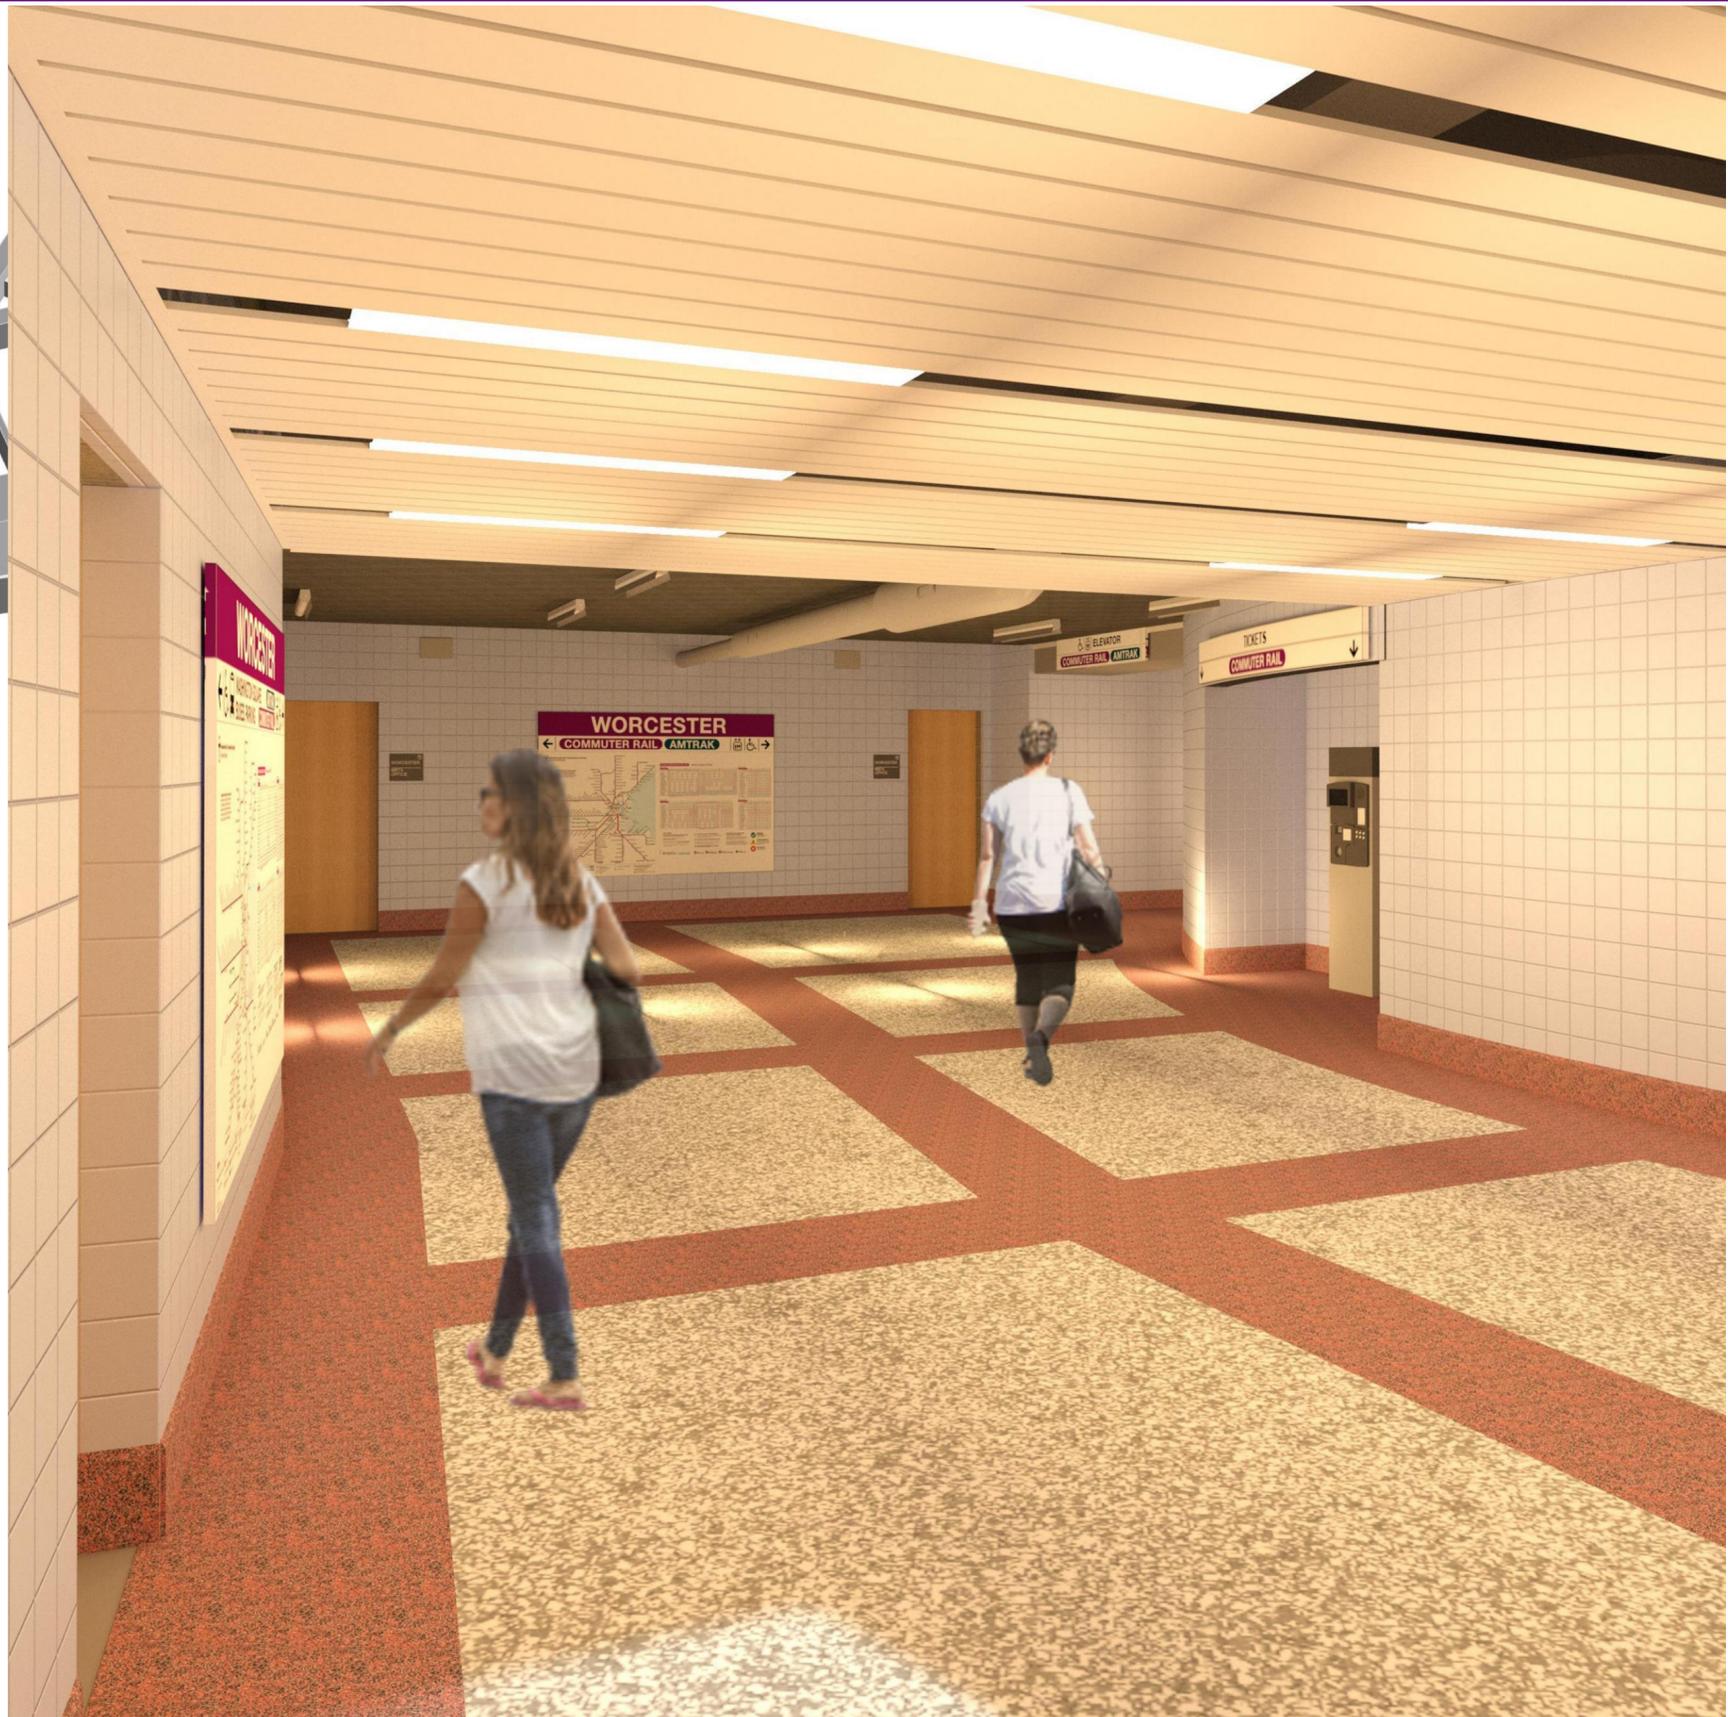
PLATFORM ACCESS FROM UNION STATION BUILDING

Key Features:

1. Stair #1
2. Elevator #1
3. Elevator Lobby
4. Elevator #1 Machine Room
5. Platform Access Corridor
6. Mechanical Room
7. Existing 3rd Party Comm. Equipment
8. Police Access Vestibule
9. MBTA Offices
10. Ticketing Alcove
