Introduction

The Gloucester Drawbridge carries the MBTA's Newburyport/Rockport Commuter Rail service over the Annisquam River in Gloucester. The existing bridge was built in 1911, reconstructed in 1932, and updated in 1984. Given the age and condition of the bridge, the MBTA slated it for replacement.

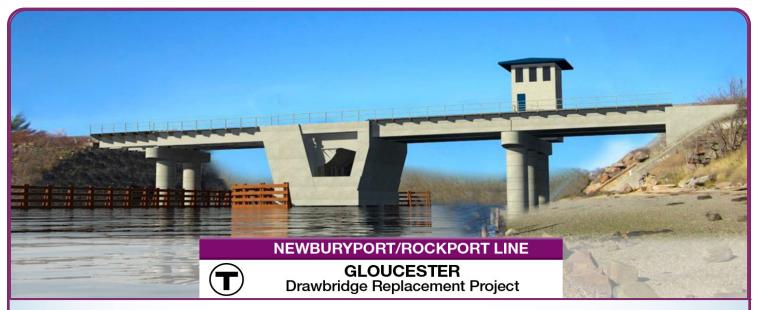
Top photo: rendering of completed bridge; below, the original drawbridge
