Massachusetts Bay Transportation Authority

COO Remarks

August 8, 2016

Beacon Junction Project

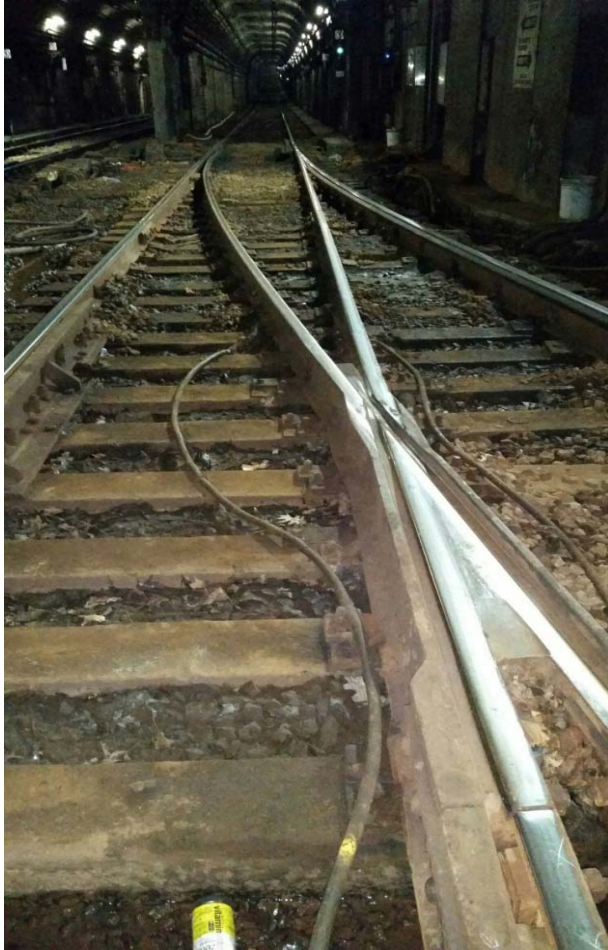
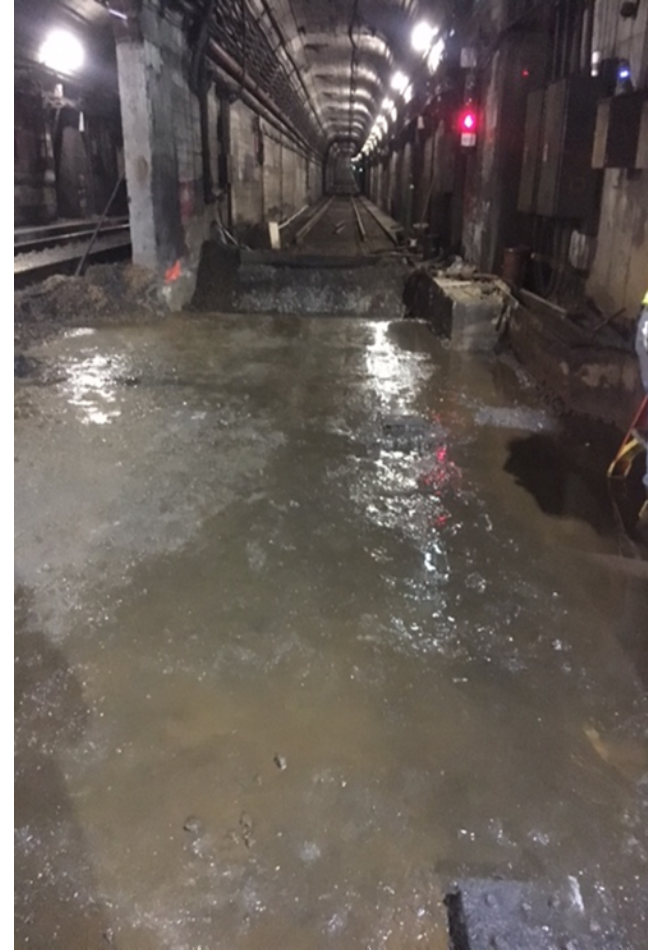
Beacon Junction

- Symptoms - Passenger Delays
 - Track surface and alignment deterioration
 - Signal operation faults
- Cause - Poor Drainage
 - Standing water
 - Fouled (contaminated) ballast
 - Loss of signals
 - Advanced track condition deterioration
- Solution – Rebuild Track Structure
 - Full Depth track construction
 - Replacement of all switch machines and track cross-overs
 - Installation of new drainage system
 - Installation of new signal equipment

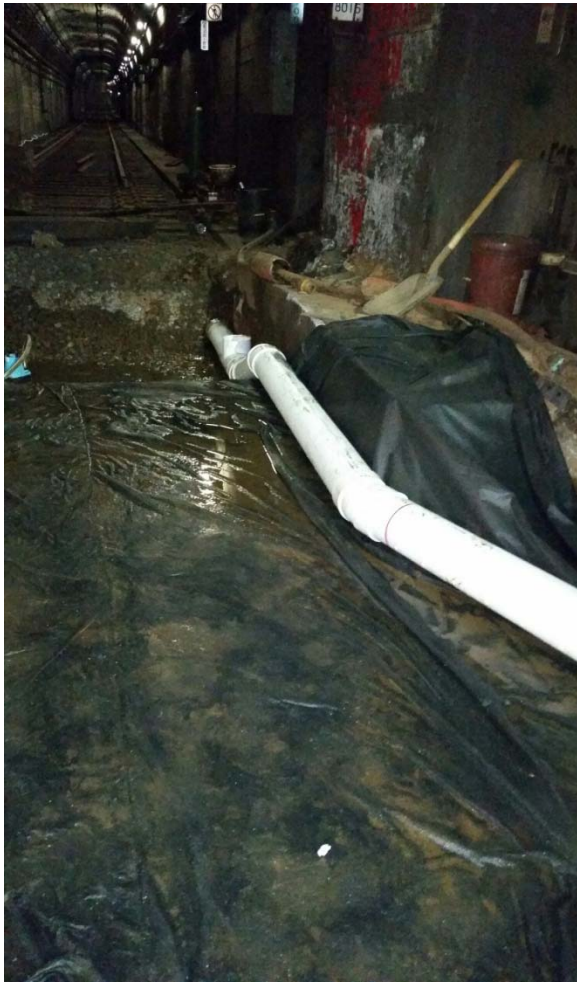
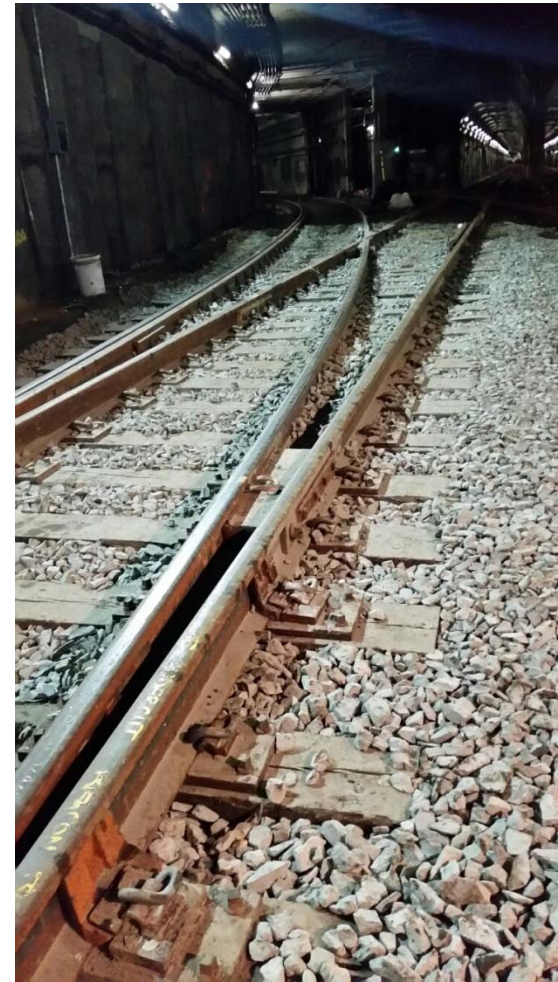
Beacon Junction

- First Weekend of work: July 29, 2016 – August 1, 2016
- Work scope: Switch 93 Green Line Eastbound track splitting for D (Riverside) Line and C (Beacon St.) lines between Kenmore and St. Mary's St. Stations
- Schedule: Work was performed over the weekend beginning with early access on Friday at 9pm and ending with a successful test train on Monday at 4:20am.
