**Massachusetts Bay
Transportation Authority**

GM Remarks

3/27/2017

MBTA Bus Operations and Maintenance: Expansion Service Model

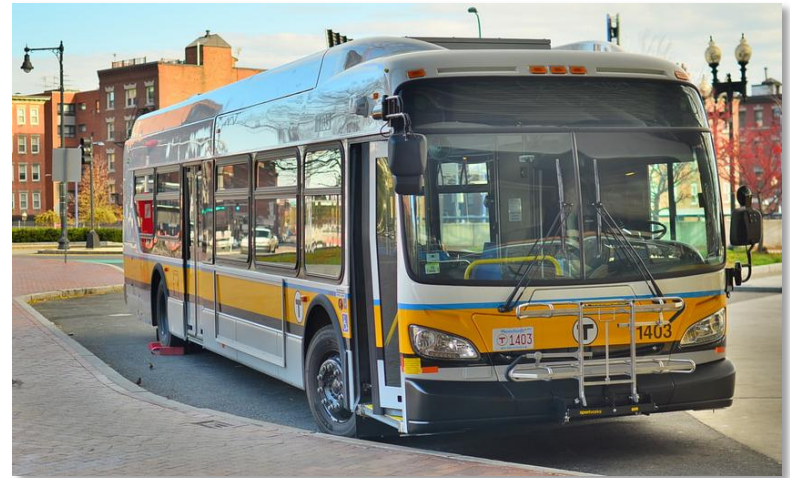
MBTA to provide 6 New Flyer Xcelsior XDE40 FT buses

- Contractor will provide full operation and maintenance of MBTA-owned vehicles for Routes 712/713
- For the first time, MBTA will provide six (6) new 40FT hybrid diesel/electric buses to contractor
 - Same New Flyer buses recently put into operation out of MBTA's Cabot garage
- Contract Length: FY2018-FY2021 (4 years) with two (2) one-year option years

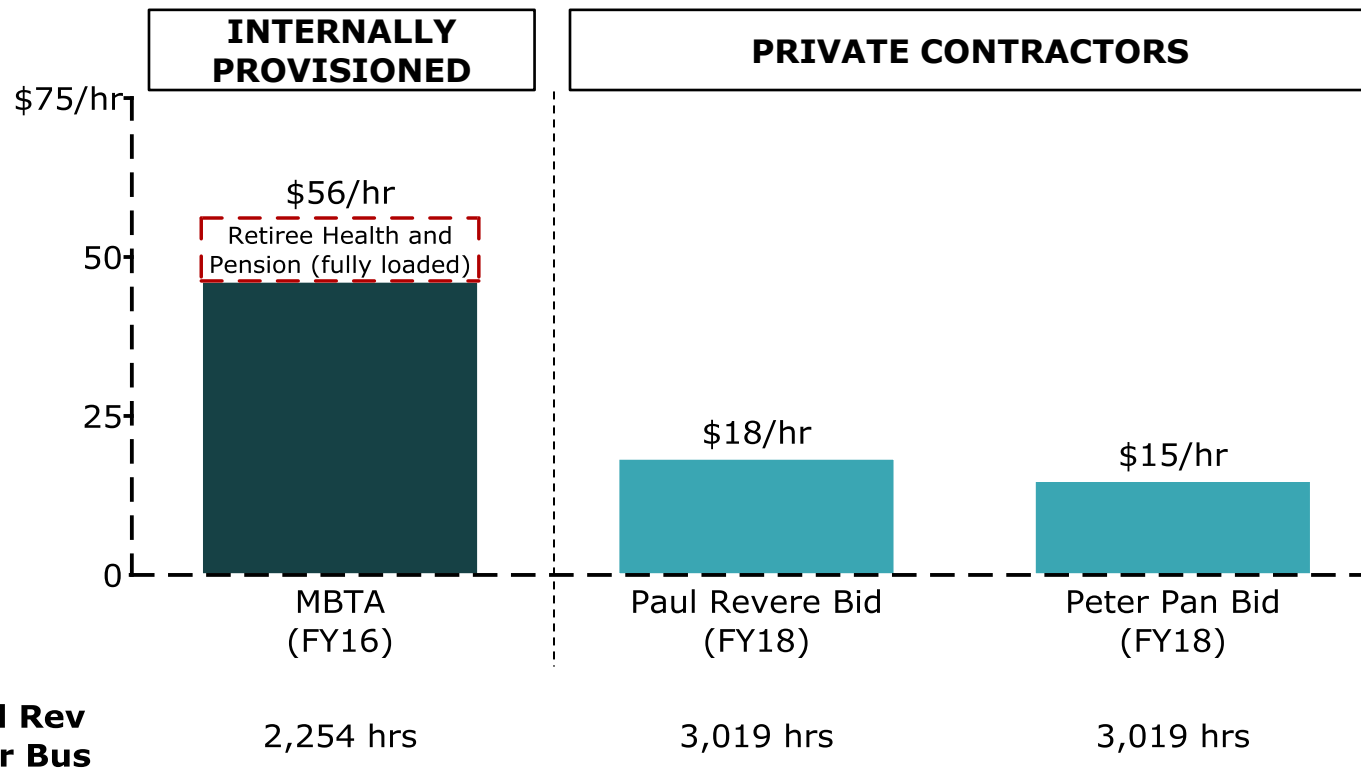
Maintenance Cost per Revenue Hour

Market Pricing: Lifecycle maintenance Costs New Flyer Xcelsior Diesel-Electric 40 Ft. Transit Bus

**Annual Rev
Hrs per Bus**

Note: MBTA FY16 costs include present value of fully funded pension and retiree health costs, include Everett Bus Shop, and exclude Non-Revenue Shops and fuel; MBTA internal costs only includes a portion of total bus G&A expense and reflect pure cost only (no profit margin)
Source: MBTA Internal Data

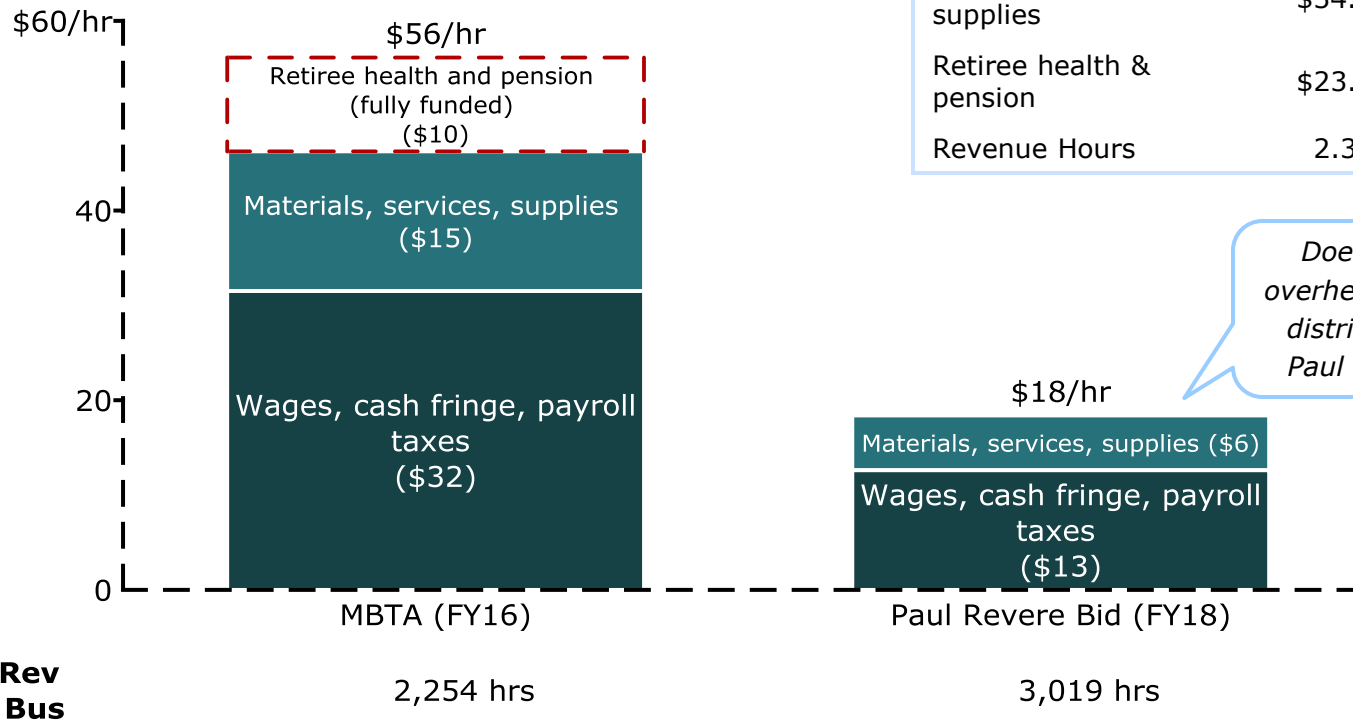
Bus Maintenance Cost per Revenue Hour

Market Pricing: Lifecycle Maintenance Costs New Flyer Xcelsior Diesel-Electric 40 Ft. Transit Bus

<u>MBTA</u>	<u>P. Revere</u>
Wages, fringe, taxes	\$74.4M	\$229K
Materials, services, supplies	\$34.5M	\$104K
Retiree health & pension	\$23.2M	-
Revenue Hours	2.34M	18.1K

Does not include all overhead expenses likely distributed over other Paul Revere contracts

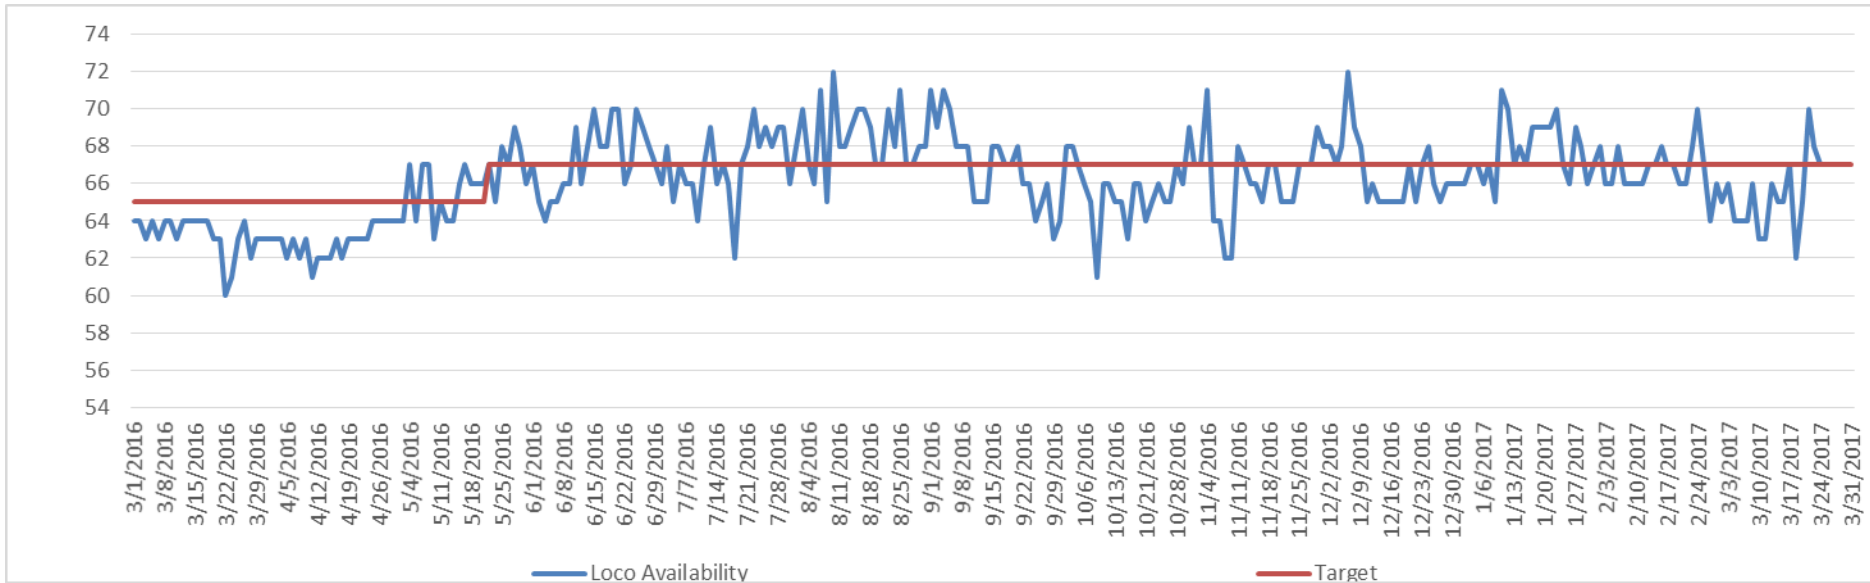
Locomotive availability

- Turbocharger failures on MPIs, legacy locomotive main engine failures and PTC program putting pressure on availability
- 1st UTEX locomotive progressing well, expected in revenue service ahead of schedule (mid April), 2nd & 3rd locomotives on plan

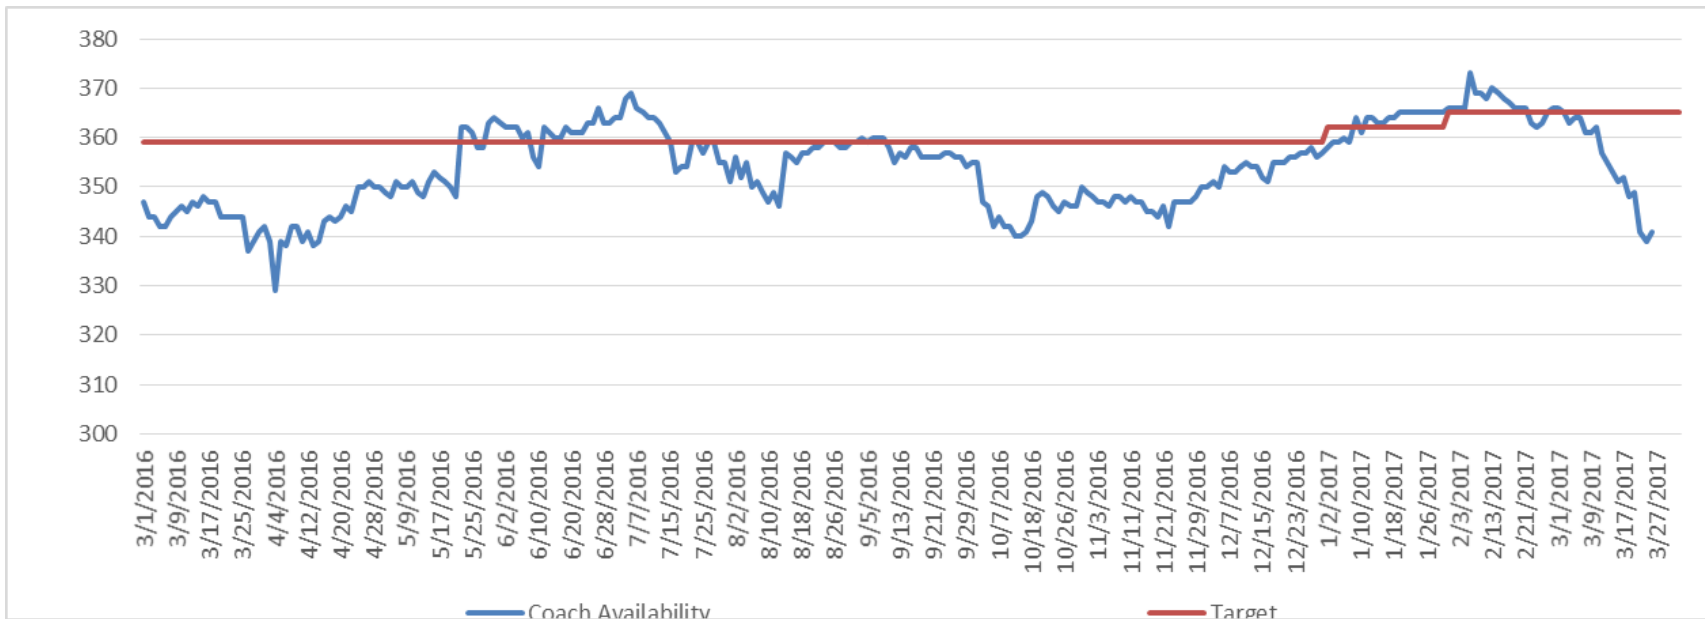
Coach availability

- Sudden decline in coach availability due to large number of coaches with damaged wheelsets coinciding with reduced wheel true facilities (capital replacement of wheel true machine at BET)
- Arranging wheel truing with Amtrak and increased production on remaining machine at Readville to return to strong position rapidly
