Memorandum

To :	Andrew Brennan, Sr. Director of Energy and the Environment, Department of Environmental Affairs, MBTA
From :	M.V. Martello, EIT, Climate Change Resiliency Intern, Department of Environmental Affairs, MBTA
Re :	MBTA Bus Facilities
Subject :	Climate Change Coastal Flood Vulnerability Summary
Date :	September 15 th , 2020

Climate Change Coastal Flood Vulnerability Summary

MBTA Bus Facilities

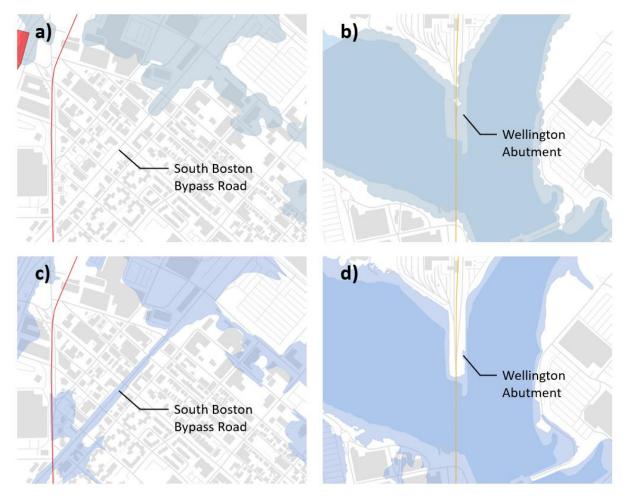
requirements. Second, the spatial resolution of the BH-FRM is at best 5 meters (16.4 feet). As a result of this limitation, some flood pathways that would arise in reality are not shown in the BH-FRM, while other areas are shown to flood, that in fact would not likely be flooded. For example, the South Boston Bypass Road is not shown to flood in the BH-FRM, but does based on FEMA flood maps, while the bridge abutment at Wellington Yard along the Orange Line is shown to flood when it does not based on FEMA flood maps, as shown in Figure 2.

Figure 2: Discrepancies between the BH-FRM 2030 1% CFEP (a, b) and the FEMA 1-500 year floodplain (c, d). A flood path along the South Boston Bypass Road not captured by the BH-FRM (left). An area of inundation along the Orange Line ROW in Wellington shown in the BH-FRM that is not congruent with historic FEMA data (right).
