Appendix E
Hazardous Materials

PHASE I ENVIRONMENTAL SITE ASSESSMENT

MBTA Draw 1 Bridge
Causeway Street
Boston, MA 02114
February 2020

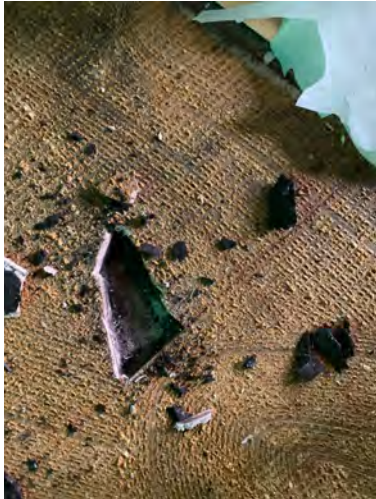
Sample Numbers	01A, 01B
Material Description	Black Tar Flooring Under 12x12 Pink Floor Tile (Carpeted Area)
Accessible Material	Accessible
Reason Inaccessible	N/A
Asbestos Detected	Positive
Asbestos Type	Chrysotile
Homogeneous Area	Tower A, 2nd Floor, Storage Area (Half Of Carpeted Area)
Total Approximate Quantity	150 SF
Condition	Good
Material Type	Misc.
NESHAP Category	RACM
Notes	Not Applicable

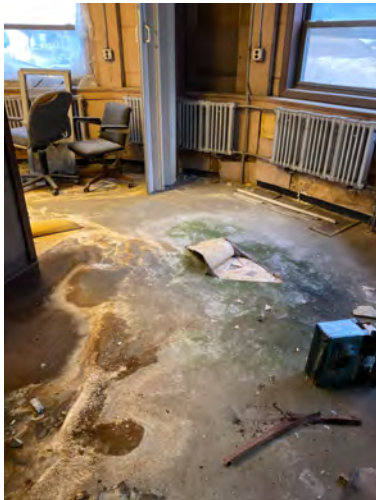
Sample Numbers	02A, 02B
Material Description	Brown Floor Tile Under 12x12 Pink Floor Tile (Carpeted Area)
Accessible Material	Accessible
Reason Inaccessible	N/A
Asbestos Detected	Negative
Asbestos Type	No Asbestos Detected
Homogeneous Area	Tower A, 2nd Floor, Carpeted Area (Offices 1 And 2)
Total Approximate Quantity	200 SF
Condition	Good
Material Type	Misc.
NESHAP Category	N/A
Notes	Not Applicable

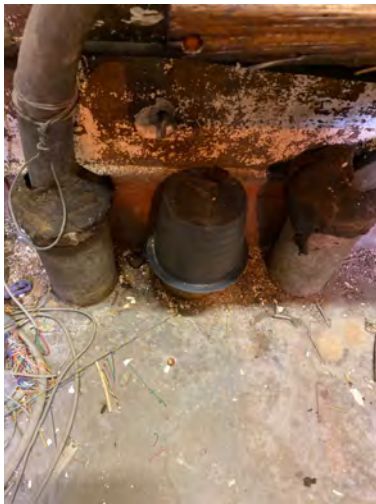
Sample Numbers	04A, 04B
Material Description	Electrical Conduit Sealant
Accessible Material	Accessible
Reason Inaccessible	N/A
Asbestos Detected	Positive
Asbestos Type	Chrysotile
Homogeneous Area	Tower A, 1st Floor Electrical Closet , Near Electrical Room
Total Approximate Quantity	5 SF
Condition	Good
Material Type	Misc.
NESHAP Category	RACM
Notes	Not Applicable

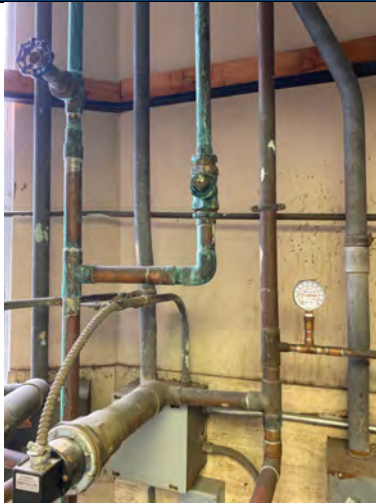
Sample Numbers	05A, 05B
Material Description	Pipe Thread Sealant
Accessible Material	Accessible
Reason Inaccessible	N/A
Asbestos Detected	Negative

Asbestos Type	No Asbestos Detected
Homogeneous Area	Tower A, 1st Floor, Boiler Room
Total Approximate Quantity	TBD
Condition	Good
Material Type	Misc.
NESHAP Category	N/A
Notes	Not Applicable

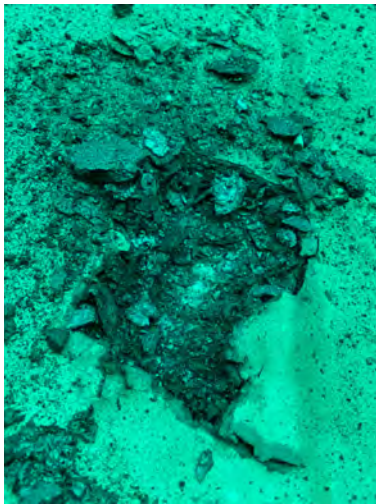
Sample Numbers	06A, 06B
Material Description	Roll On Asphalt Roofing Material
Accessible Material	Accessible
Reason Inaccessible	N/A
Asbestos Detected	Negative
Asbestos Type	No Asbestos Detected
Homogeneous Area	Tower A, Electrical Room Roof
Total Approximate Quantity	1000 SF
Condition	Good
Material Type	Misc.
NESHAP Category	N/A
Notes	Not Applicable

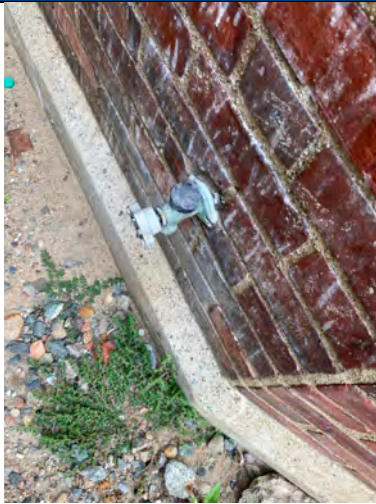
Sample Numbers	07A, 07B
Material Description	Exterior Hose Valve Putty
Accessible Material	Accessible
Reason Inaccessible	N/A
Asbestos Detected	Negative

Asbestos Type	No Asbestos Detected
Homogeneous Area	Tower A, Hose Valve
Total Approximate Quantity	2 SF
Condition	Good
Material Type	Misc.
NESHAP Category	N/A
Notes	Not Applicable

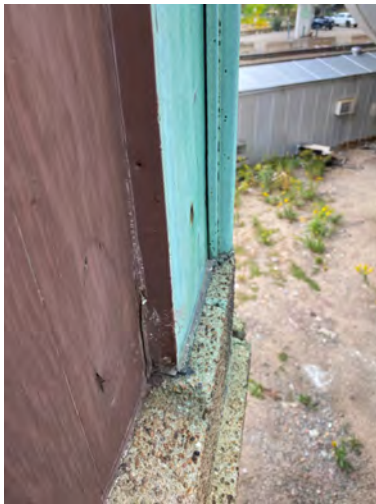
Sample Numbers	08A, 08B
Material Description	Exterior White Window Caulk
Accessible Material	Accessible
Reason Inaccessible	N/A
Asbestos Detected	Negative
Asbestos Type	No Asbestos Detected
Homogeneous Area	Tower A, Second Floor 1 Pane Windows
Total Approximate Quantity	20 Each
Condition	Good
Material Type	Misc.
NESHAP Category	N/A
Notes	Not Applicable

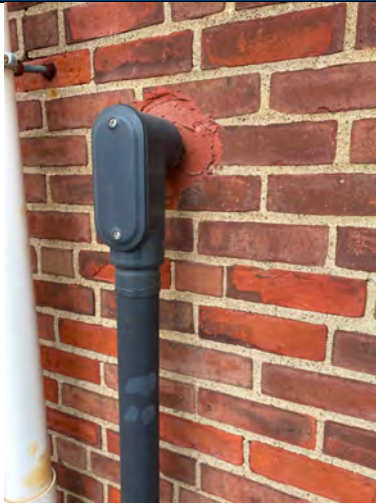
Sample Numbers	09A, 09B
Material Description	Exterior Red Fire Stop
Accessible Material	Accessible
Reason Inaccessible	N/A
Asbestos Detected	Negative

Asbestos Type	No Asbestos Detected
Homogeneous Area	Tower A, Exterior Brick Wall
Total Approximate Quantity	20 SF
Condition	Good
Material Type	Misc.
NESHAP Category	N/A
Notes	Not Applicable

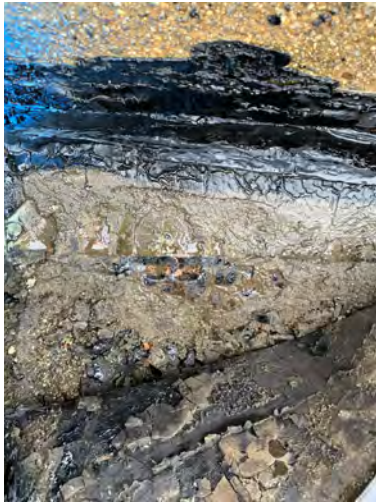
Sample Numbers	10A, 10B, 10C
Material Description	Roof Parapet Flashing
Accessible Material	Accessible
Reason Inaccessible	N/A
Asbestos Detected	Positive
Asbestos Type	Chrysotile
Homogeneous Area	Tower A Roof Parapet
Total Approximate Quantity	210 SF
Condition	Damaged
Material Type	Misc.
NESHAP Category	RACM
Notes	Not Applicable

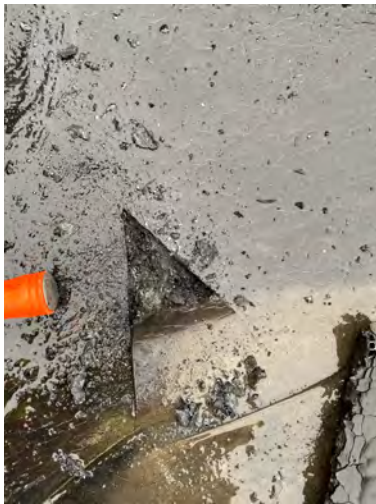
Sample Numbers	12A, 12B, 12C, 12D
Material Description	Asphalt Roofing Material
Accessible Material	Accessible
Reason Inaccessible	N/A
Asbestos Detected	Negative
Asbestos Type	No Asbestos Detected
Homogeneous Area	Tower A, Main Roof
Total Approximate Quantity	2000 SF
Condition	Good
Material Type	Misc.
NESHAP Category	N/A
Notes	Not Applicable

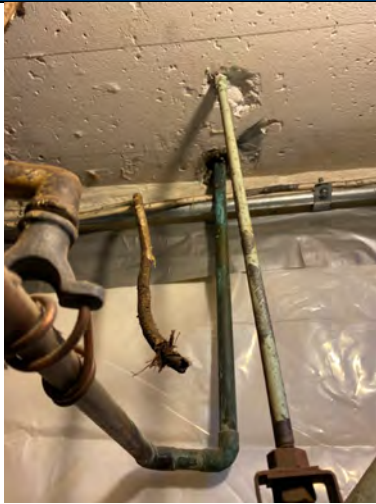
Sample Numbers	13A, 13B
Material Description	Cloth Wire Cover
Accessible Material	Accessible
Reason Inaccessible	No Access
Asbestos Detected	Negative

Asbestos Type	No Asbestos Detected
Homogeneous Area	Tower A 1st Floor
Total Approximate Quantity	10 LF
Condition	Good
Material Type	Surfacing
NESHAP Category	N/A
Notes	Not Applicable

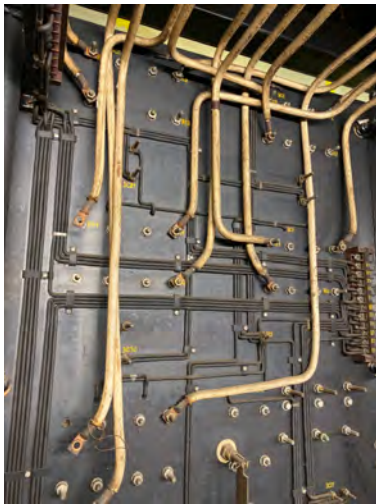
Sample Numbers	14A, 14B
Material Description	White Cable Wrap
Accessible Material	Accessible
Reason Inaccessible	No Access
Asbestos Detected	Negative
Asbestos Type	No Asbestos Detected
Homogeneous Area	Tower A Electrical Room
Total Approximate Quantity	300 LF
Condition	Good
Material Type	Misc.
NESHAP Category	N/A
Notes	Not Applicable

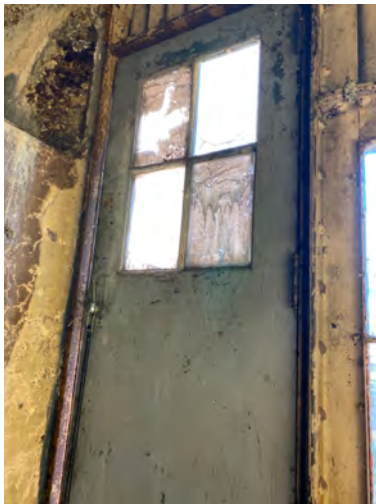
Sample Numbers	16A, 16B
Material Description	Soft Glaze Assoc. With Door
Accessible Material	Accessible
Reason Inaccessible	N/A
Asbestos Detected	Negative
Asbestos Type	No Asbestos Detected
Homogeneous Area	Mechanical Rooms, Spans 1 And 2 Doors
Total Approximate Quantity	4 Each
Condition	Damaged
Material Type	Misc.
NESHAP Category	N/A
Notes	2 door in each room

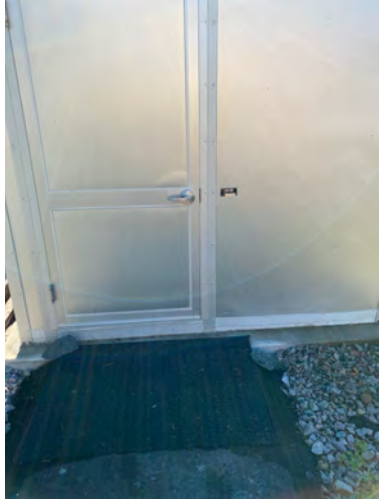
Sample Numbers	17A, 17B
Material Description	Gray Building Caulk
Accessible Material	Accessible
Reason Inaccessible	N/A
Asbestos Detected	Negative

Asbestos Type	No Asbestos Detected

Homogeneous Area	Between Concrete Base And Aluminum Structure For F No Access Restroom	
Total Approximate Quantity	40 LF	
Condition	Damaged	
Material Type	Misc.	
NESHAP Category	N/A	
Notes	Not Applicable

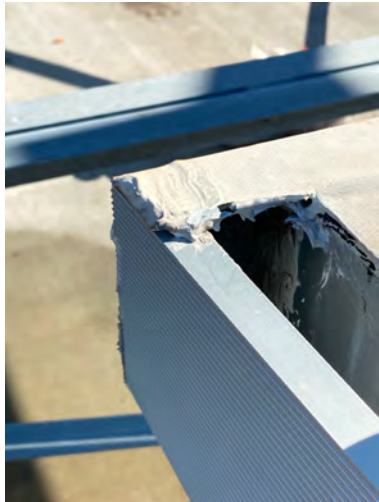
Material Description	White Rubber Roof Sealant	
Accessible Material	Accessible	
Reason Inaccessible	N/A	
Asbestos Detected	Negative	
Asbestos Type	No Asbestos Detected	
Homogeneous Area	Inaccessible Restroom Roof	
Total Approximate Quantity	65 SF	
Condition	Good	
Material Type	Misc.	
NESHAP Category	N/A	
Notes	Not Applicable

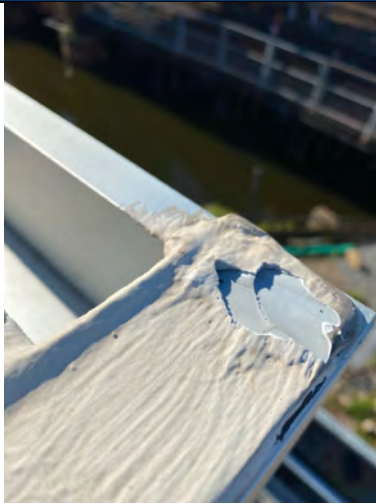
Asbestos Type	No Asbestos Detected
Homogeneous Area	New Control Tower Roof
Total Approximate Quantity	250 SF
Condition	Good
Material Type	Misc.
NESHAP Category	N/A
Notes	The new control tower roof has not been sampled

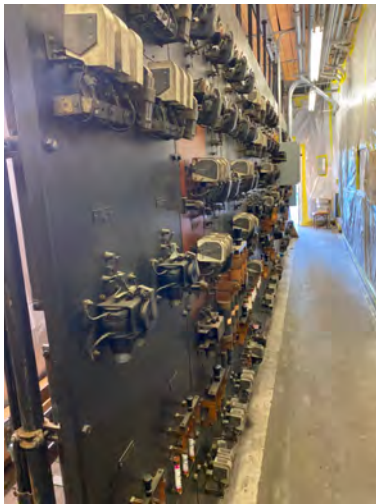
Sample Numbers	N/A
Material Description	Asbestos Cement Switch Panels
Accessible Material	Inaccessible
Reason Inaccessible	No Access
Asbestos Detected	N/A
Asbestos Type	N/A
Homogeneous Area	Tower A Electrical Room
Total Approximate Quantity	300 SF
Condition	Good
Material Type	Misc.
NESHAP Category	N/A
Notes	Not Applicable

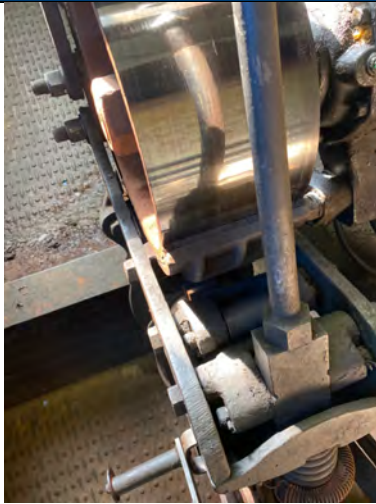
Sample Numbers	N/A
Material Description	Asbestos Cement Break Pads
Accessible Material	Inaccessible
Reason Inaccessible	N/A
Asbestos Detected	N/A

Asbestos Type	N/A
Homogeneous Area	Mechanical Rooms, Span 1 And 2
Total Approximate Quantity	16 Each
Condition	Good
Material Type	Misc.
NESHAP Category	N/A
Notes	8 pads in each mech room

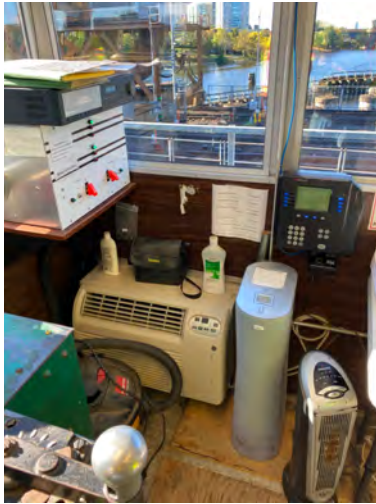
Sample Numbers	N/A
Material Description	Glue Behind Wooden Panels
Accessible Material	Inaccessible
Reason Inaccessible	No Access
Asbestos Detected	N/A
Asbestos Type	N/A
Homogeneous Area	New Control Tower
Total Approximate Quantity	120 SF
Condition	Good
Material Type	Misc.
NESHAP Category	N/A
Notes	Assumed glue behind wooden panels in new control tower

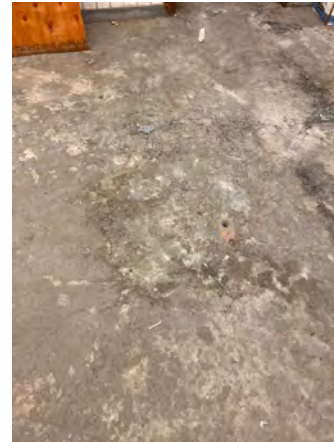
Sample Numbers	01
Sample Location	1st Floor
Description	Gray Paint On Concrete Floor
Laboratory Result (%)	0.25
Substrate	Concrete
Paint Locations	
Quantity of Deteriorated Paint (SF)	1000

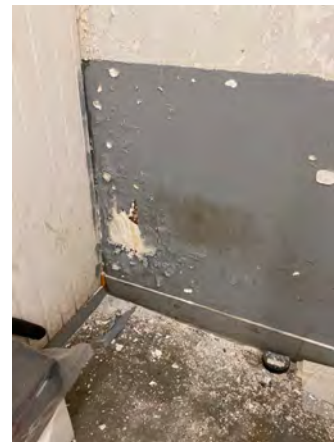
Sample Numbers	02
Sample Location	1st Floor Wall
Description	Gray Paint On Wall
Laboratory Result (%)	3.2
Substrate	Plaster
Paint Locations	1st Floor
Quantity of Deteriorated Paint (SF)	TBD

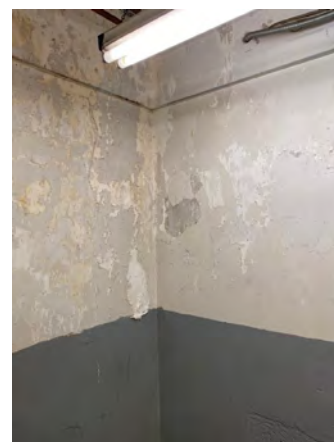
Sample Numbers	03
Sample Location	1st Floor Wall
Description	White Paint On Wall
Laboratory Result (%)	7.2
Substrate	Plaster
Paint Locations	1st Floor
Quantity of Deteriorated Paint (SF)	TBD

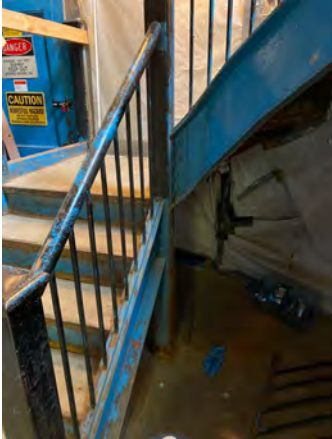
Sample Numbers	04

Sample Location	1st And 2nd Floor Stair Case	
Description	Blue Paint On Handrail	
Laboratory Result (%)	14	
Substrate	Metal	
Paint Locations	1st And 2nd Floor Staircase	
Quantity of Deteriorated Paint (SF)	TBD

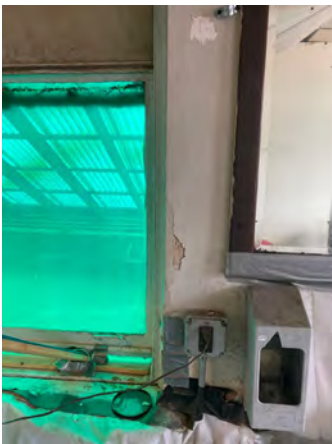
Sample Numbers	05

Sample Location	2nd Floor Top Of The Stairs	
Description	White Paint On Wall	
Laboratory Result (%)	11	
Substrate	Plaster	
Paint Locations	2nd Floor Top Of The Stairs	
Quantity of Deteriorated Paint (SF)	TBD

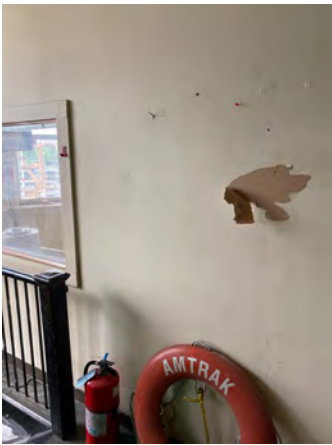
Sample Numbers	06

Sample Location	2nd Floor, Control Room Wall	
Description	Off White Paint On Dry Wall	
Laboratory Result (%)	<0.0080	
Substrate	Drywall	
Paint Locations	2nd Floor, Control Room Wall	
Quantity of Deteriorated Paint (SF)	TBD

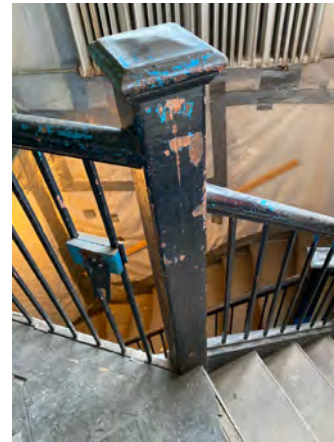
Sample Numbers	07
Sample Location	2nd Floor Staircase Handrail
Description	Black Paint On Handrail
Laboratory Result (%)	17
Substrate	Metal
Paint Locations	2nd Floor Hand Rail
Quantity of Deteriorated Paint (SF)	TBD

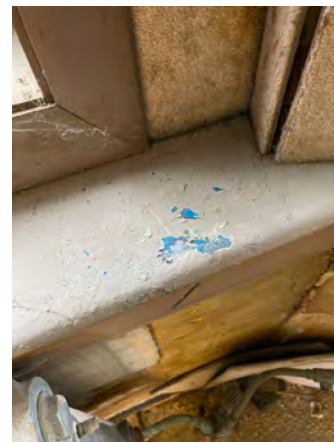
Sample Numbers	08
Sample Location	2nd Floor Window Sill
Description	Brown Paint On Window Sill
Laboratory Result (%)	7.9
Substrate	Wood
Paint Locations	2nd Floor Window Sill
Quantity of Deteriorated Paint (SF)	TBD

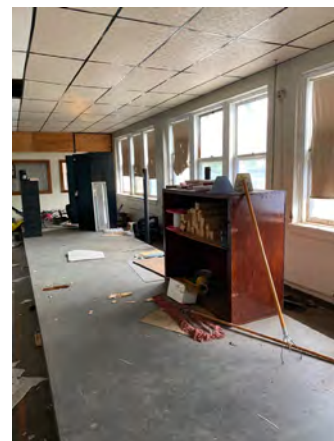
Sample Numbers	09
Sample Location	2nd Floor, Locker Room Area
Description	White Paint On Window Sill
Laboratory Result (%)	7.0
Substrate	Wood
Paint Locations	2nd Floor, Locker Room Area
Quantity of Deteriorated Paint (SF)	TBD

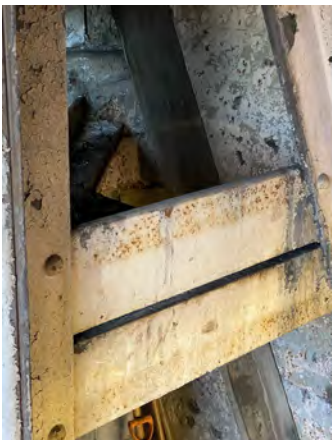
Sample Numbers	11

Sample Location	Mechanical Room, Span 2	
Description	Beige Paint On Mechanical Room Steel Structures	
Laboratory Result (%)	1.1	
Substrate	Metal	
Paint Locations	Span 2, Mechanical Room	
Quantity of Deteriorated Paint (SF)	TBD

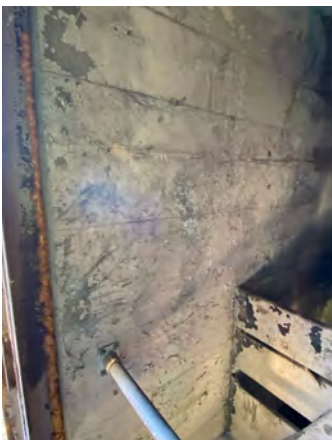
Sample Numbers	12

Sample Location	Span 2, Mechanical Room	
Description	Beige Paint On Mechanical Room Wall	
Laboratory Result (%)	0.26	
Substrate	Concrete	
Paint Locations	Span 2, Mechanical Room	
Quantity of Deteriorated Paint (SF)	TBD

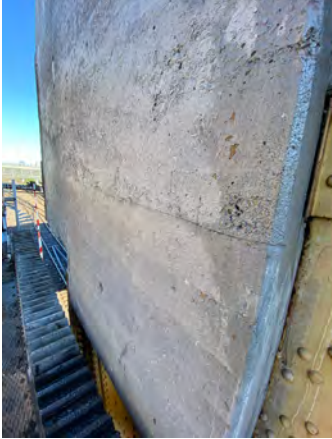
Sample Numbers	13

Sample Location	Mechanical Room Exterior Wall	
Description	Gray Paint On Span 2 Mechanical Room Exterior Wall	
Laboratory Result (%)	0.018	
Substrate	Concrete	
Paint Locations	Span 2, Mechanical Room Exterior Wall	
Quantity of Deteriorated Paint (SF)	TBD

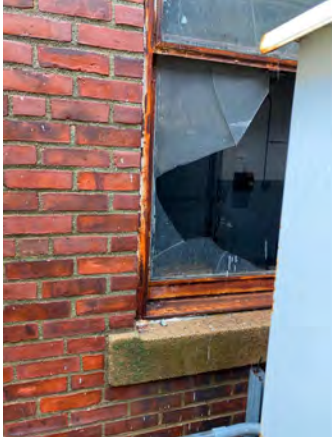
Sample Number	04

Accessible Material	Yes	
Material Interior or Exterior	Exterior	
Material Description	Exterior Window Caulk	
Substrate Adjacent to Material	Brick	
Ground Cover Below Material	Soil

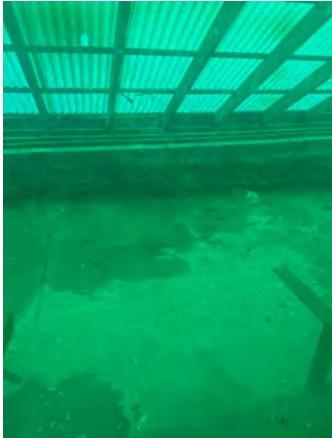
Sample Number	05

Accessible Material	Yes	
Material Interior or Exterior	Exterior	
Material Description	Parapet Flashing Material	
Substrate Adjacent to Material	Brick	
Ground Cover Below Material

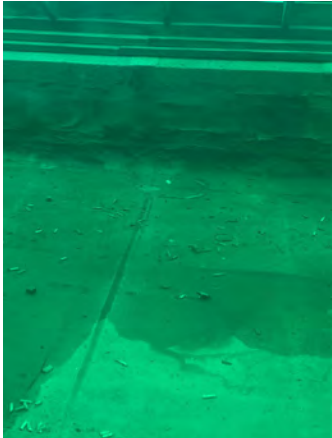
Sample Number	06

Accessible Material	Yes	
Material Interior or Exterior	Exterior	
Material Description	Parapet Flashing Material	
Substrate Adjacent to Material	Brick	
Ground Cover Below Material

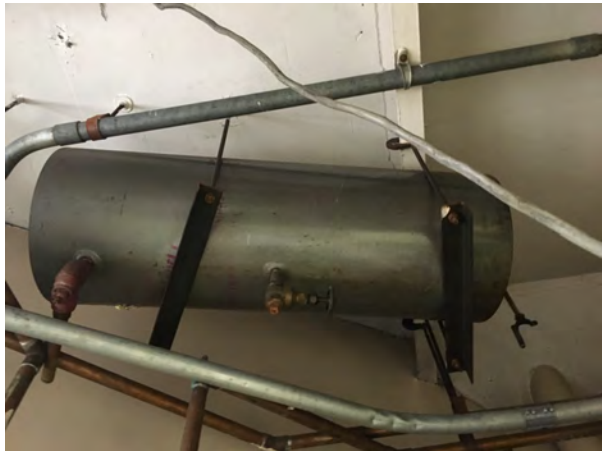
ITEM		
Area	Tower A - 1st Floor

Description	Miscellaneous Tank	
Quantity	1	
Notes	18 Gallon Pressurization Tank (Abandoned)

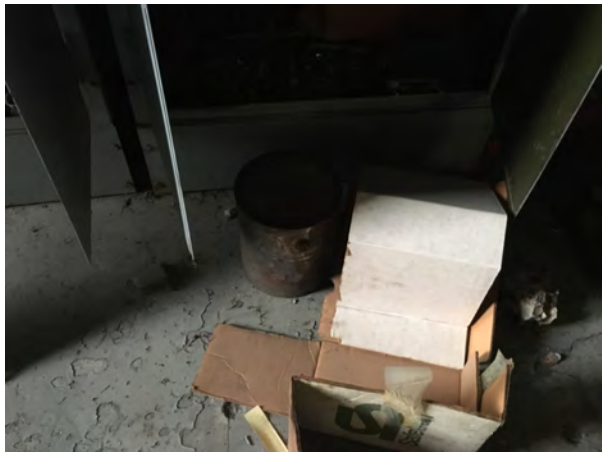
ITEM		
Area	Tower A - 1st Floor

Description	Miscellaneous Unknown Contents	
Quantity	2	
Notes	1 Gallon Metal Container

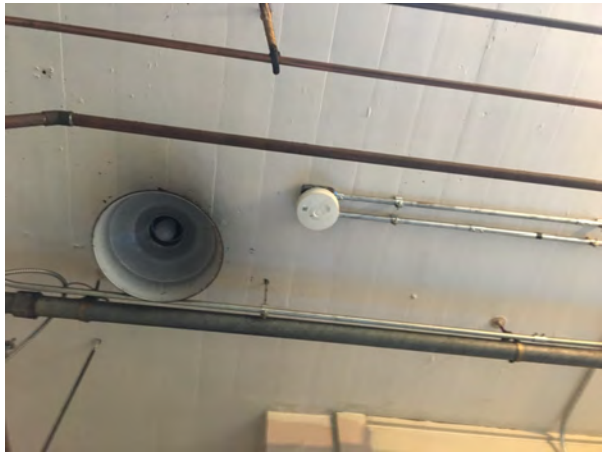
ITEM		
Area	Tower A - 1st Floor

Description	Heavy Metal Containing Devices Smoke Detector Batteries	
Quantity	1	
Notes	N/A

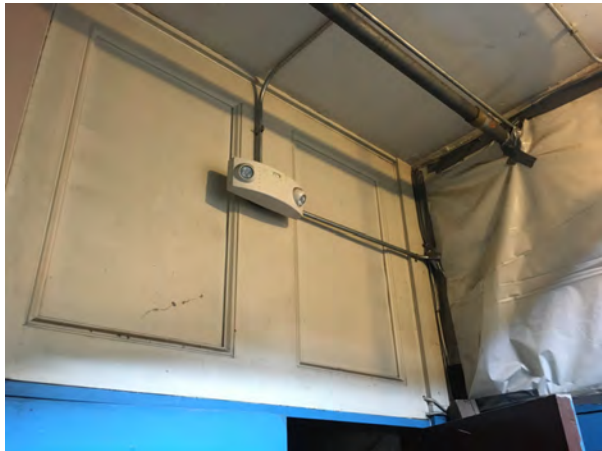
ITEM		
Area	Tower A - 1st Floor

Description	Heavy Metal Containing Devices Emergency Lighting System Batteries	
Quantity	2	
Notes	N/A

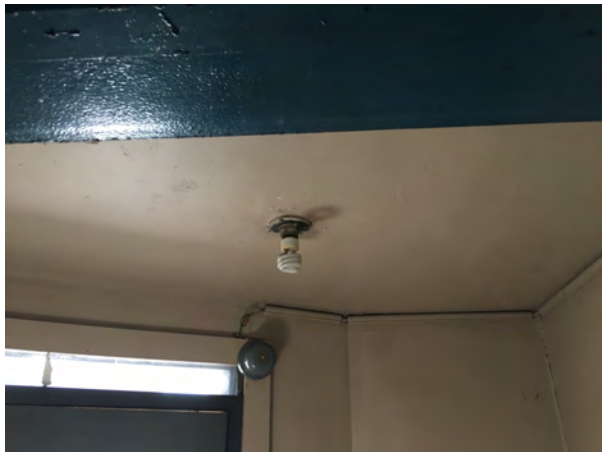
ITEM		
Area	Tower A - 1st Floor

Description	Heavy Metal Containing Devices CFL	
Quantity	2	
Notes	N/A

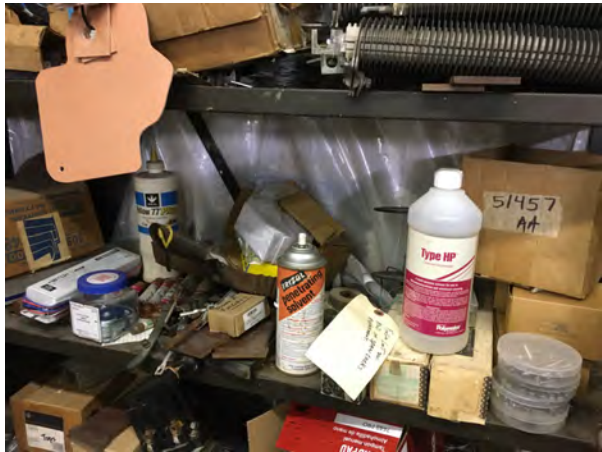
ITEM		
Area	Tower A - 1st Floor

Description	Miscellaneous Solvents	
Quantity	3	
Notes	2 Aerosol Solvent/2 Quart Plastic Containers (1 Degreaser/1 Lubricant)

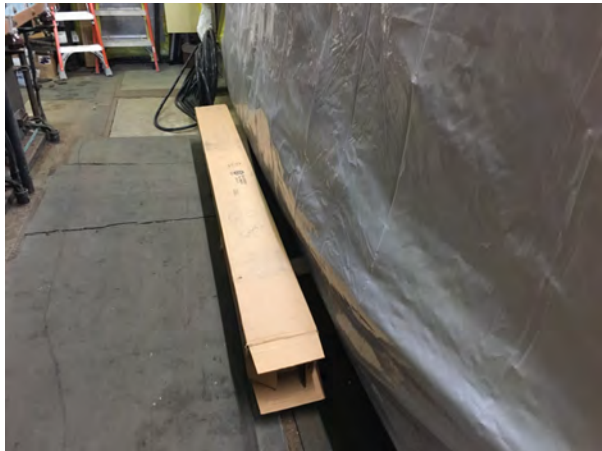
ITEM		
Area	Tower A - 1st Floor

Description	Heavy Metal Containing Devices Fluorescent (Silver Tip)	
Quantity	30	
Notes	8' (Stockpiled)

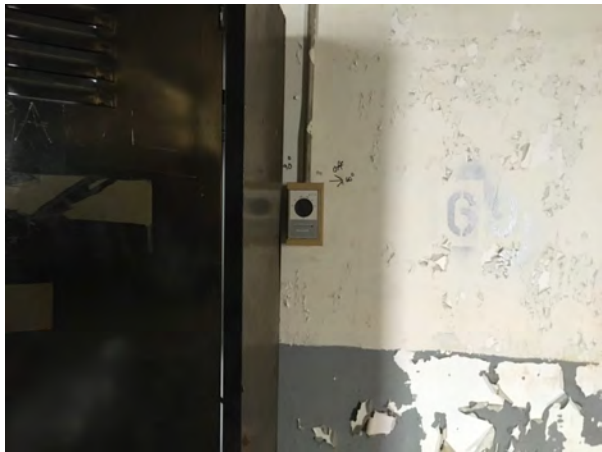
ITEM		
Area	Tower A - 1st Floor

Description	Heavy Metal Containing Devices Thermostats	
Quantity	1	
Notes	N/A

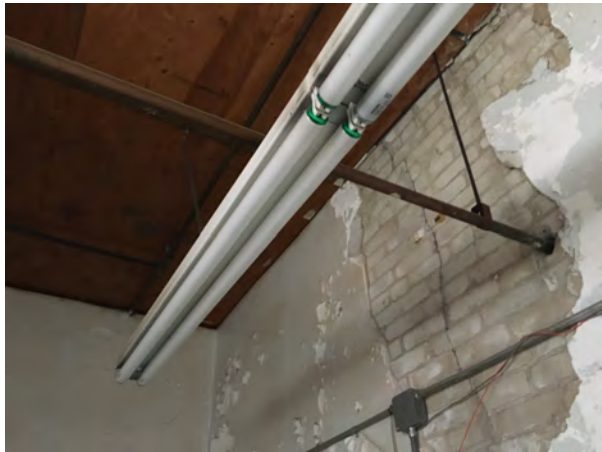
ITEM		
Area	Tower A - 1st Floor

Description	Heavy Metal Containing Devices Fluorescent (Green Tip)	
Quantity	5	
Notes	4'

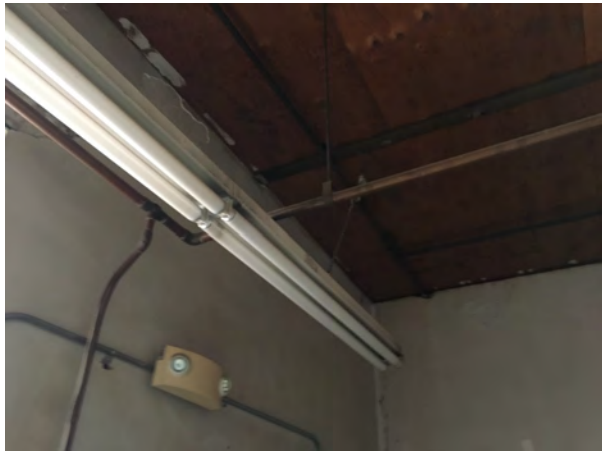
ITEM		
Area	Tower A - 1st Floor

Description	Heavy Metal Containing Devices Fluorescent (Silver Tip)	
Quantity	32	
Notes	4'

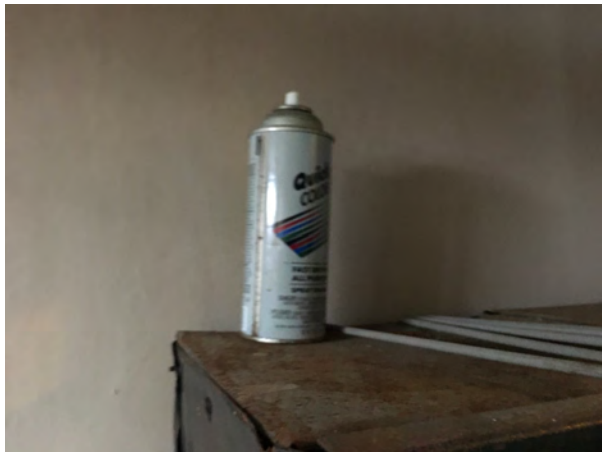
ITEM		
Area	Tower A - 1st Floor

Description	Miscellaneous Paints	
Quantity	2	
Notes	Aerosol

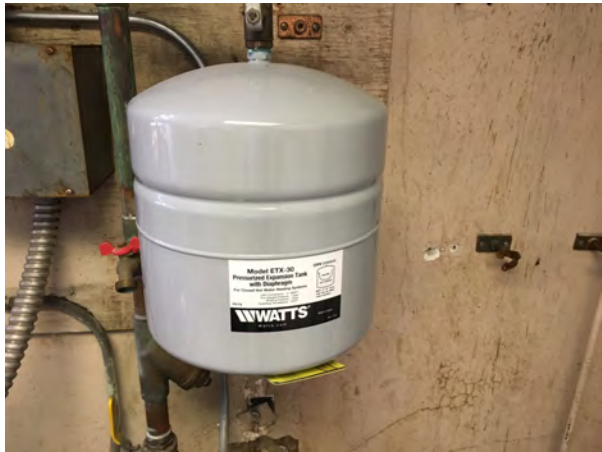
ITEM		
Area	Tower A - 1st Floor

Description	Miscellaneous Tank	
Quantity	2	
Notes	Small Pressurized Expansion Tank Associated With Heating System

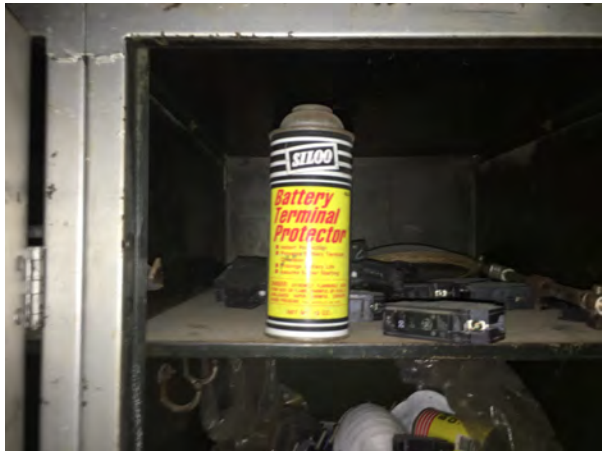
ITEM		
Area	Tower A - 1st Floor

Description	Miscellaneous Solvents	
Quantity	1	
Notes	Aerosol

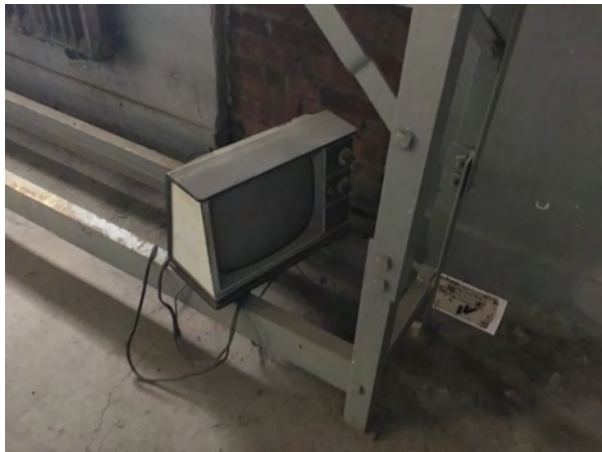
ITEM		
Area	Tower A - 1st Floor

Description	Miscellaneous Other Electronic Recyclables	
Quantity	2	
Notes	1 Television/1 Stereo

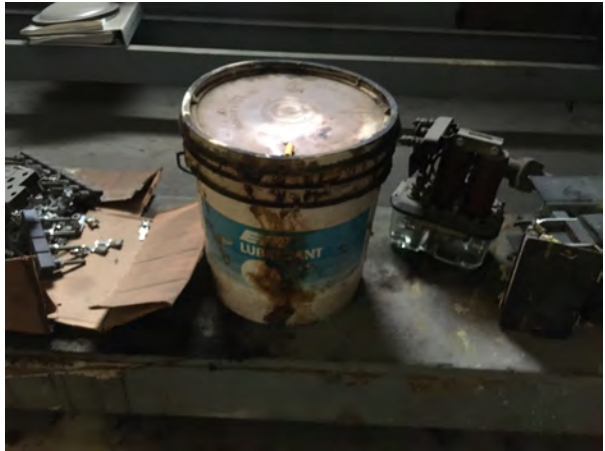
ITEM	
Area	Tower A - 1st Floor
Description	Miscellaneous Oils
Quantity	1
Notes	15 LB Plastic Container

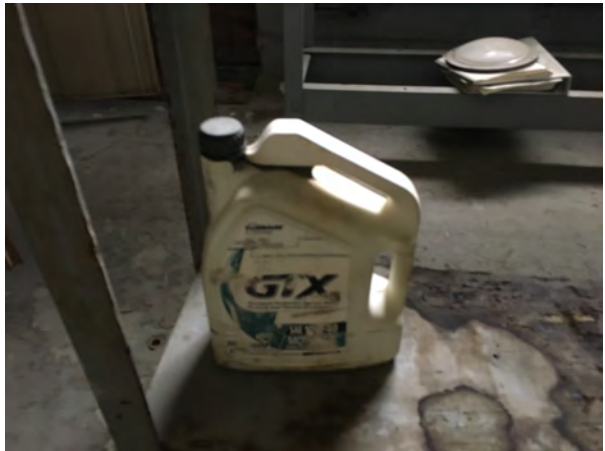
ITEM	
Area	Tower A - 1st Floor
Description	Miscellaneous Oils
Quantity	1
Notes	5 Liter Plastic Container

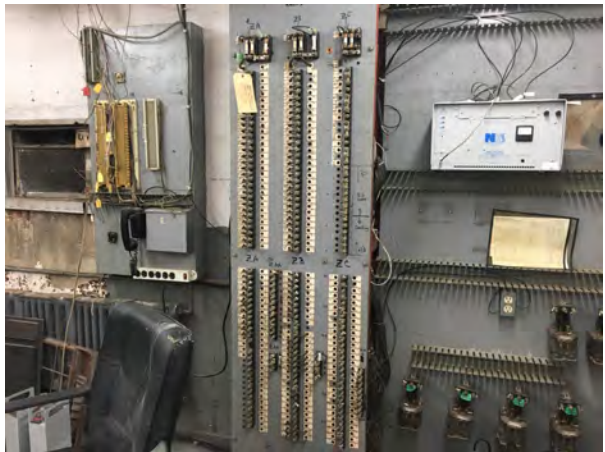
ITEM	
Area	Tower A - 1st Floor
Description	Miscellaneous Electrical Components
Quantity	20
Notes	Miscellaneous Panels

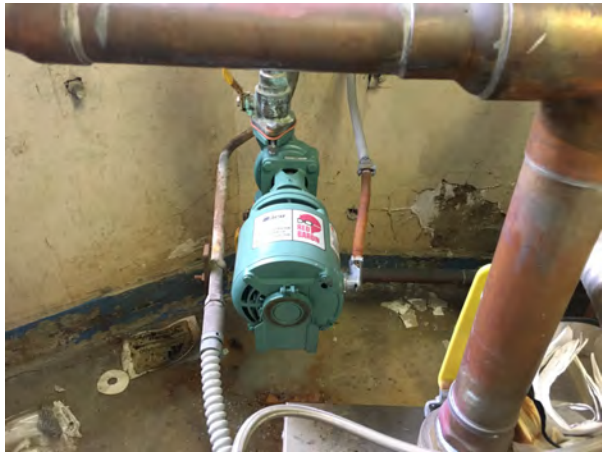
ITEM		
Area	Tower A - 1st Floor

Description	Small Motor	
Quantity	2	
Notes	Associated with Heating System

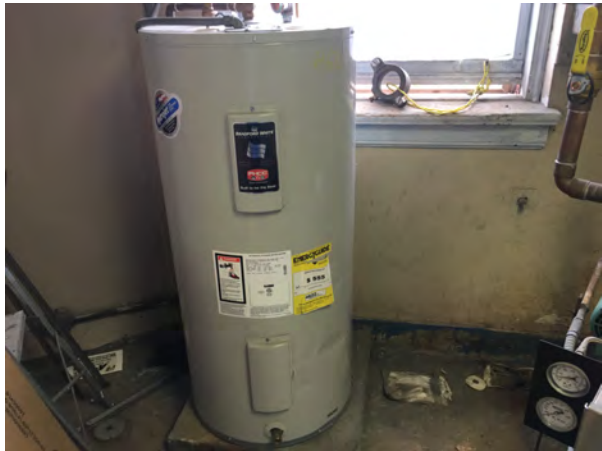
ITEM		
Area	Tower A - 1st Floor

Description	Heating/Water System Components	
Quantity	2	
Notes	Appear to be Newer Components

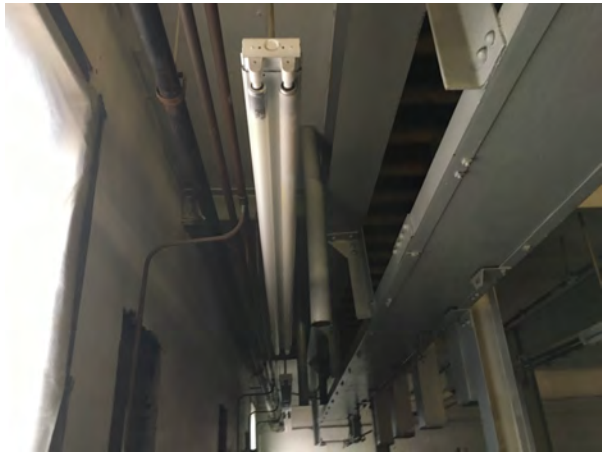
ITEM		
Area	Tower A - 1st Floor

Description	Heavy Metal Containing Devices Fluorescent (Silver Tip)	
Quantity	12	
Notes	8'

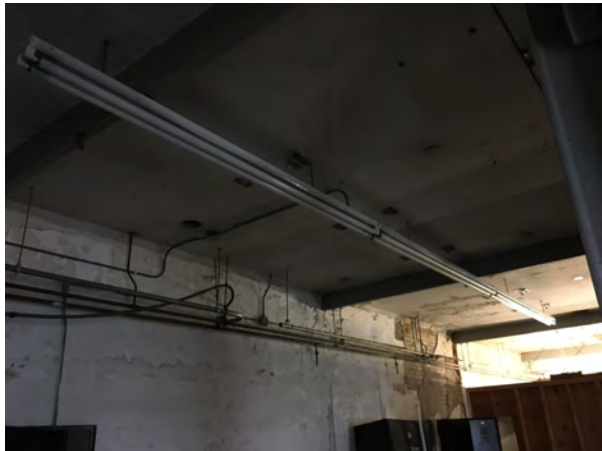
ITEM		
Area	Tower A - 1st Floor

Description	PCB Containing Devices PCB Ballast	
Quantity	32	
Notes	N/A

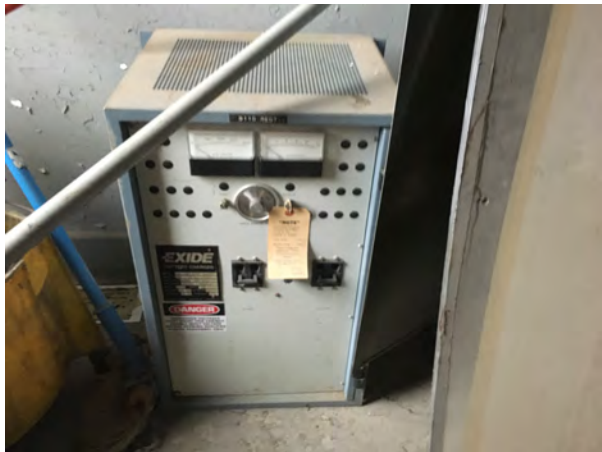
ITEM		
Area	Tower A - 1st Floor

Description	Battery Charger	
Quantity	1	
Notes	N/A

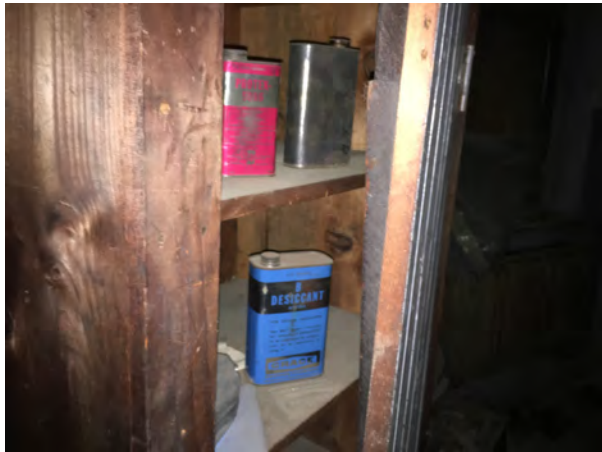
ITEM		
Area	Tower A - 1st Floor

Description	Miscellaneous Desiccant	
Quantity	2	
Notes	1 Metal Container (160 Grams) / 1 Metal Container (650 Grams)

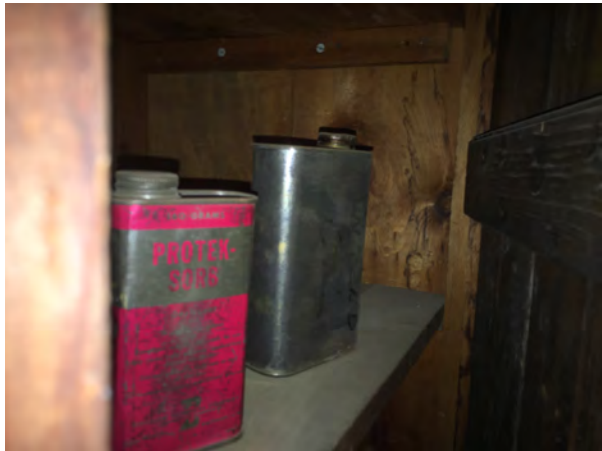
ITEM		
Area	Tower A - 1st Floor

Description	Miscellaneous Unknown Contents	
Quantity	1	
Notes	Metal Container ~ 1 Quart

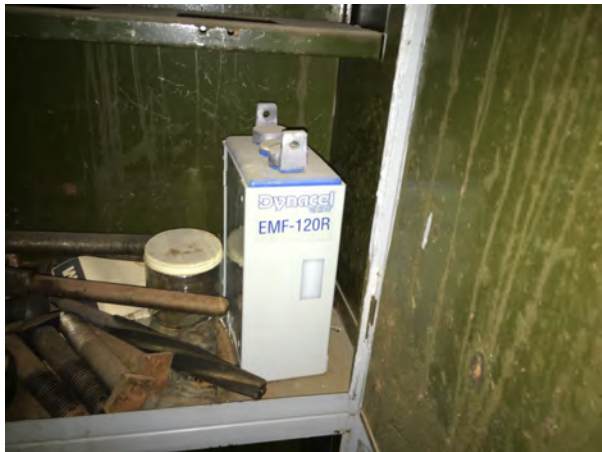
ITEM		
Area	Tower A - 1st Floor

Description	Heavy Metal Containing Devices Battery	
Quantity	7	
Notes	N/A

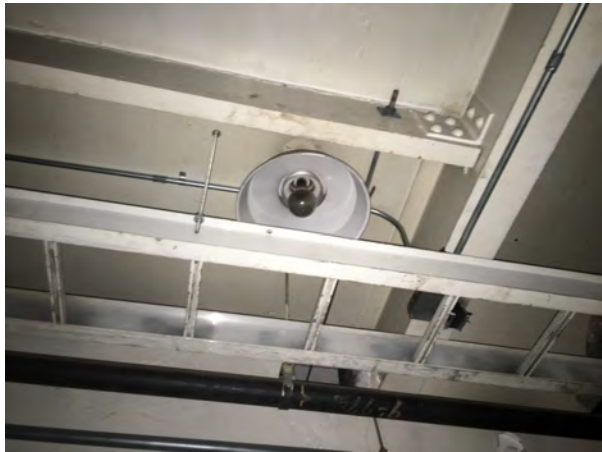
ITEM		
Area	Tower A - 1st Floor

Description	Heavy Metal Containing Devices Incandescent Bulb	
Quantity	5	
Notes	N/A

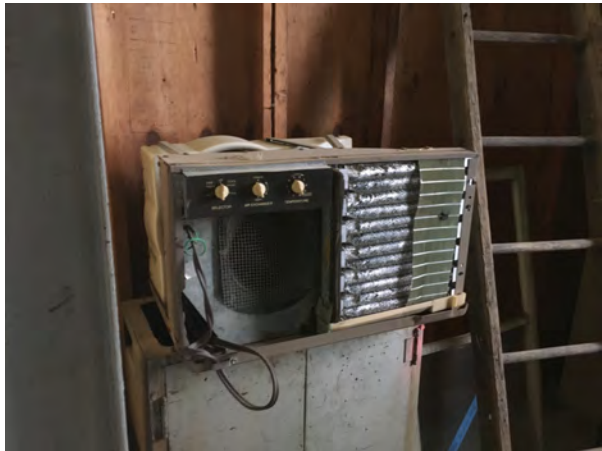
ITEM		
Area	Tower A - 1st Floor

Description	Refrigerants Air Conditioner	
Quantity	2	
Notes	N/A

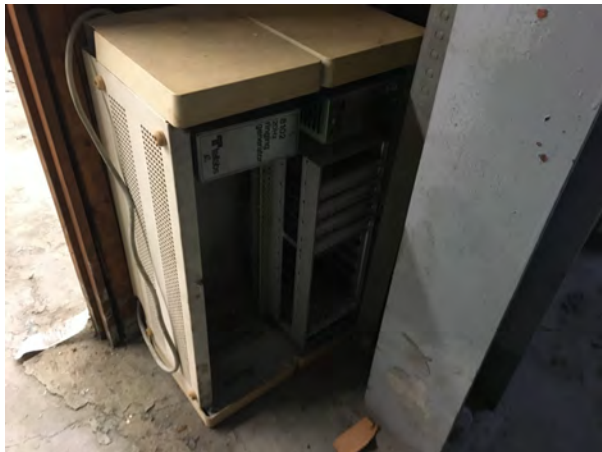
ITEM		
Area	Tower A - 1st Floor

Description	Miscellaneous Electrical Components	
Quantity	2	
Notes	N/A

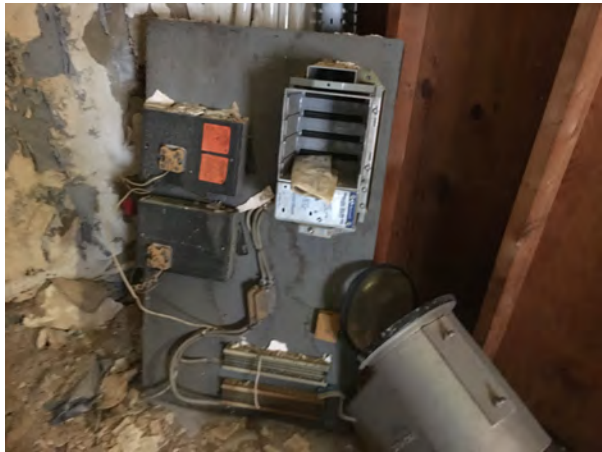
ITEM		
Area	Tower A - 1st Floor

Description	Miscellaneous Electrical Components	
Quantity	80	
Notes	N/A

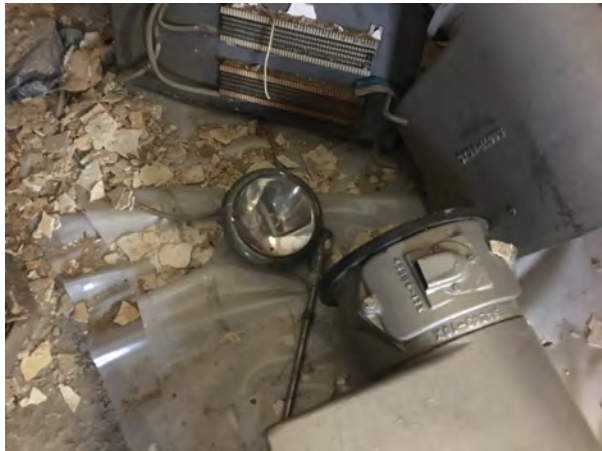
ITEM		
Area	Tower A - 1st Floor

Description	Heavy Metal Containing Devices HID Lamp	
Quantity	1	
Notes	N/A

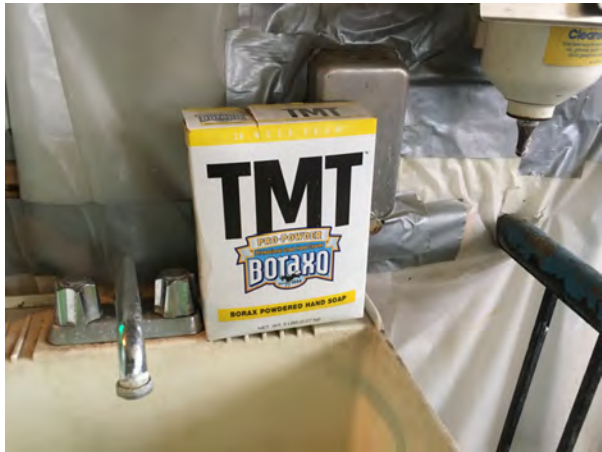
ITEM		
Area	Tower A - 2nd Floor

Description	Miscellaneous Cleaning Supplies	
Quantity	1	
Notes	5 Lb Cardboard Container

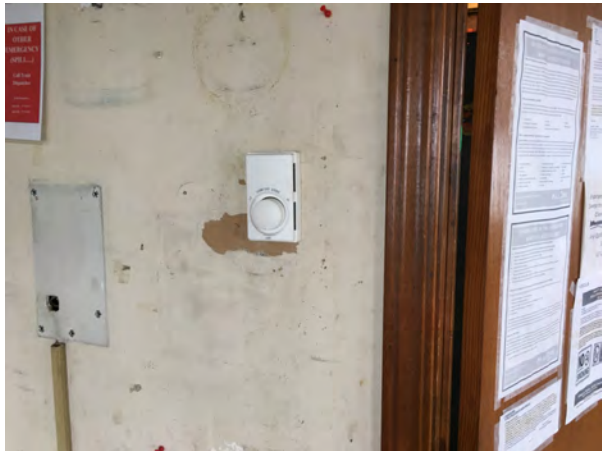
ITEM		
Area	Tower A - 2nd Floor

Description	Heavy Metal Containing Devices Thermostats	
Quantity	1	
Notes	N/A

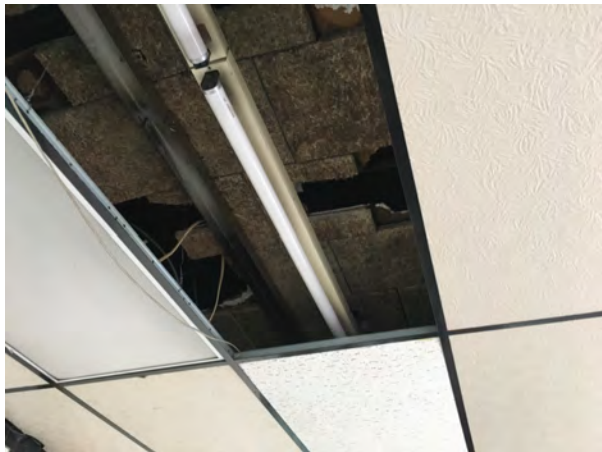
ITEM		
Area	Tower A - 2nd Floor

Description	Heavy Metal Containing Devices Fluorescent (Silver Tip)	
Quantity	16	
Notes	4'

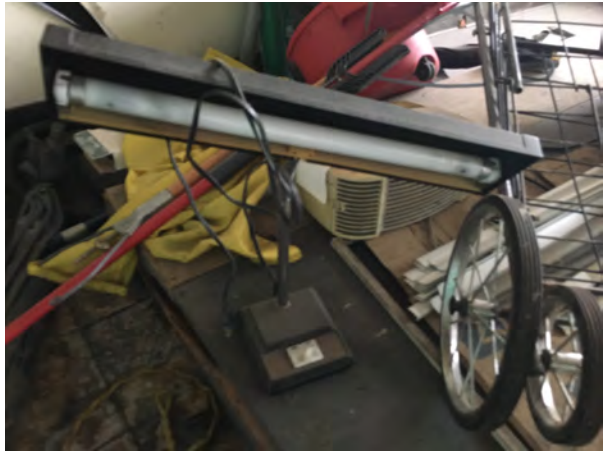
ITEM	
Area	Tower A - 2nd Floor
Description	Heavy Metal Containing Devices Fluorescent (Silver Tip)
Quantity	1
Notes	2'

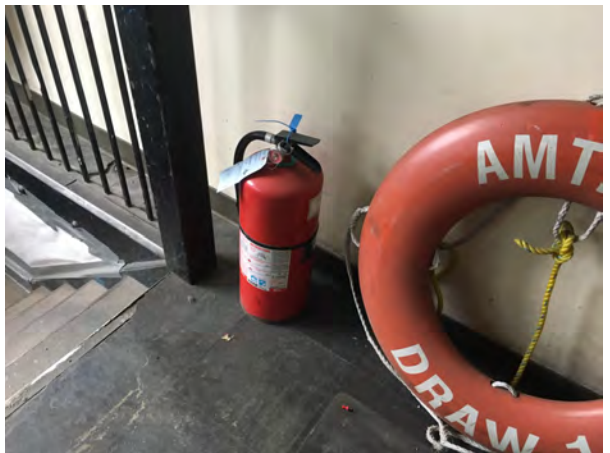
ITEM	
Area	Tower A - 2nd Floor
Description	Refrigerants Fire Extinguisher
Quantity	1
Notes	N/A

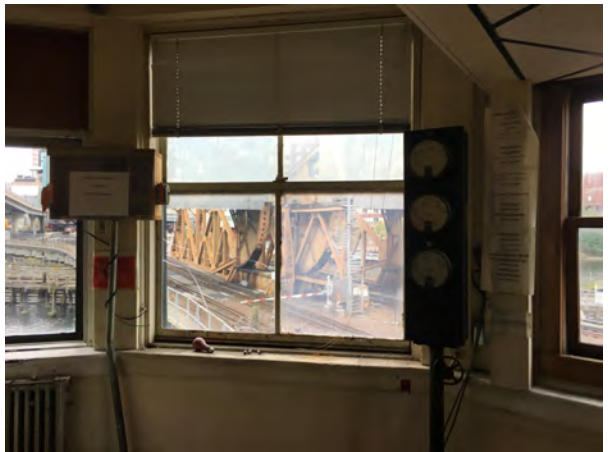
ITEM	
Area	Tower A - 2nd Floor
Description	Miscellaneous Electrical Components
Quantity	6
Notes	Miscellaneous Components/Panels

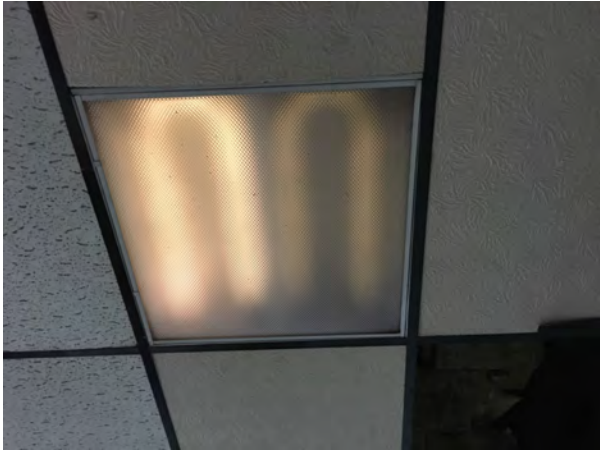
ITEM		
Area	Tower A - 2nd Floor

Description	Heavy Metal Containing Devices Fluorescent Bulb (U-Bulb)	
Quantity	16	
Notes	N/A

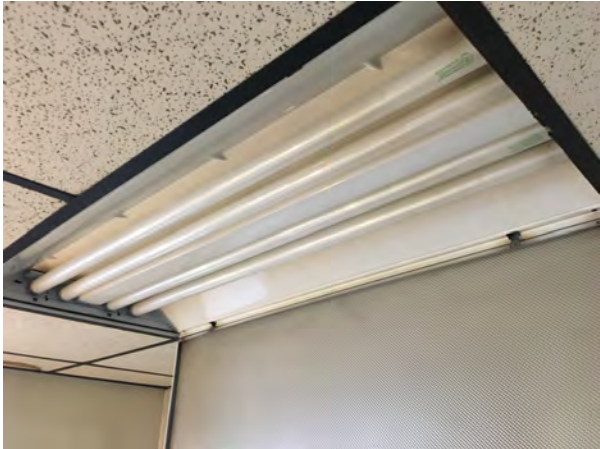
ITEM		
Area	Tower A - 2nd Floor

Description	PCB Containing Devices PCB Ballast	
Quantity	31	
Notes	N/A

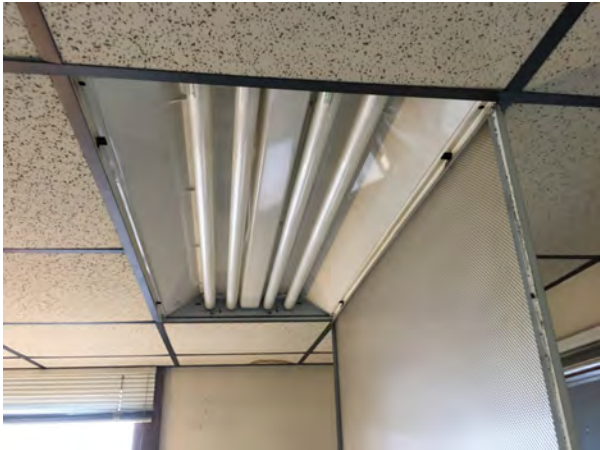
ITEM		
Area	Tower A - 2nd Floor

Description	Heavy Metal Containing Devices Fluorescent (Silver Tip)	
Quantity	25	
Notes	4'

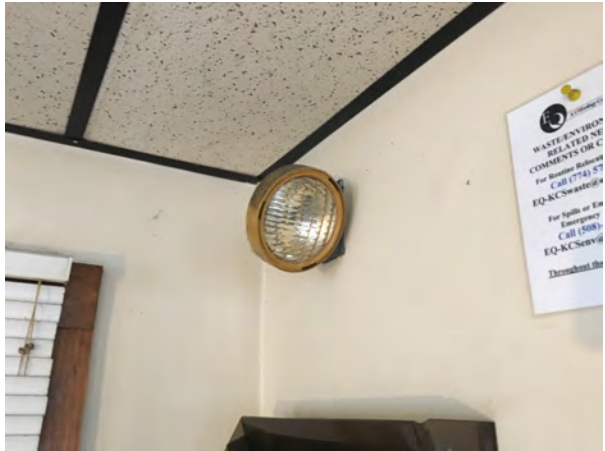
ITEM	
Area	Tower A - 2nd Floor
Description	Heavy Metal Containing Devices HID Lamp
Quantity	6 (5 Stockpiled)
Notes	N/A

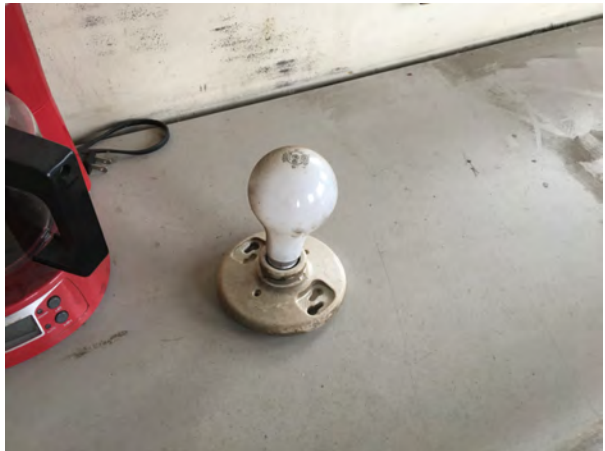
ITEM	
Area	Tower A - 2nd Floor
Description	Heavy Metal Containing Devices Incandescent Bulb
Quantity	2
Notes	N/A

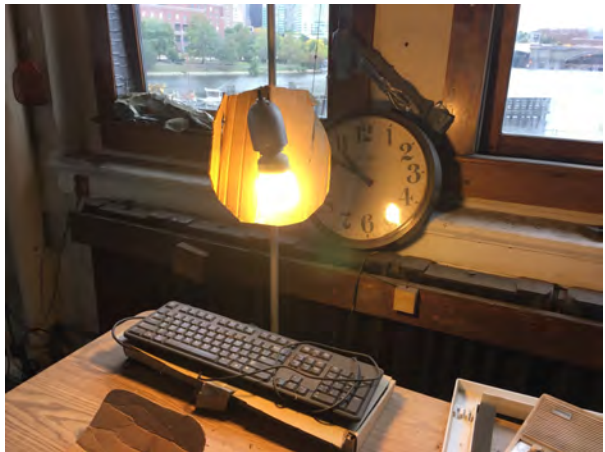
ITEM	
Area	Tower A - 2nd Floor
Description	Heavy Metal Containing Devices CFL
Quantity	1
Notes	N/A

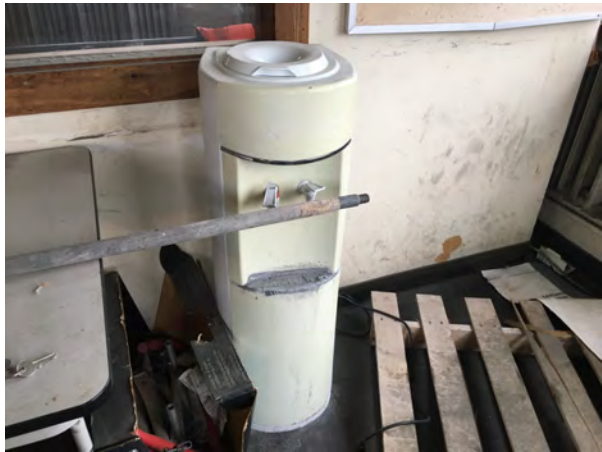
ITEM		
Area	Tower A - 2nd Floor

Description	Refrigerants Water Cooler	
Quantity	1	
Notes	N/A

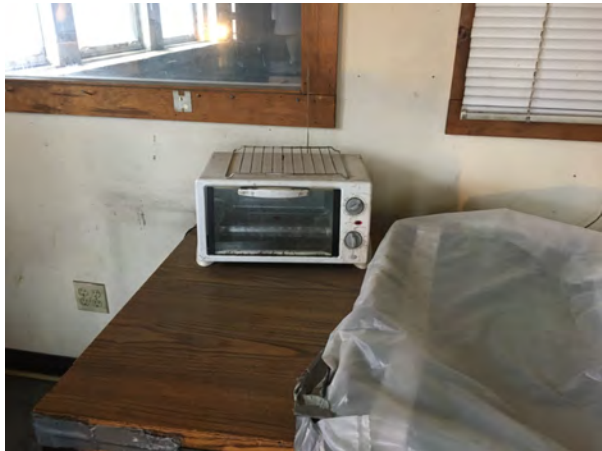
ITEM		
Area	Tower A - 2nd Floor

Description	Miscellaneous Other Electronic Recyclables	
Quantity	11	
Notes	3 Space Heaters/2 Toaster Oven/2 Coffee Maker/1 Keyboard/1 Phone/1 Monitor/1 Air Filtration Device1 Television

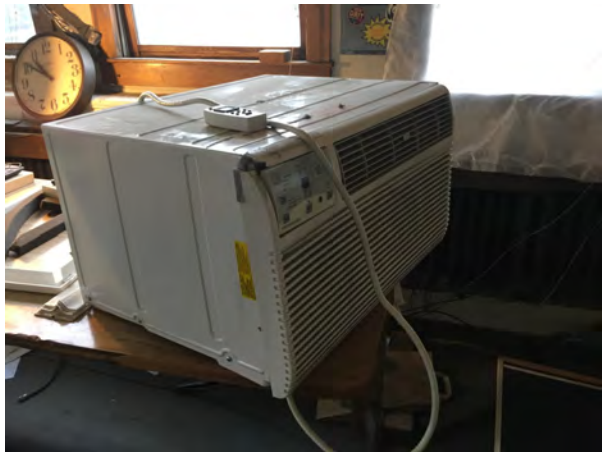
ITEM		
Area	Tower A - 2nd Floor

Description	Refrigerants Air Conditioner	
Quantity	1	
Notes	N/A

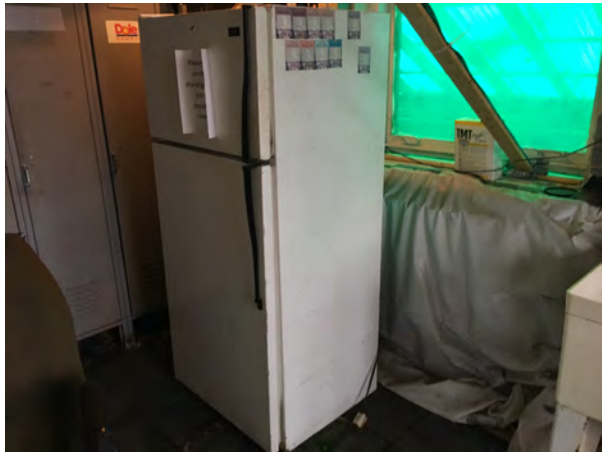
ITEM		
Area	Tower A - 2nd Floor

Description	Refrigerants Refrigerator	
Quantity	2	
Notes	N/A

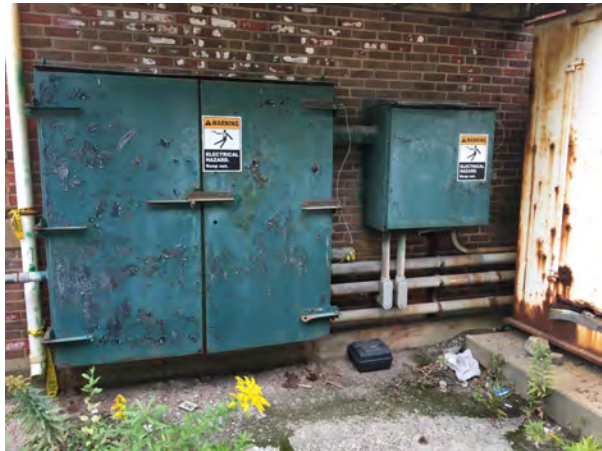
ITEM		
Area	Exterior-Tower A

Description	Miscellaneous Electrical Components	
Quantity	4	
Notes	Miscellaneous Panels/Cabinets
