Appendix E
Hazardous Materials

PHASE I ENVIRONMENTAL SITE ASSESSMENT

MBTA Draw 1 Bridge
Causeway Street
Boston, MA 02114
February 2020

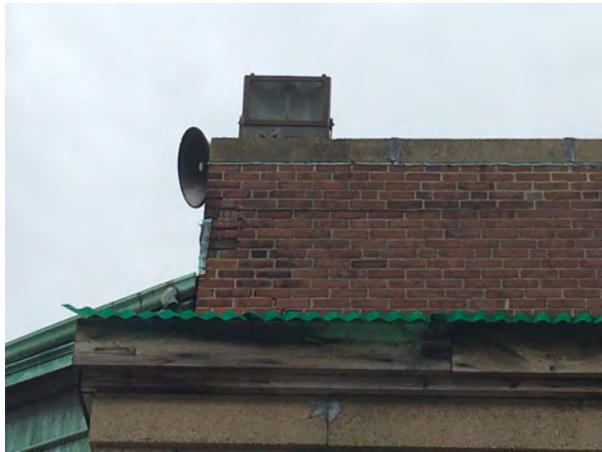
ITEM		
Area	Exterior-Tower A

Description	Heavy Metal Containing Devices HID Lamp	
Quantity	6	
Notes	N/A

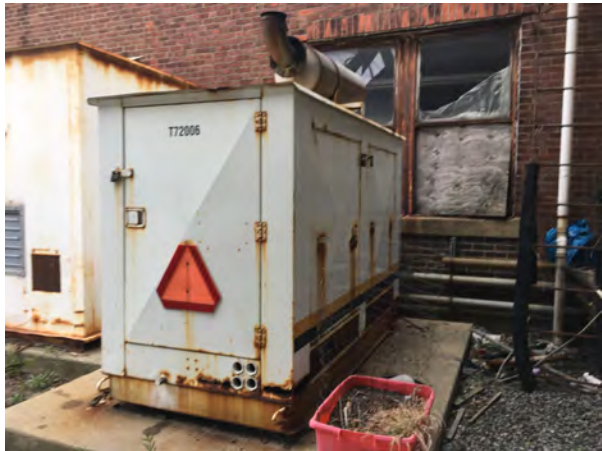
ITEM		
Area	Exterior-Tower A

Description	Generator	
Quantity	2	
Notes	No Access.

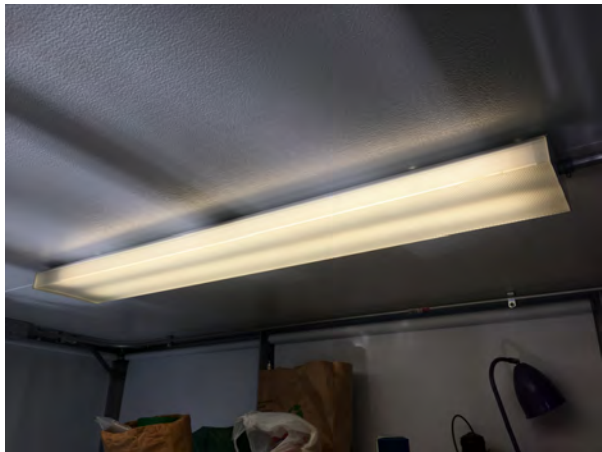
ITEM		
Area	New Control Tower

Description	Heavy Metal Containing Devices Fluorescent (Green Tip)	
Quantity	4	
Notes	N/A

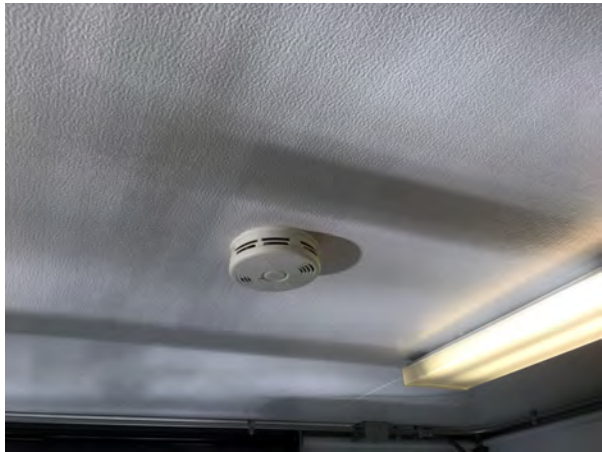
ITEM		
Area	New Control Tower

Description	Heavy Metal Containing Devices Smoke Detector Batteries	
Quantity	TBD	
Notes	1

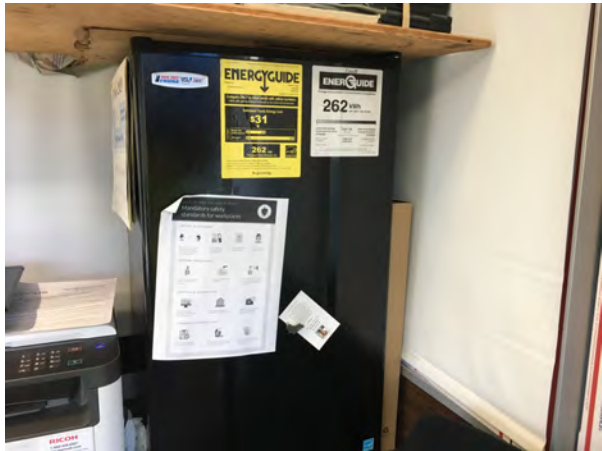
ITEM		
Area	New Control Tower

Description	Refrigerants Refrigerator	
Quantity	2	
Notes	N/A

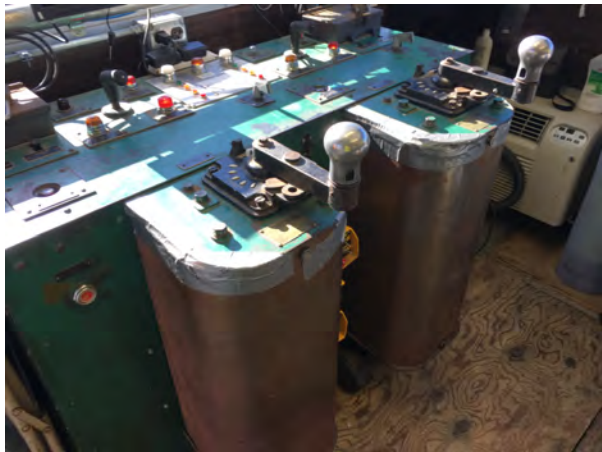
ITEM		
Area	New Control Tower

Description	Miscellaneous Electrical Components	
Quantity	3	
Notes	Control Panel/Cabinets

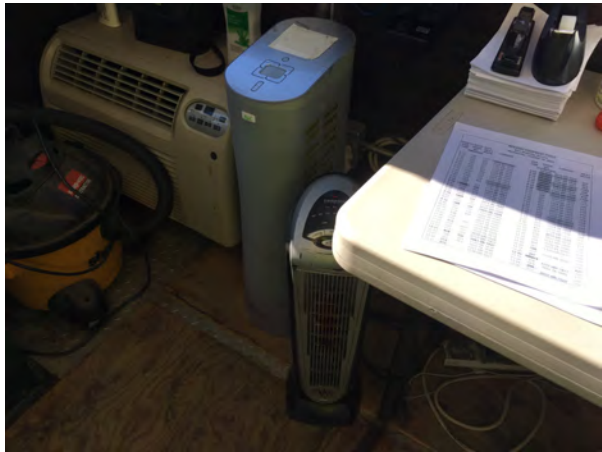
ITEM		
Area	New Control Tower

Description	Miscellaneous Other Electronic Recyclables	
Quantity	6	
Notes	1 Monitor/1 Printer/1 Computer/2 Space Heaters/1 Television

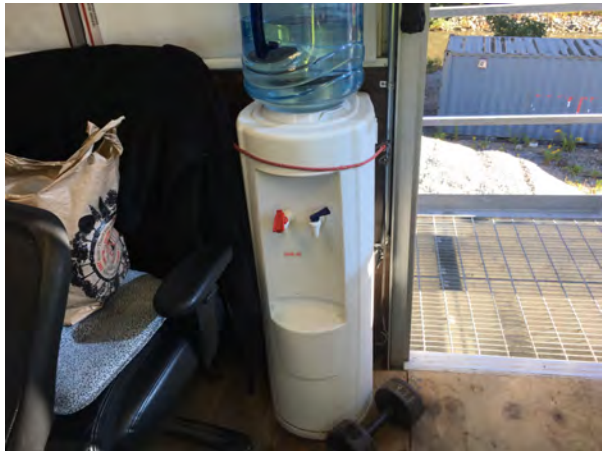
ITEM		
Area	New Control Tower

Description	Refrigerants Water Cooler	
Quantity	1	
Notes	N/A

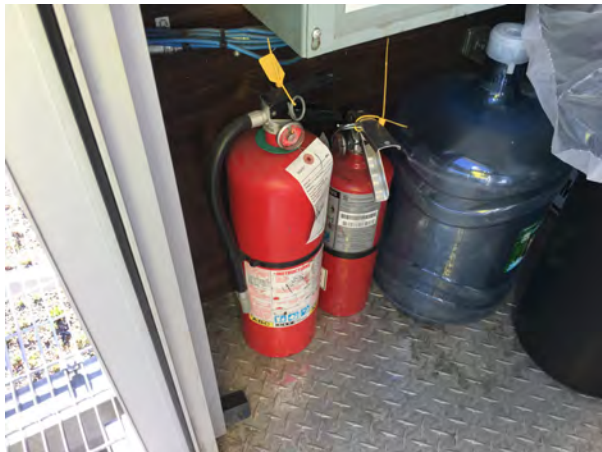
ITEM		
Area	New Control Tower

Description	Refrigerants Fire Extinguisher	
Quantity	2	
Notes	N/A

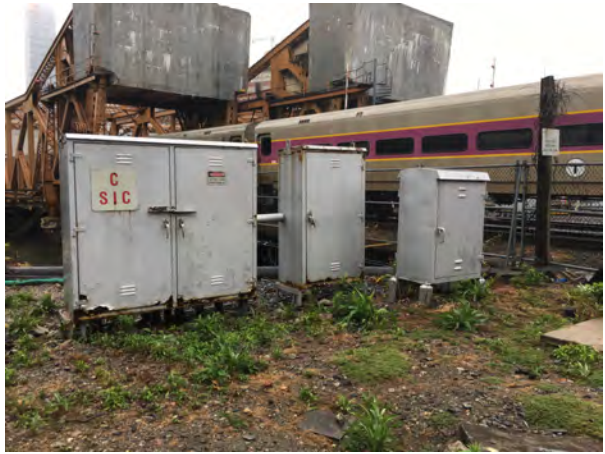
ITEM		
Area	New Control Tower

Description	Miscellaneous Electrical Components	
Quantity	5	
Notes	Miscellaneous Panels/Cabinets

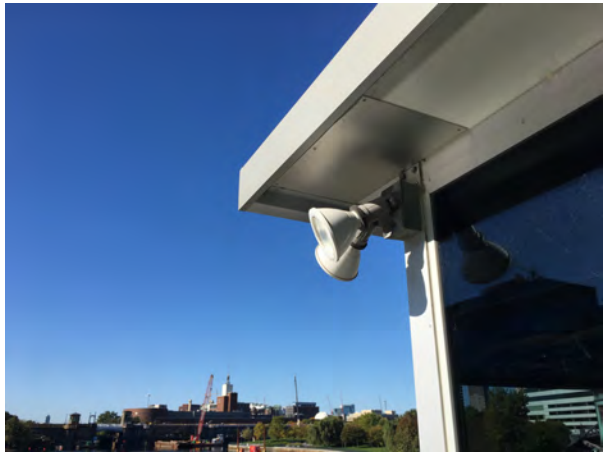
ITEM		
Area	New Control Tower

Description	Heavy Metal Containing Devices HID Lamp	
Quantity	9	
Notes	N/A

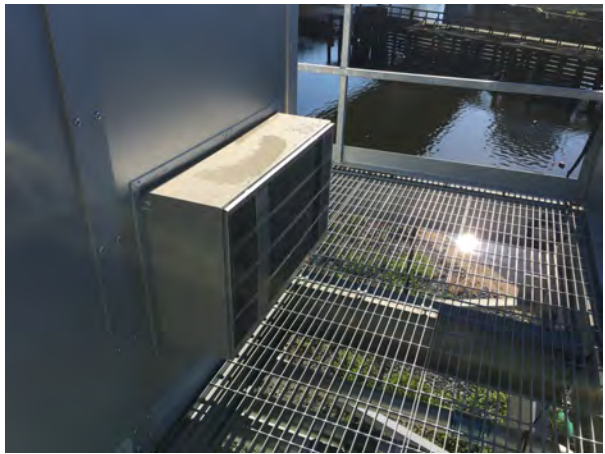
ITEM		
Area	New Control Tower

Description	Refrigerants Air Conditioner	
Quantity	1	
Notes	N/A

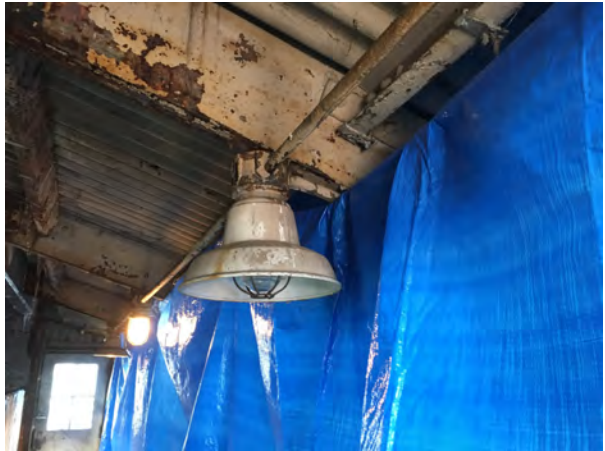
ITEM	
Area	Span 1 & 2
Description	Heavy Metal Containing Devices HID Lamp
Quantity	6
Notes	N/A

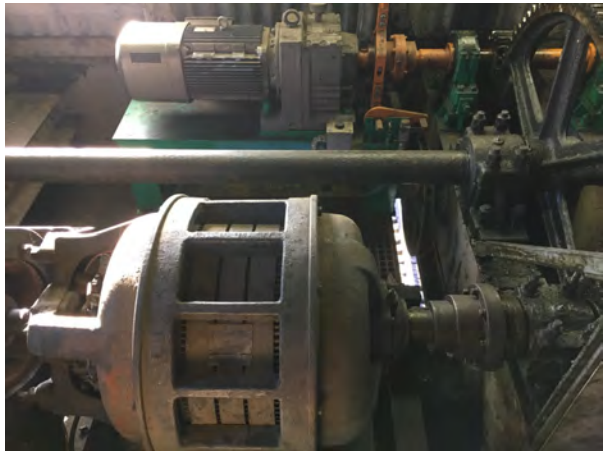
ITEM	
Area	Span 1 & 2
Description	Miscellaneous Large Motor
Quantity	6
Notes	3 Per Span

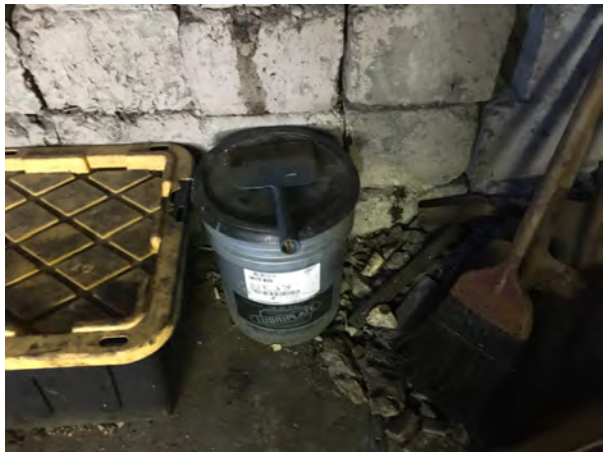
ITEM	
Area	Span 1 & 2
Description	Miscellaneous Oils
Quantity	3 (Grease/Lubricant)
Notes	2-5 Gallon Plastic Container /1-5Gallon Metal Container

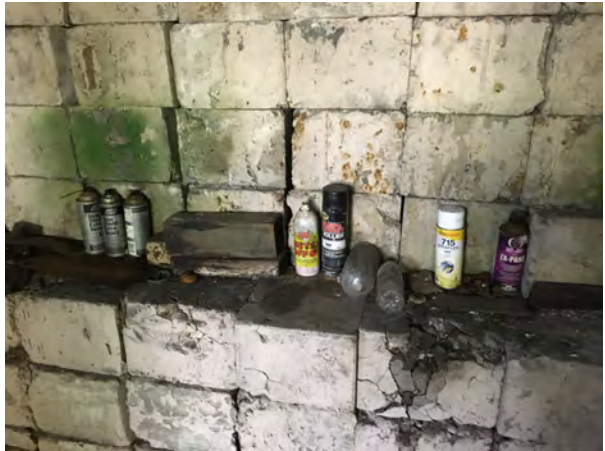
ITEM	
Area	Span 1 & 2
Description	Miscellaneous Oils
Quantity	17
Notes	16 Aerosol Lubricant/1 Aersosol Pesticide

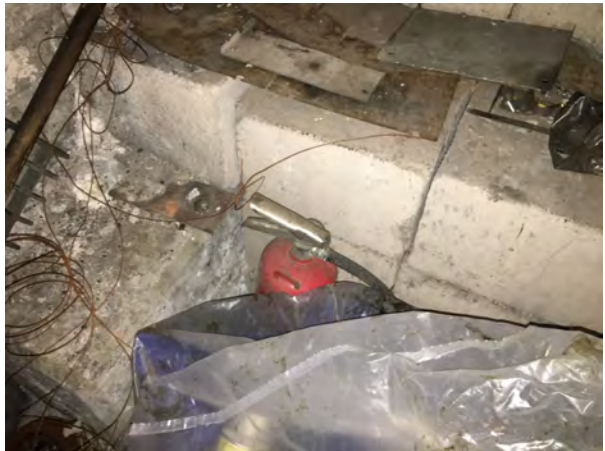
ITEM	
Area	Span 1 & 2
Description	Refrigerants Fire Extinguisher
Quantity	1
Notes	N/A

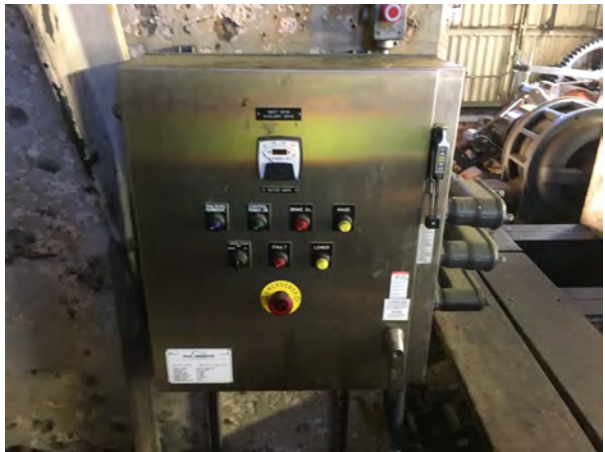
ITEM	
Area	Span 1 & 2
Description	Miscellaneous Electrical Components
Quantity	2
Notes	1 Panel Per Span/1 Exterior Panel/1 Cabinet

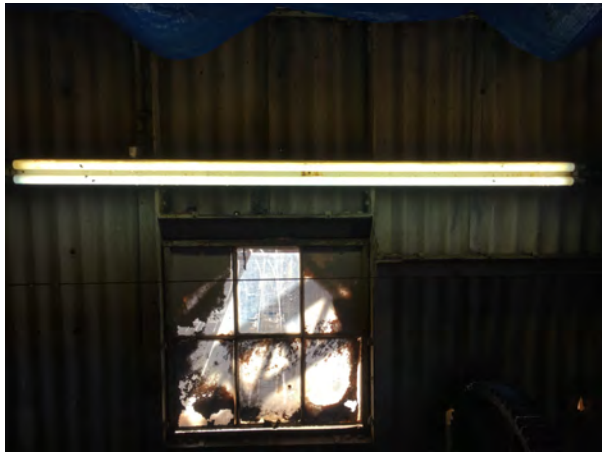
ITEM		
Area	Span 1 & 2

Description	Heavy Metal Containing Devices Fluorescent (Silver Tip)	
Quantity	12	
Notes	8'

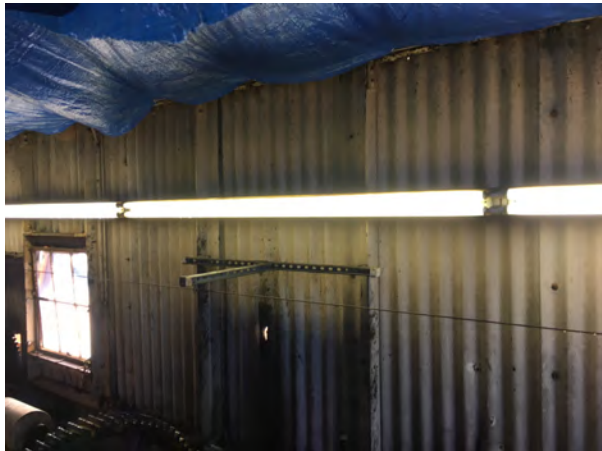
ITEM		
Area	Span 1 & 2

Description	PCB Containing Devices PCB Ballast	
Quantity	6	
Notes	N/A

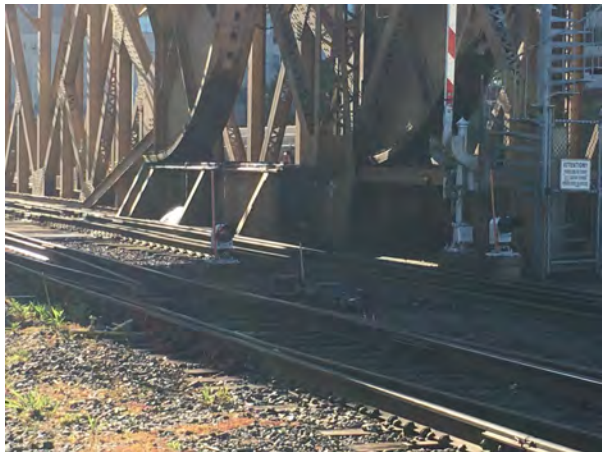
ITEM		
Area	Span 1 & 2

Description	Heavy Metal Containing Devices HID Lamp	
Quantity	8	
Notes	N/A
