**Massachusetts Bay
Transportation Authority**

Rail Transit Tunnel Inspection Manual

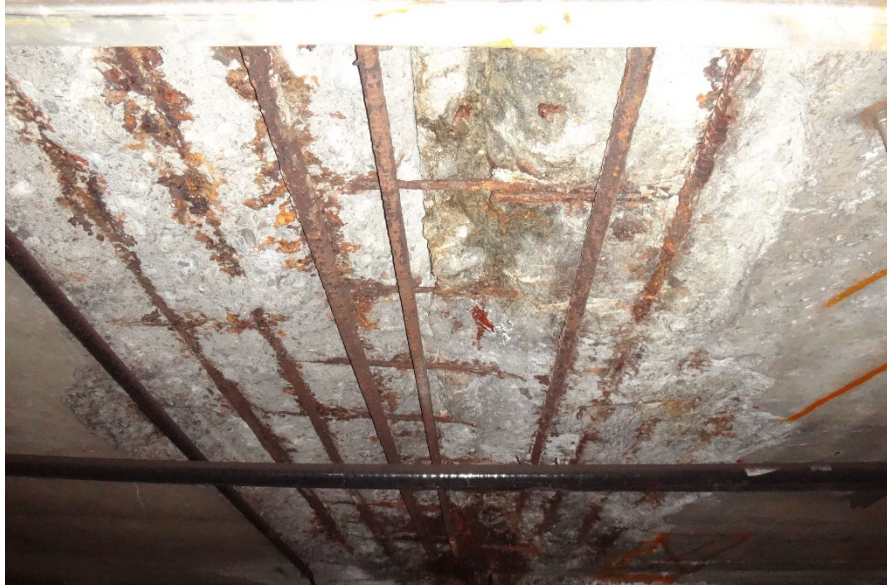
Figure 6.2.1-1 Concrete Deficiency: Spall with Exposed Reinforcing Steel

- a) Spalls: Spalls are visually apparent along the concrete surfaces of the tunnel. Spalls are roughly circular or oval depressions caused by the separation and subsequent removal of a portion of the concrete revealing a fracture that is roughly parallel, or slightly inclined, to the surface. Often, portions of the main reinforcing steel or prestressing strands are exposed and exhibit varying degrees of corrosion and/or section loss if not epoxy coated.

Spalls should be documented in length and width or length and height (depending on the plane on which the spall is found) with a corresponding depth and should be classified into different defect codes as discussed in Section 7. The presence and condition of exposed reinforcement should also be documented, as this can affect the condition state coding.

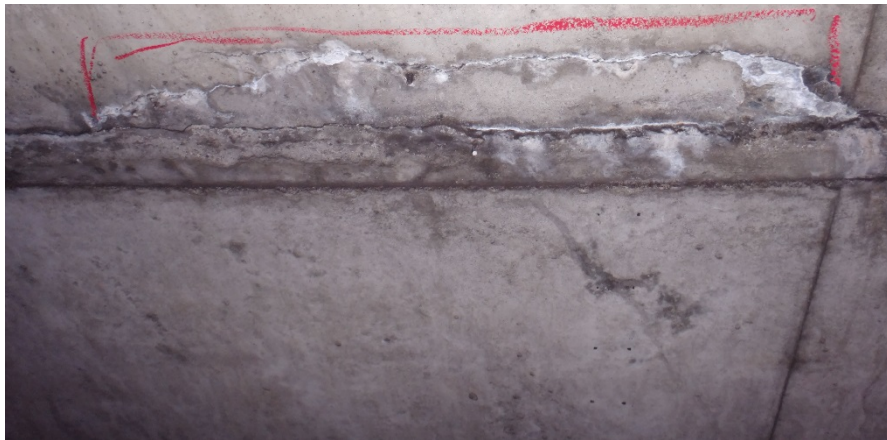
Figure 6.2.1-2 Concrete Deficiency: Delamination

- b) Delamination (sometimes referred to as incipient spalls): A delaminated area of concrete is one that produces a hollow sound when struck by a hammer. Delaminated areas are more difficult to detect than spalls since they are laminar to the surface of the concrete. Areas of delamination that are visibly apparent due to the presence of cracks (such as map or pattern cracks that may encompass the full perimeter of the area with noticeable distress, movement, or separation between adjacent surfaces) are often referred to as incipient spalls. Incipient spalls are considered critical findings if they present a safety issue and should be dealt with immediately in accordance with the provisions outlined in Section 4.7.

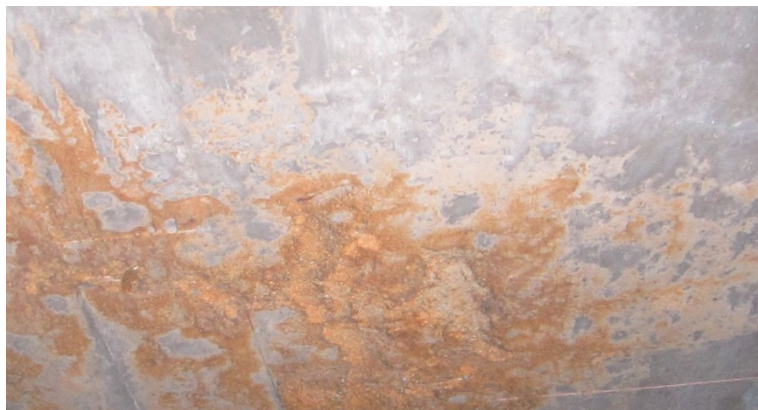
Figure 6.2.1-4 Concrete Deficiency: Rust Staining

- Random Cracks — Meandering irregular cracks on the surface of concrete. They have no form and do not logically fall into any of the classifications described above.
- d) Rust Staining: Rust staining is a visibly apparent discoloration of the concrete's surface caused by dissolved materials passing through cracks and being deposited on the surface when the water emerges and evaporates. Rust staining is typically brown or red

It is not uncommon for rust staining to be the result of corrosion of ancillary metal items or brackets that are supported from the concrete element. This type of rust staining is not structural and is typically superficial. The inspector should clearly make a distinction between the two.

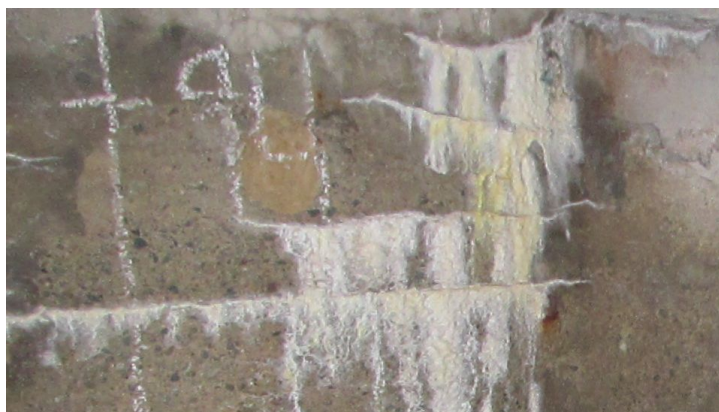
Figure 6.2.1-5 Concrete Deficiency: Efflorescence

- e) Efflorescence: Efflorescence, similar to rust staining, is a visibly apparent discoloration of the surface of the concrete caused by a combination of calcium carbonate leached out of the cement paste and other recrystallized carbonate and chloride compounds that form on the concrete surface.

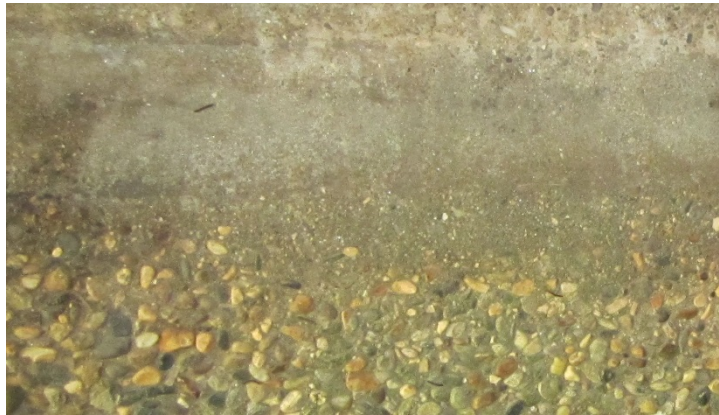
Figure 6.2.1-6 Concrete Deficiency: Scaling

- f) **Wetness:** Wetness is visibly apparent and typically occurs on regions of the concrete liner (walls, roof, or invert slab) where water is visible penetrating either through existing cracks or through construction/expansion joints. The type of structure and the method of construction may greatly contribute to the likelihood of encountering wetness within a segment of tunnel.
- g) **Scaling:** Scaling is the visibly apparent gradual and continuing loss of surface mortar and aggregate. It should be documented noting an associated length/height or height/width with corresponding depth. Various degrees of scaling are discussed in Section 7.

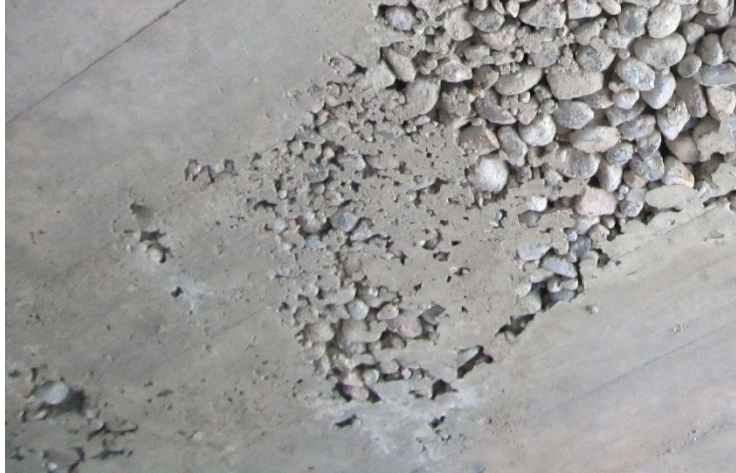
Figure 6.2.1-7 Concrete Deficiency: Honeycomb

- i) **Mudballs:** Mudballs are visibly apparent small holes that are left in the surface by the dissolution of clay balls or soft shale particles. Mudballs should be documented and classified in a manner similar to that used for pop-outs.
- j) **Honeycomb:** Honeycomb represents areas of typically small voids within concrete and represents construction defects that result from insufficient vibration of concrete. When honeycomb is at the surface, it is visible as small irregular-shaped voids, often exposing aggregate or other embedded items.

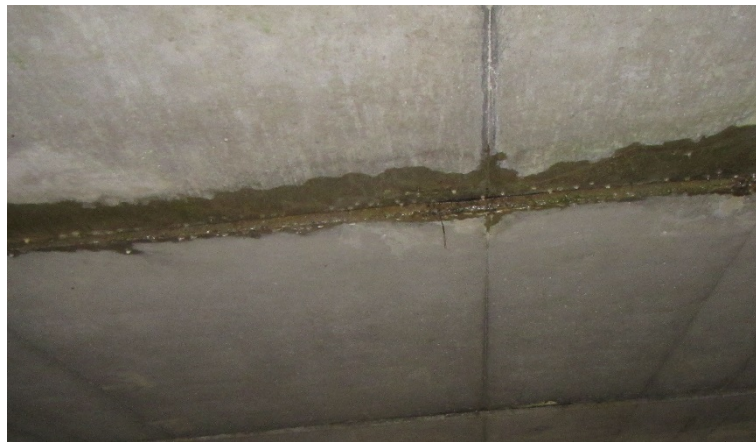
Figure 6.2.1-8 Concrete Deficiency: Differential Settlement

- Differential settlement that may have occurred along expansion joints or in transition areas of the tunnel, such as at the interface between an arch section and a box section or between a tunnel section and a station.

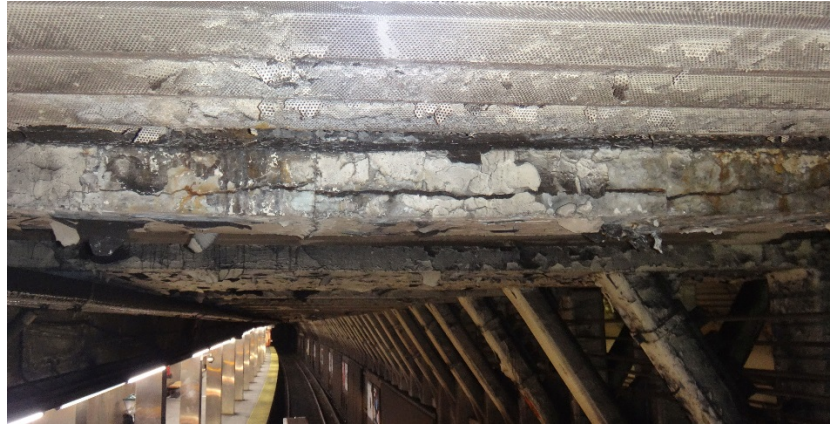
Figure 6.2.1-9 Concrete Deficiency: Incipient Spall at Concrete Encased Steel Beam

- Incipient spalls at concrete-encased steel beams, particularly where longitudinal separation cracks are visually apparent along the flange of the beam or where active leaks are readily apparent.

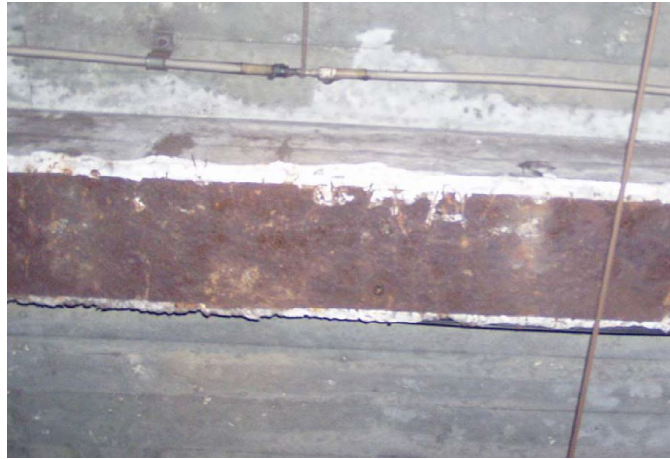
Figure 6.2.2-1 Steel Deficiency: Light Corrosion

- Minor — A light, loose formation of corrosion that easily brushes off the surface.

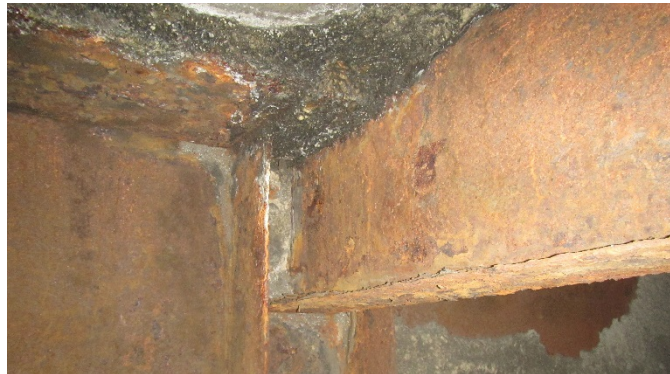
Figure 6.2.2-2 Steel Deficiency: Moderate Corrosion

- Moderate — A looser corrosion formation with scales or flakes forming. Definite areas of corrosion are discernible.

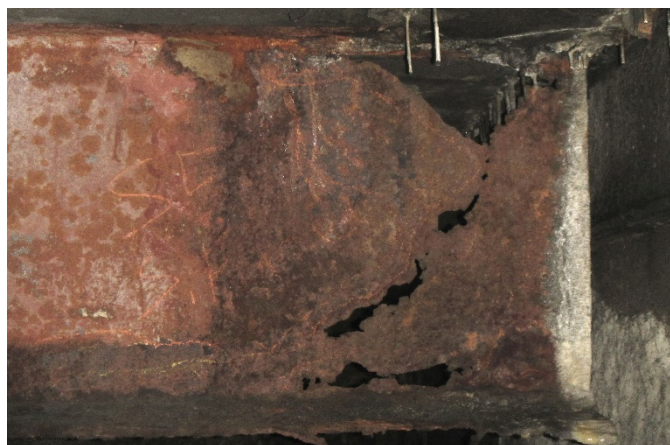
Figure 6.2.2-3 Steel Deficiency: Severe Corrosion

- Severe — A heavy, stratified corrosion or corrosion scale with pitting of the metal surface. This corrosion condition eventually culminates in loss of steel section and generally occurs where there is water infiltration.

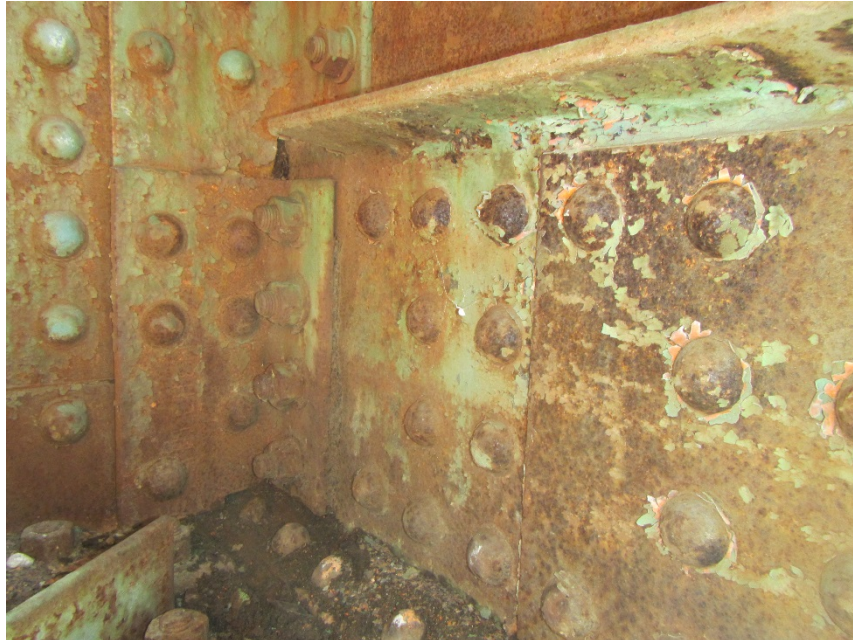
Figure 6.2.2-4 Steel Deficiency: Connection (Light Corrosion)

- b) Cracks: Cracks in the steel may vary from hairline thickness to a width sufficient to transmit light through the member. Any type of crack in a primary steel member is serious and should be reported at once. Look for cracks radiating from problematic details such as cuts, notches, and weldments. All cracks in the steel will be classified as severe.
- c) Connection: Steel connections may consist of riveted, bolted, or welded connections. For riveted or bolted connections, individual fasteners may be missing, loose, or corroded. Welded connections should be checked for cracks.

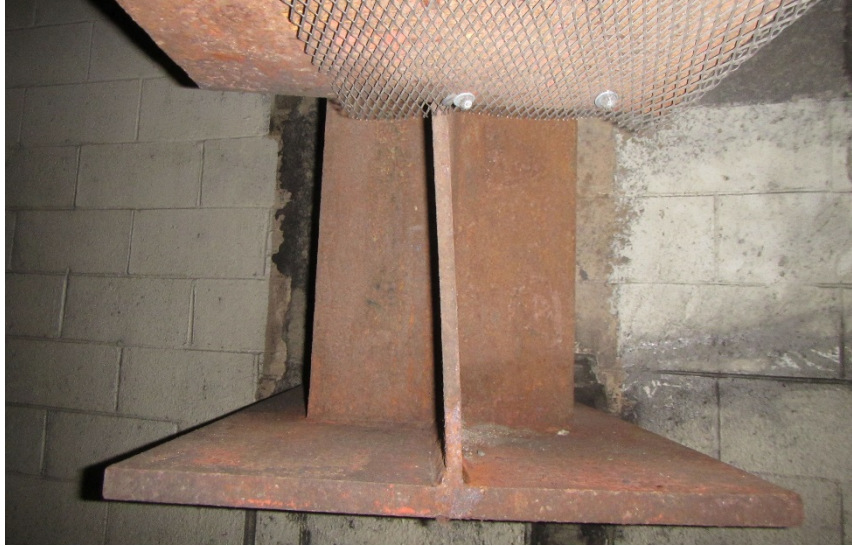
Figure 6.2.2-5 Steel Deficiency: Distortion

- d) Distortion: Distortion develops primarily because of damage arising from thermal strain, overload, or added load conditions. Erection or collision damage may also cause buckles, kinks, and cuts.

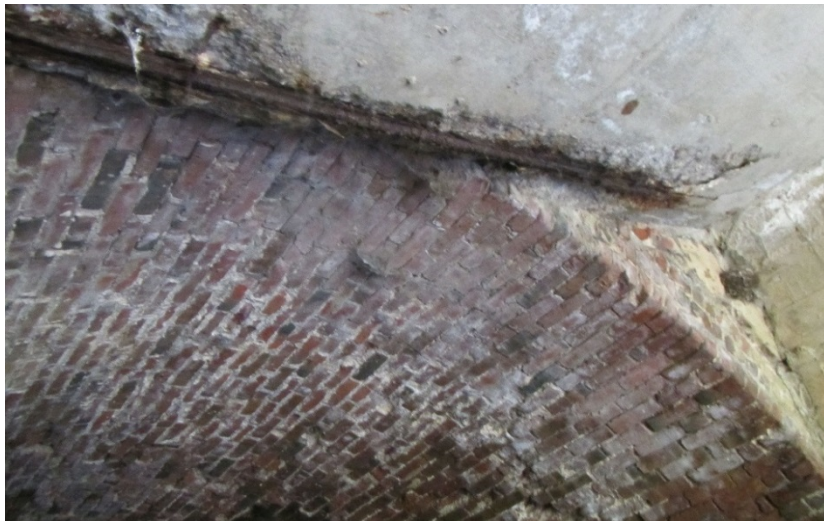
Figure 6.2.3-1 Masonry Deficiency: Mortar Breakdown and Efflorescence

- a) Efflorescence, Rust Staining: Efflorescence and rust staining are defined in Section 6.2.1 d) and e) above. The presence of either in masonry structures or facades typically manifests through cracked or defective mortar joints. The presence of rust staining would also likely indicate that the reinforcing steel behind the masonry facing is corroding.
- b) Mortar Breakdown: Mortar should be checked for its soundness and bonding to the masonry units. It is important to note cracked and missing mortar, especially the depth and extent of missing mortar.

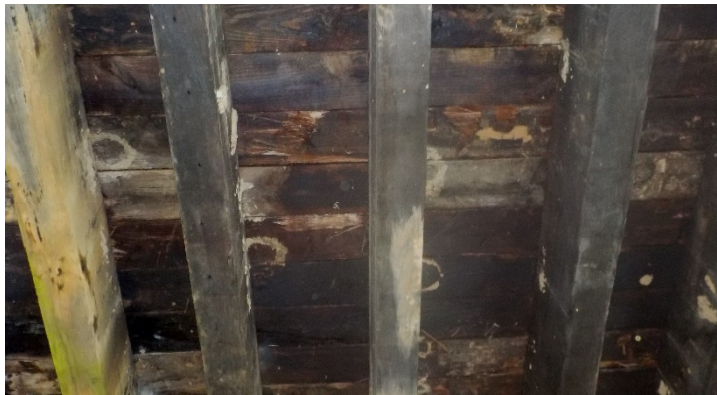
Figure 6.2.4-1 Timber Deficiency: Decay or Rot

- a) Decay or Rot: Decay is the primary cause of timber deterioration. It is produced by living fungi that feed on the cell walls of timber members. Decay occurs in areas where moisture is present and causes a black, brown, or white discoloration on the surface. This leads to soft wood and section loss, which should be investigated and documented.

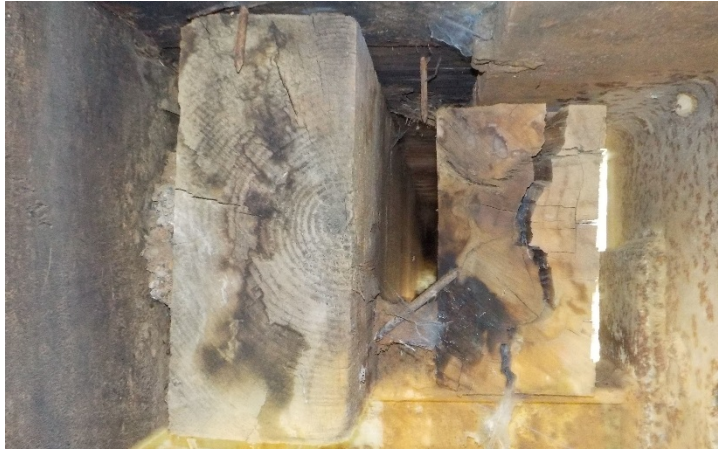
Figure 6.2.4-2 Timber Deficiency: Cracks and Splits

- b) Voids: Voids in this context refer to the presence of voids in the earth material behind lagging and not voids within the timber itself. These can sometimes be seen between the planks or detected by probing with a wire.
- c) Cracks, Splits, Checks: Cracks in timber members are classified as checks, which penetrate to a partial depth, and splits, which penetrate completely through the member.

The extent and location of both should be identified, with special emphasis on splits within timber beams.

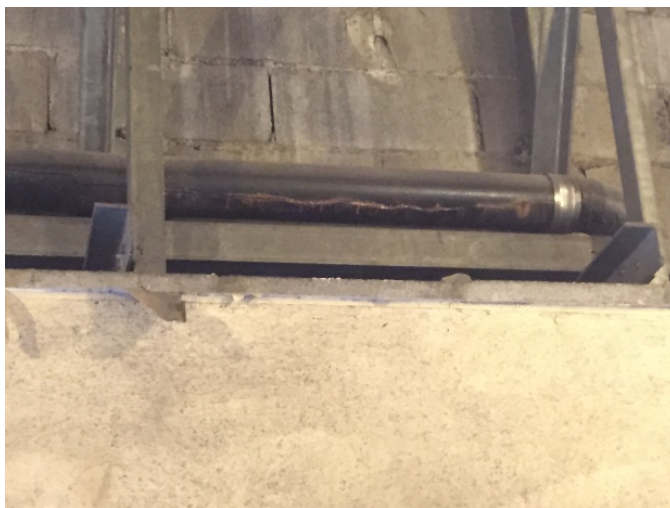
Figure 6.3.1-1 Drain System Deficiency: Cracked Pipe

- Clogs
- Cracked pipes (see photo below for an example of deterioration)

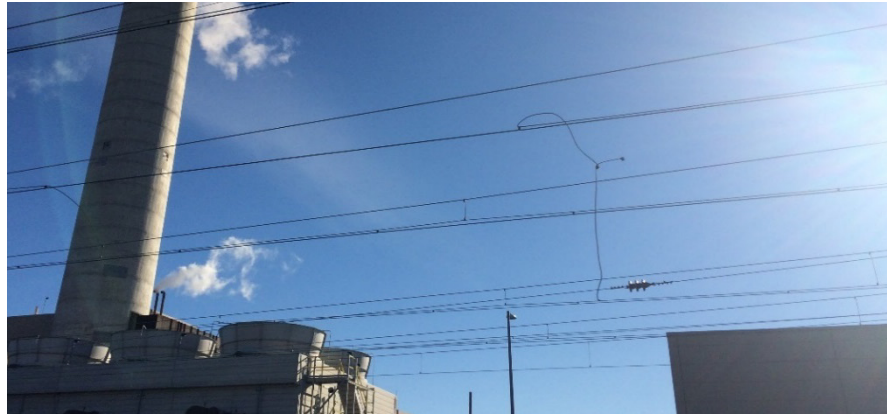
Figure 6.6.2-1 Power Asset Deficiency: Fatigue Break of a Conductor

- a) Power/Cable Conductor
 - Broken cables/conductors — Cables and conductors can break apart during extreme changes in temperature and from fatigue, progressive burning, and improper application.

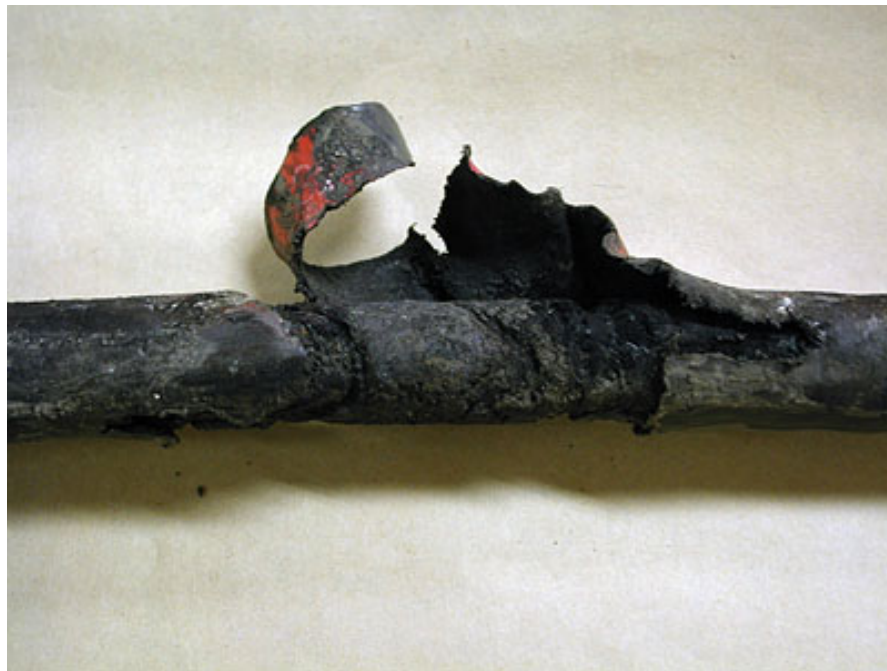
Figure 6.6.2-2 Power Asset Deficiency: Signs of Arcing on Cable

- Signs of arcing — The protective cover or sheath can be damaged from the outside in by arcing. This type of damage can appear as burn marks on the cable's sheath or the sheath being completely melted through, as seen in the photo below.

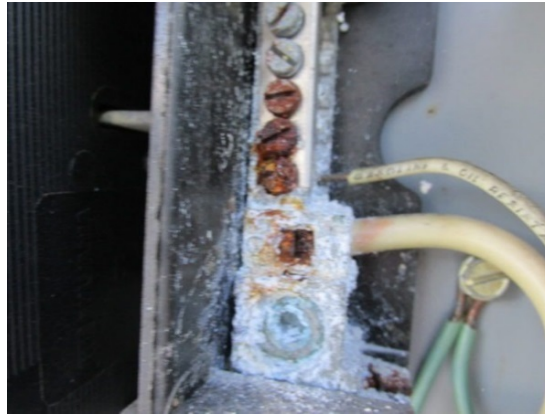
Figure 6.6.2-3 Power Asset Deficiency: Corrosion

- Corrosion — Corrosion can occur at the end of power cables on the taps. Corrosion can be caused by stray current, improper tightening, exposure to salt water, etc. The following photograph illustrates an example of a corroded tap.

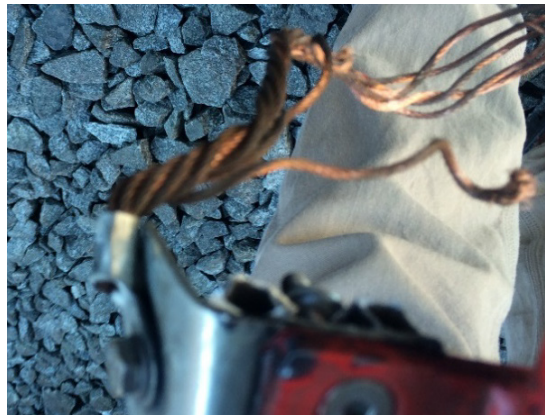
Figure 6.6.2-4 Power Asset Deficiency: Frayed Conductor

- Frayed conductors — Stranded conductors can come apart.

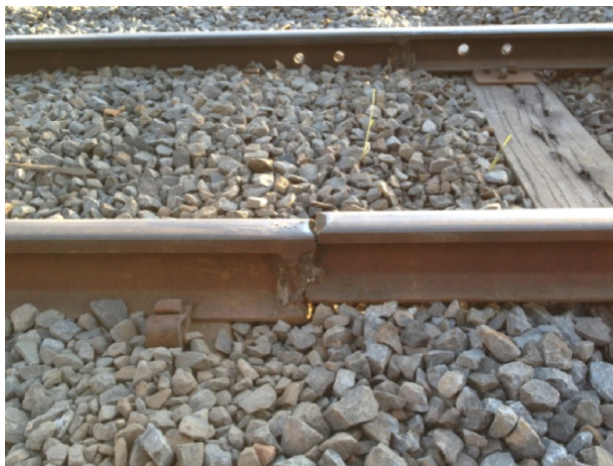
Figure 6.6.3-1 Track Asset Deficiency: Broken Rail

- a) Broken Rail: A rail can be cracked through with a transverse fracture that goes from the top to the bottom of the rail. Such cracks will affect the signal system and power return. Emergency clamps can be used to allow trains to pass until the broken rail section can be replaced with a new rail or joint. Other external cracks such as fissures and fractures are visible to the eye. Internal failures include splits, piping, fissures, cracks, or separations inside the rail and can only be found using tests such as ultrasounds or x-rays. Hence, the visual inspection can only pick up defects visible on the outside of the rail, not internal defects.

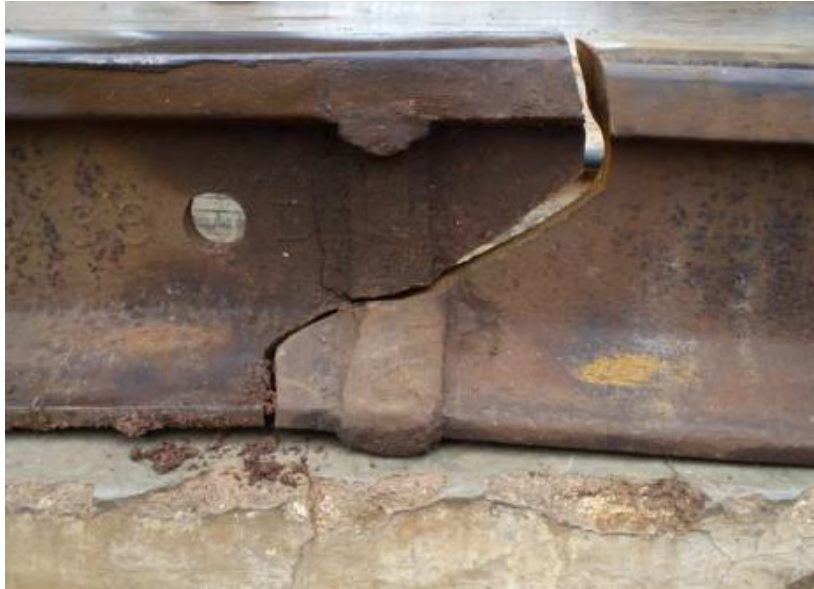
Figure 6.6.3-2 Track Asset Deficiency: Weld Failure

- b) **Weld Failures:** Weld failures are separations at the weld, be it a shop weld or a field weld. Field weld failures are usually identified using x-ray or ultrasound testing and may not be visible on the outside of the rail until failure of the rail has occurred. See the photograph below for a visual aid to determining deterioration.

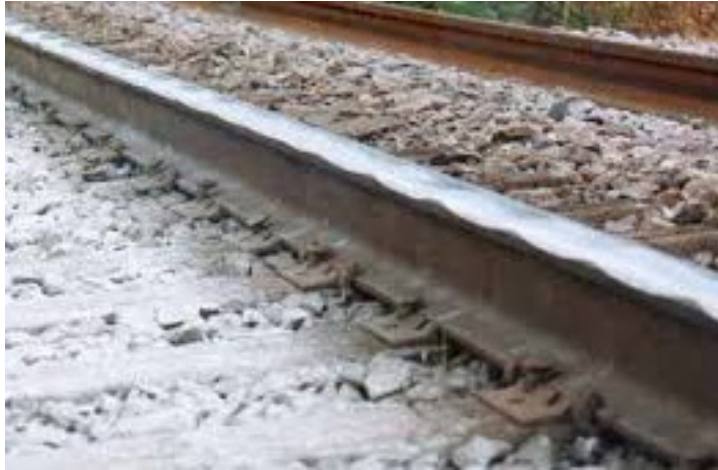
Figure 6.6.3-5 Track Asset Deficiency: Corrugation

- e) Corrugation: Corrugation, or “washboarding,” occurs on the rail head due to factors that include wheel slippage. It creates a wave pattern on the rail head that can generate noise and vibration. It is observed through visual inspection. Corrugation can be ground away with a rail grinder, or the rail can be replaced.

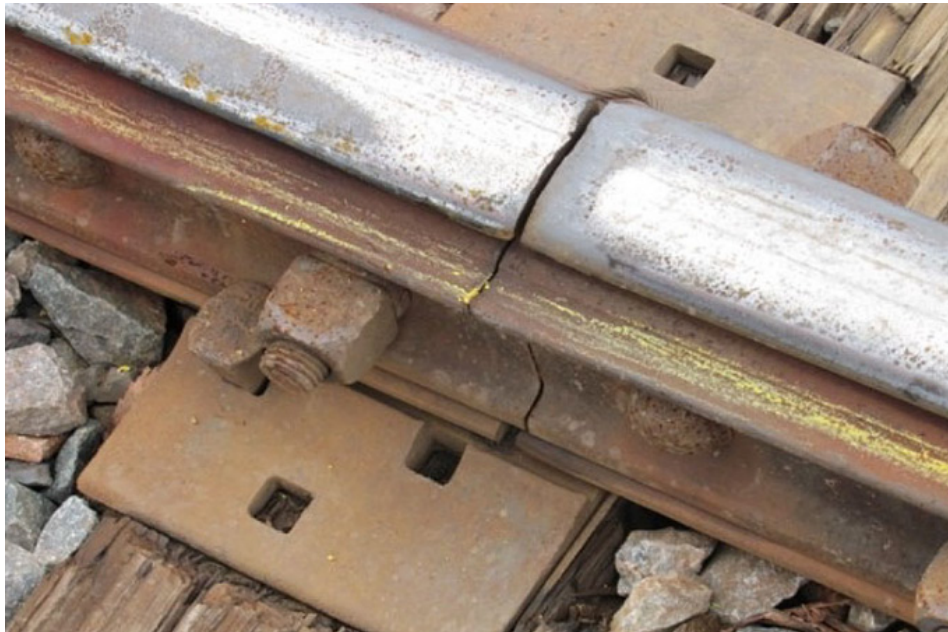
Figure 6.6.3-6 Track Asset Deficiency: Joint Defect

- f) Joint Defect: Joint bar hole cracks can only be seen if the bars are removed or if the crack permeates beyond the joint bar. Where rail is welded, there will not be that many joint bars except in turnouts or in power or signal block areas where insulated joint may be involved. Joint bar inspection must include the bolts themselves to determine whether they have cracked and fallen off. Torqueing bolts too tight may overstrain the bolts, leading to crack failures. Loose joint bars can be easily detected through visual inspection and by tapping with a hammer.

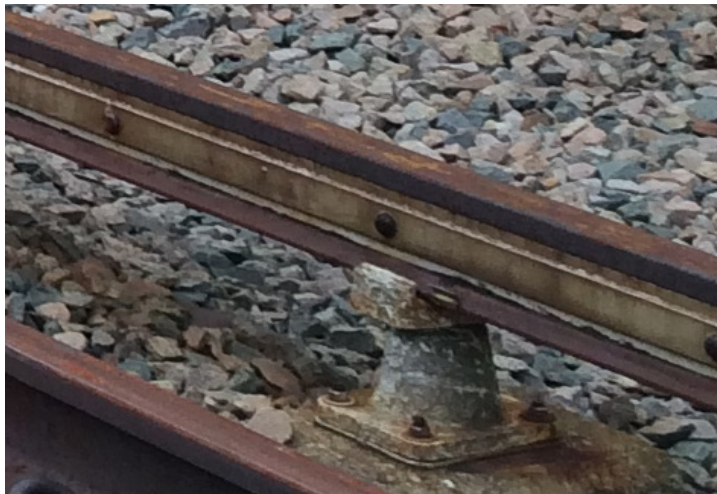
Figure 6.6.3-7 Track Asset Deficiency: Cable

- Loose joint bolt and nut connections
- Loose or detached third rail anchor
- Dirty or broken insulators

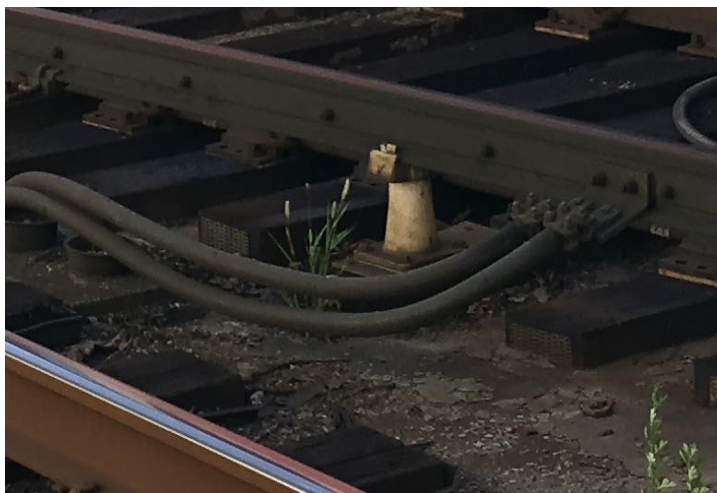
Figure 6.6.3-8 Track Asset Deficiency: Cable

- Disconnected cables from third rail tabs

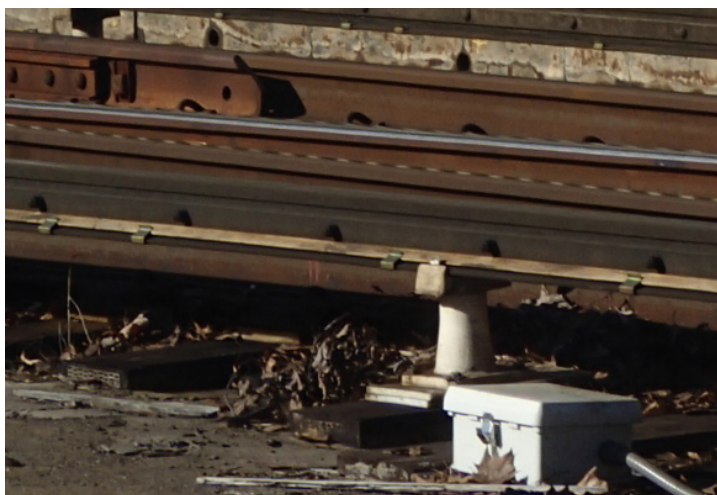
Figure 6.6.3-9 Track Asset Deficiency: Cable

- Detached or loose heater rods

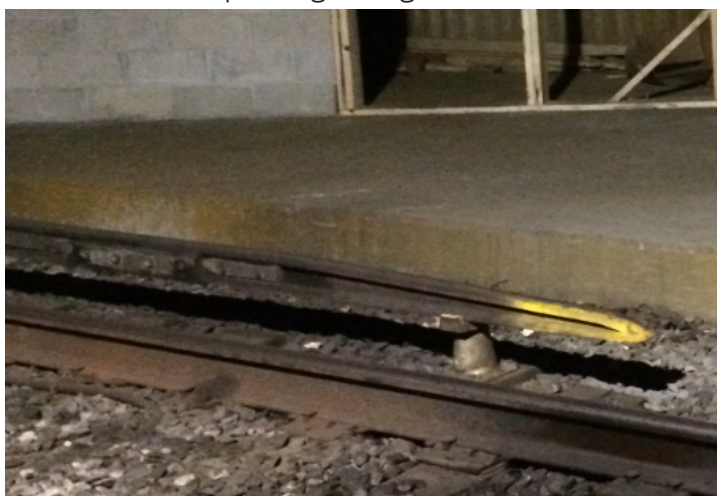
Figure 6.6.3-10 Track Asset Deficiency: Cable

- Risers or run-offs pointing too high or low

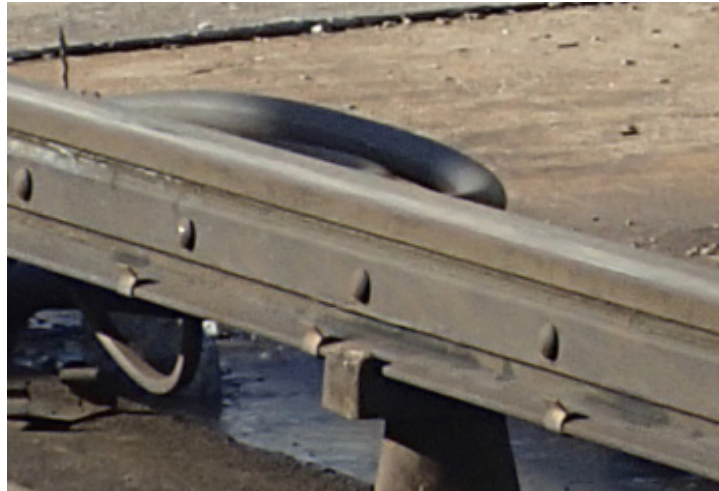
Figure 6.6.3-11 Track Asset Deficiency: Cable

- Cracked rail, excessive pitting, and gauge with running rail; see the photo below of a typical running rail

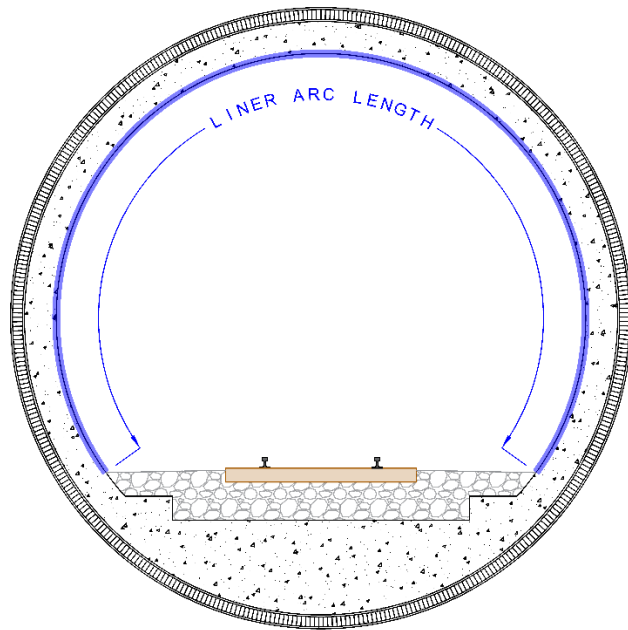
Figure 7.3.4-2 Element Qty Boundary: Liner (SF - Circular & Arch)

Liner (continued)
